UNITED STATES ENVIRONMENTAL PROTECTION AGENCY
REGION 5
77 W. JACKSON BOULEVARD
CHICAGO, IL 60604

SITE VISIT REPORT - FINAL

INSTALLATION NAME: Polychem Services, Inc., LLC
U.S. EPA ID No.: ILD 980 578 876
LOCATION ADDRESS: 374 E. Joe Orr Road
Chicago Heights, IL 60411
NAICS CODES: 325211 (Plastics, Material and Resin
Manufacturing); 424690 (Other Chemical and
Allied Products Merchant Wholesalers)
DATE OF INSPECTION: January 18, 2012
EPA INSPECTOR: Michael Valentino

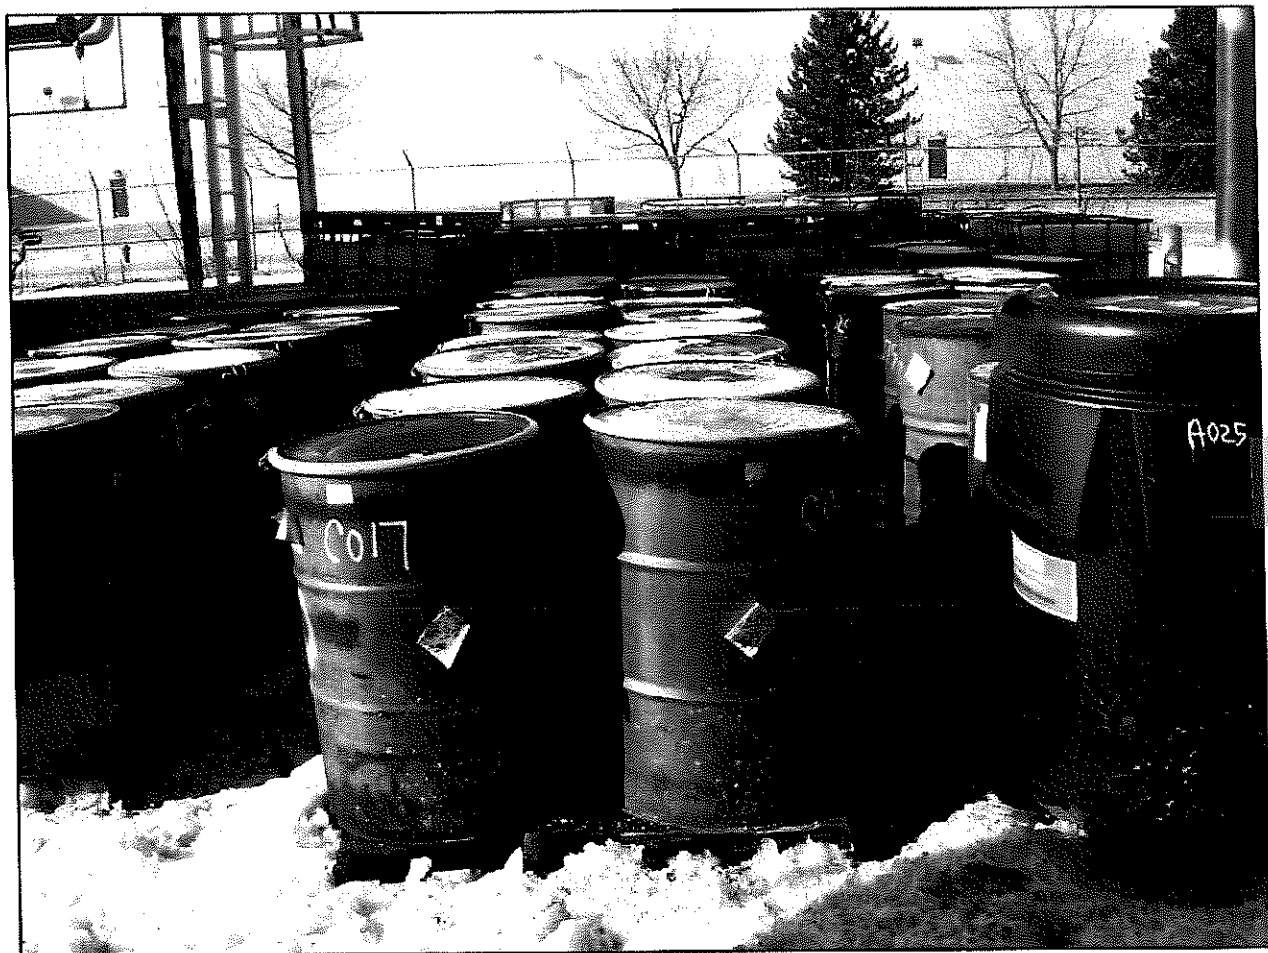
Photo 1 Taken by: Michael Valentino	Polychem Services, Inc.
1/18/12 10:52 am	West of production building just north of product tank farm. Photo shows rows of hazardous waste drums affixed with hazardous waste labels and flammable decals. Alpha-numeric markings on drums (e.g., "A025, C017") are from EPA during its March 2011 investigation. Overpack drum (R. foreground) is from EPA's March 2011 investigation. (Approx. drum count: 48)
Orientation: West

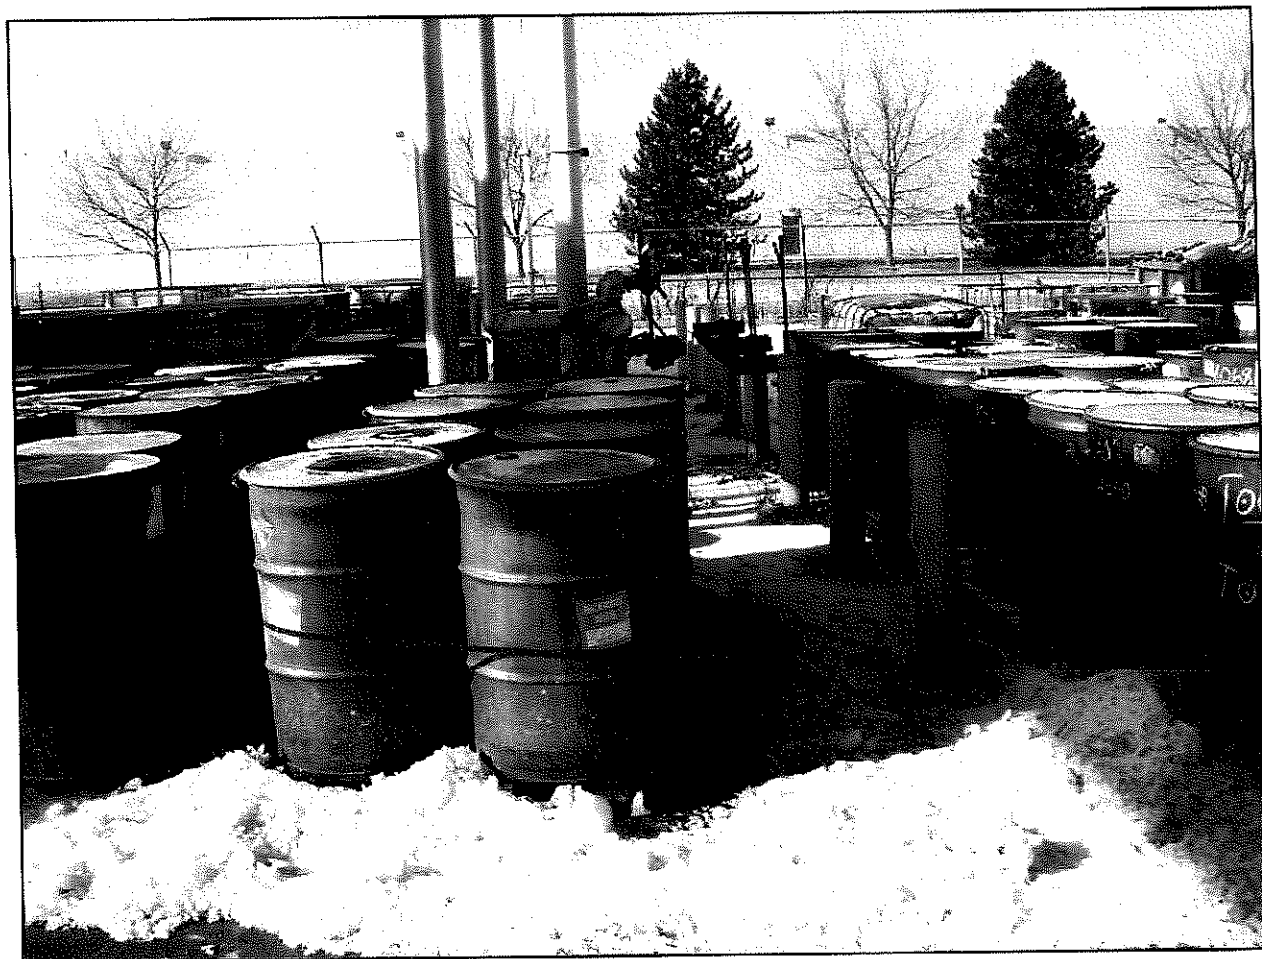
<p>Photo 2 Taken by: Michael Valentino</p>	<p>Polychem Services, Inc.</p>
<p>1/18/12 10:52 am Orientation: West</p>	<p>West of production building just north of product tank farm. Just north of where Photo 1 was taken. More rows of hazardous waste drums. Painted numbers (e.g., "55") on furthest left drum in foreground are indicative of JAS Environmental drum identification used in developing its waste inventory for Heartland. (Drum count, center pallets only: 8)</p>

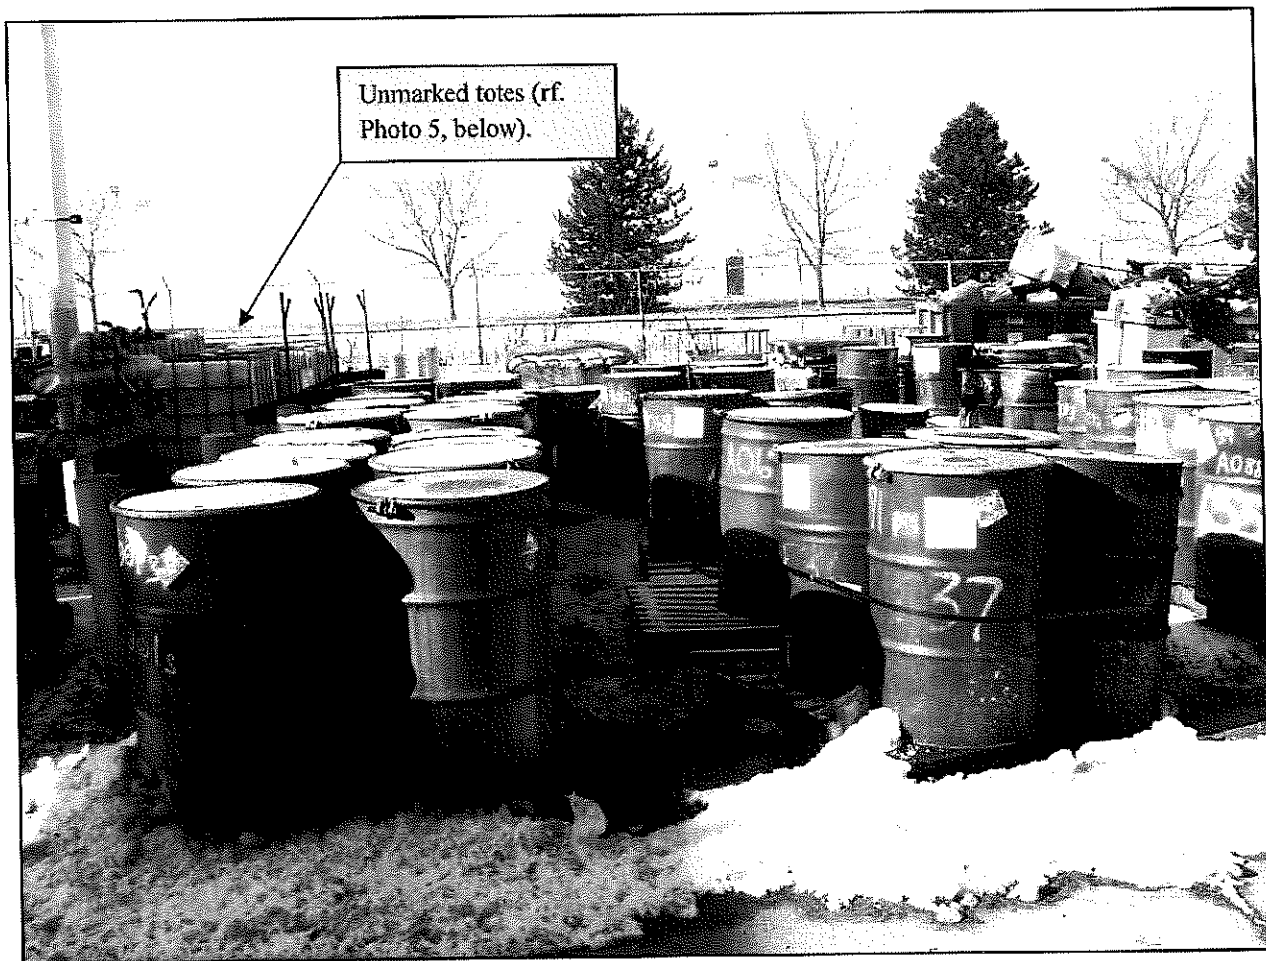
Photo 3	Taken by: Michael Valentino	Polychem Services, Inc.
1/18/12	10:52 am	West of production building just north of product tank farm. Just north of where Photo 2 was taken. (Approx. drum count, left and center-right pallets only: 27)
Orientation: West

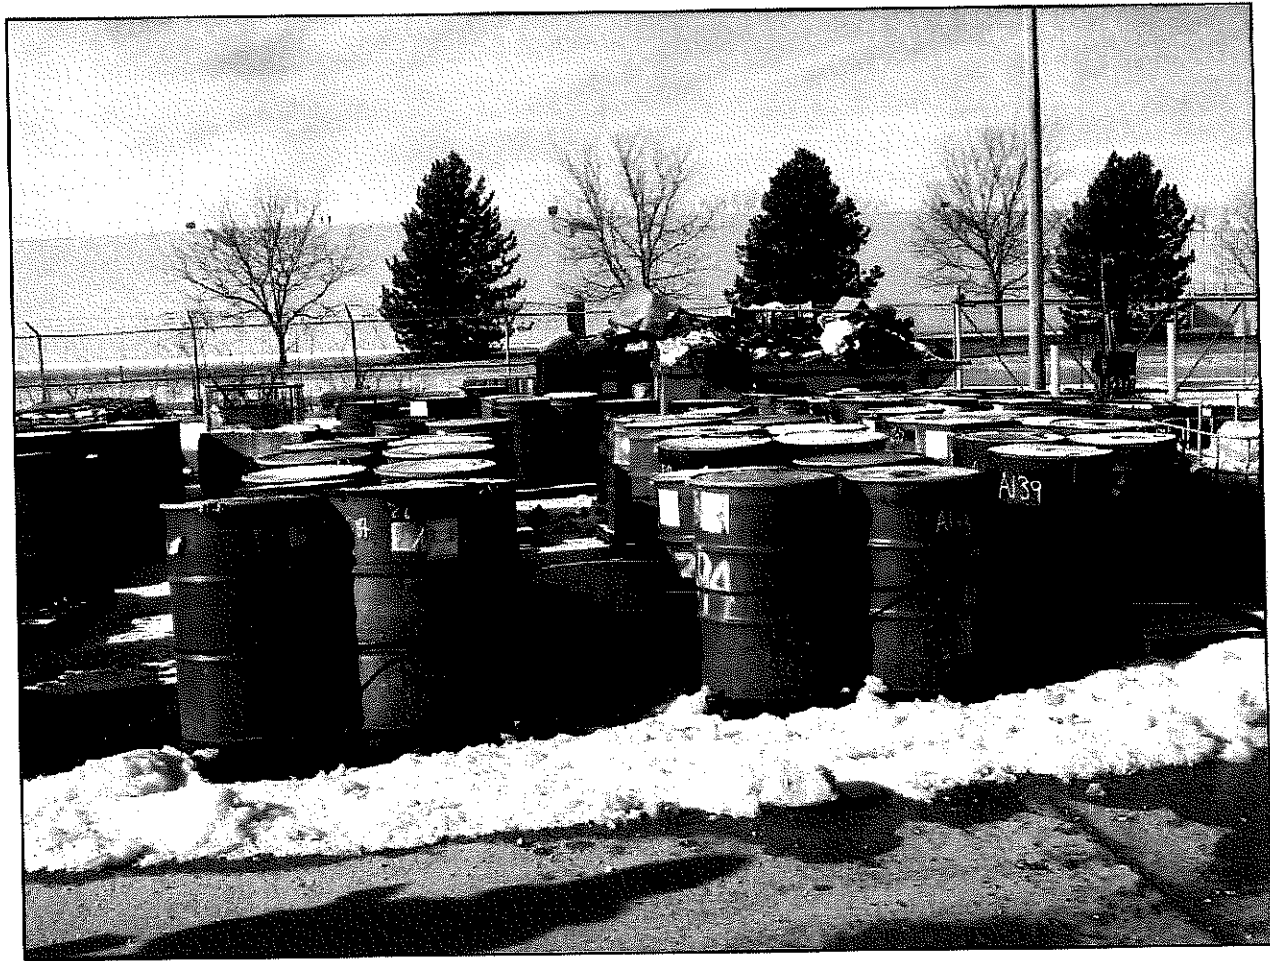
Photo 4	Taken by: Michael Valentino	Polychem Services, Inc.
1/18/12	10:53 am	West of production building just north of product tank farm. Just north of where Photo 3 was taken. (Approx. drum count, excluding furthest left pallets: 47)
Orientation: West

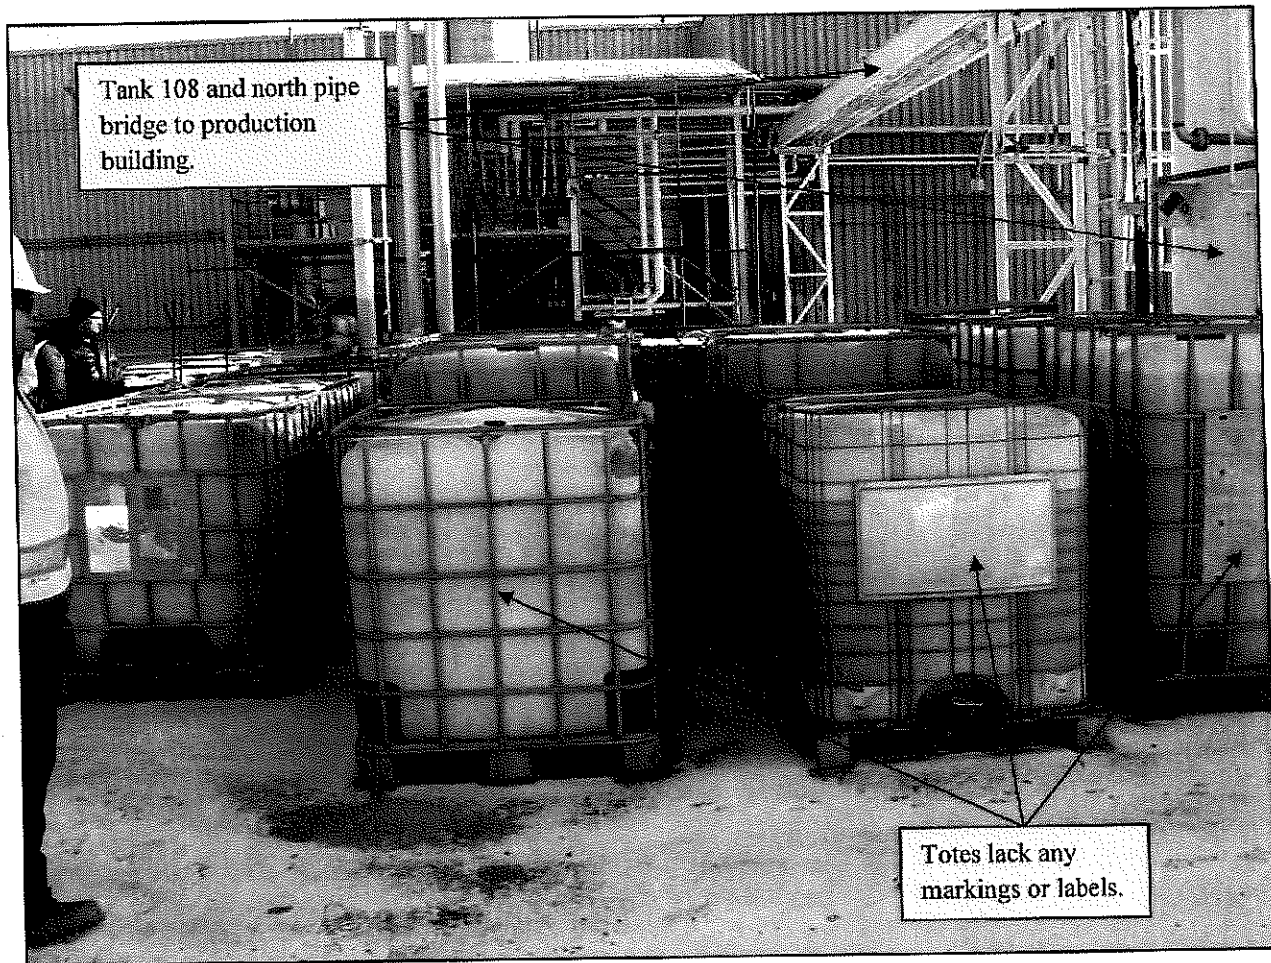
<p>Photo 5 Taken by: Michael Valentino</p> <p>1/18/12 10:56 am</p> <p>Orientation: East</p>	<p>Polychem Services, Inc.</p> <p>West of production building just north of product tank farm. Unmarked totes possibly containing hardened sodium sulfate salt, according to Polychem officials.</p>
---	--

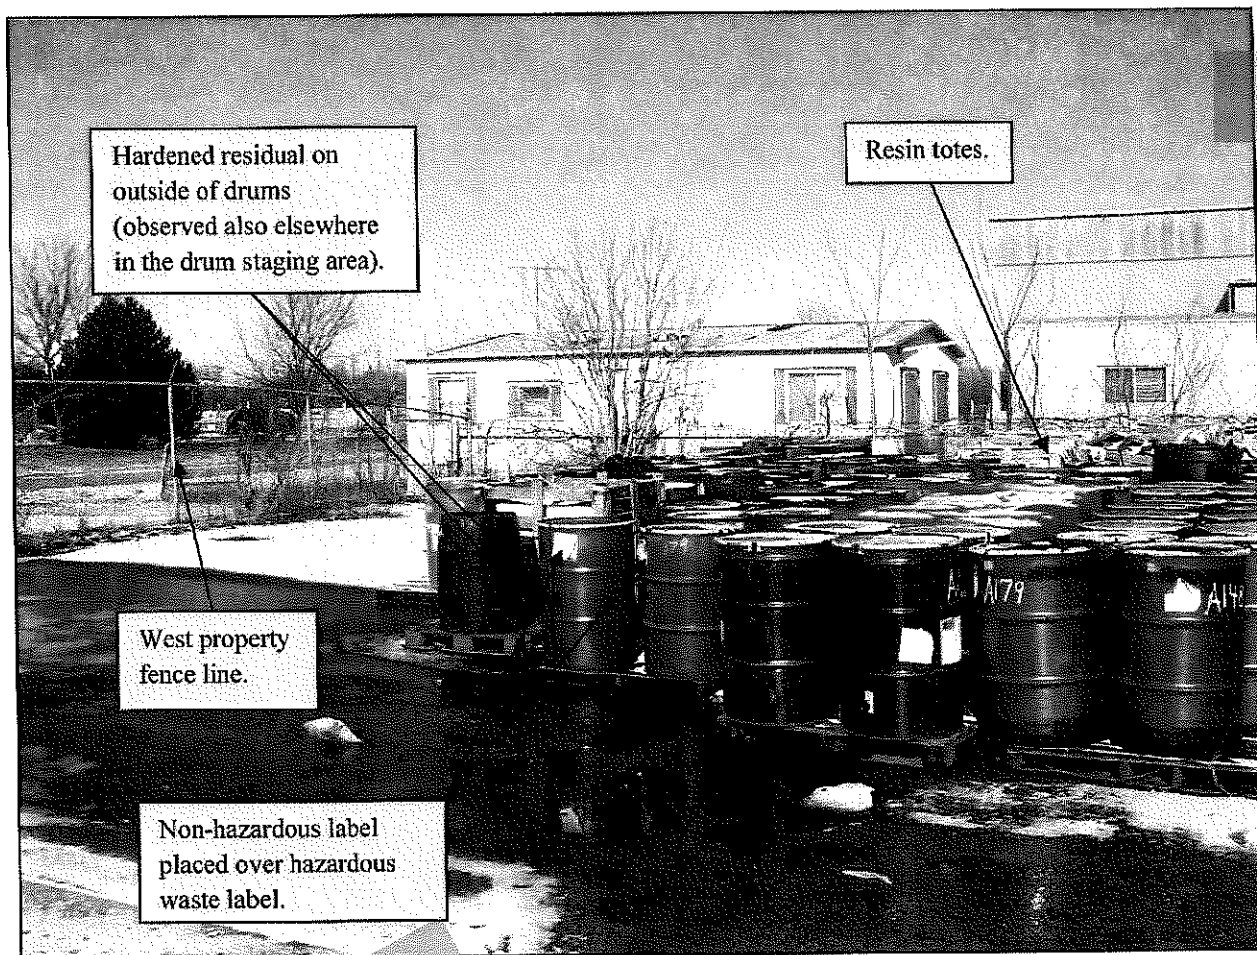
Photo 6	Taken by: Michael Valentino	Polychem Services, Inc.
1/18/12	10:58 am	Northwest corner of site. Mixture of hazardous and non-hazardous (predominantly) drums, resin totes left by Heartland, according to Polychem officials. (Approx. drum count, to the left of drum "A179" in right foreground: 34)
Orientation: Northwest

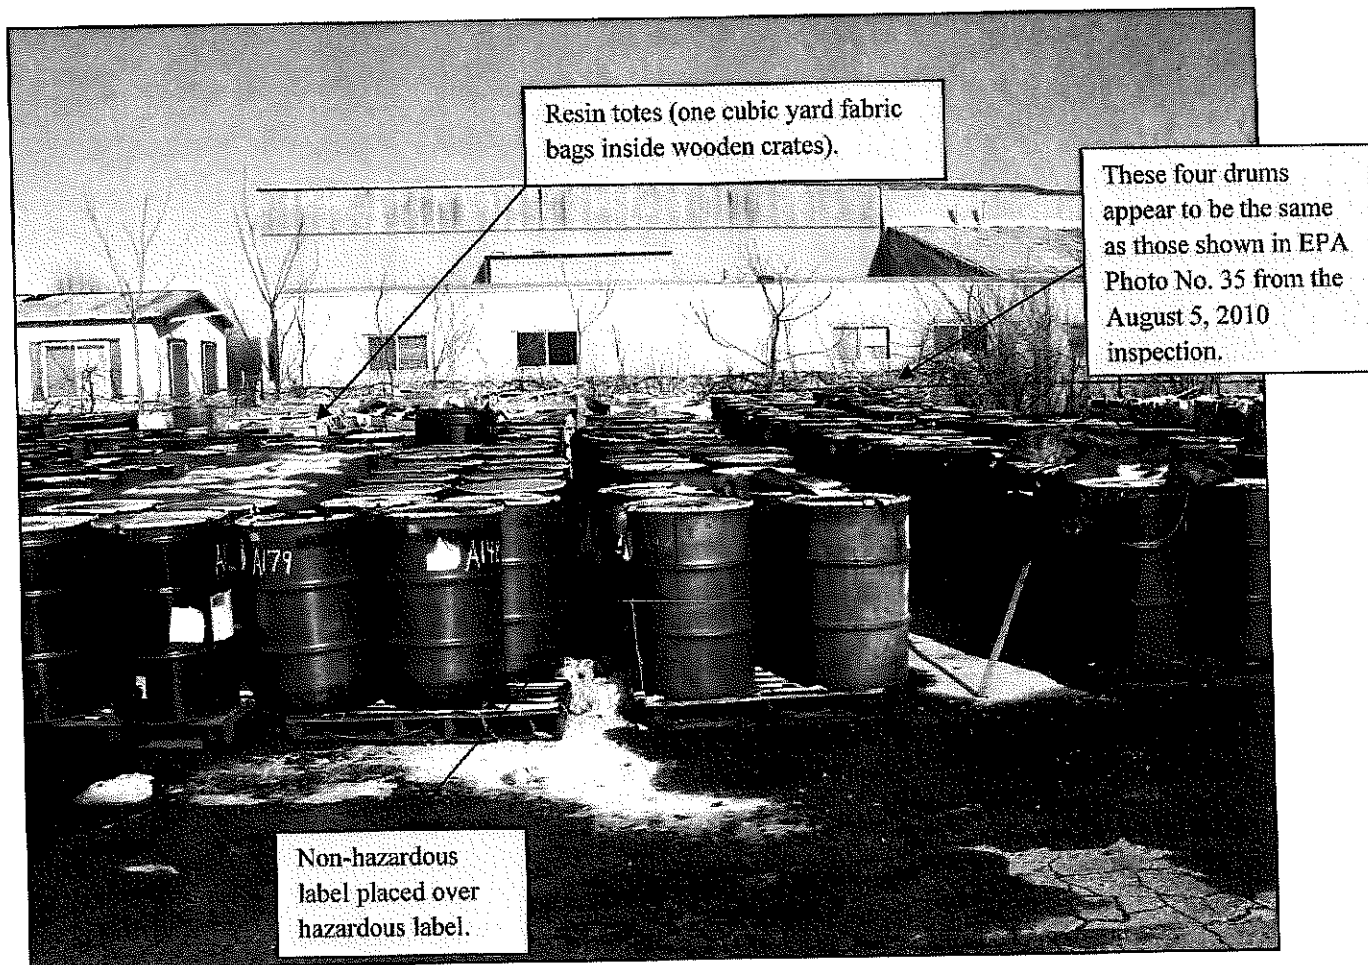
Photo 7	Taken by: Michael Valentino	Polychem Services, Inc.
1/18/12	10:58 am	Northwest corner of site. Mixture of hazardous and non-hazardous (predominantly) drums, resin totes left by Heartland, according to Polychem officials. Just east of Photo 6. (Approx. drum count, from drum "A179" to the row of full pallets to the right: 70)
Orientation:	North

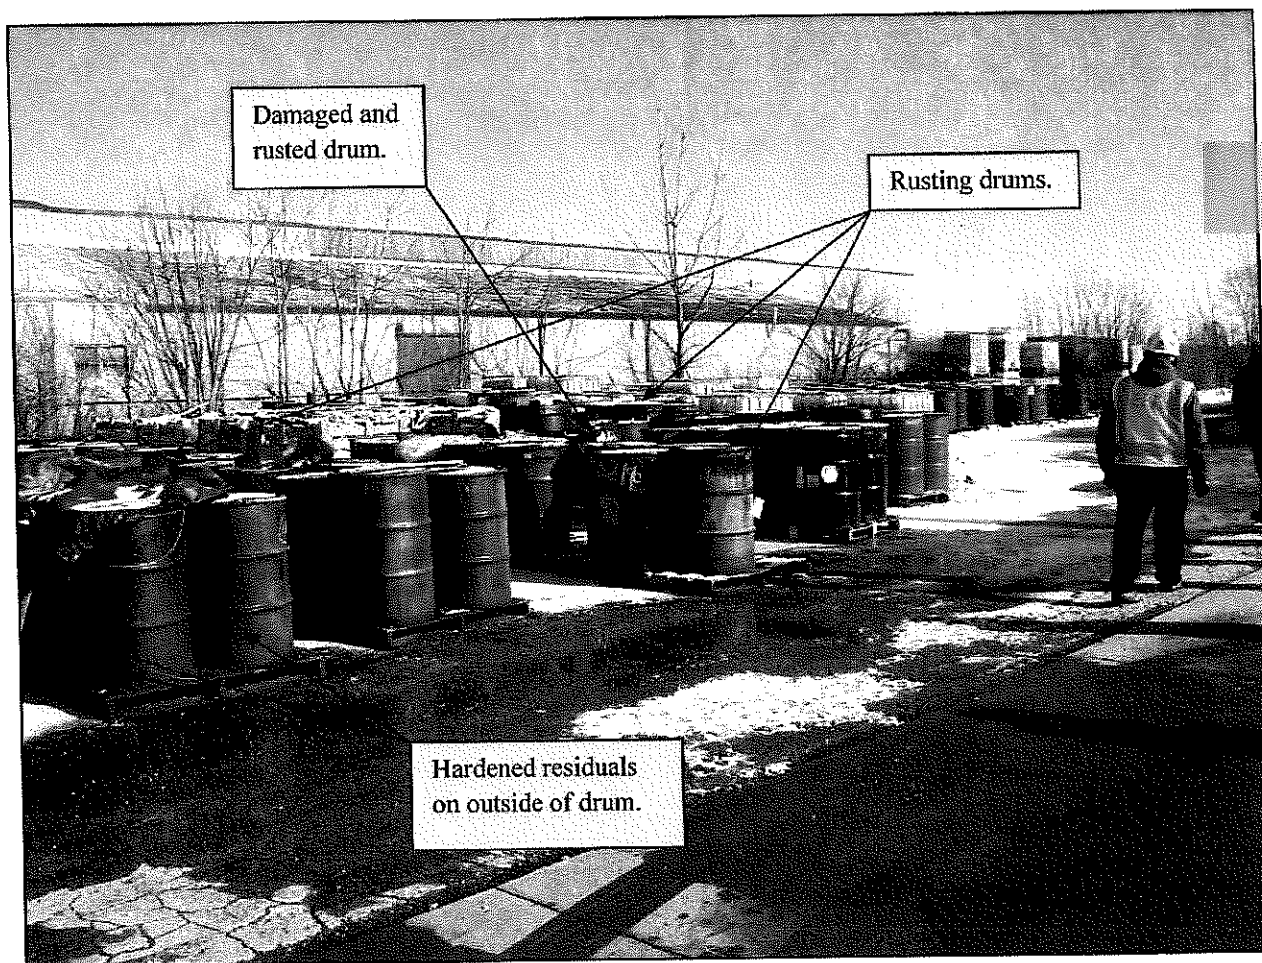
Photo 8	Taken by: Michael Valentino	Polychem Services, Inc.
1/18/12	10:58 am	North side of site. Mixture of hazardous and non-hazardous (predominantly) drums, resin totes left by Heartland, according to Polychem officials. Just east of Photo 7. (Approx. drum count, to the right of drums "211/A190" and "545/A189": 42)
Orientation: Northeast

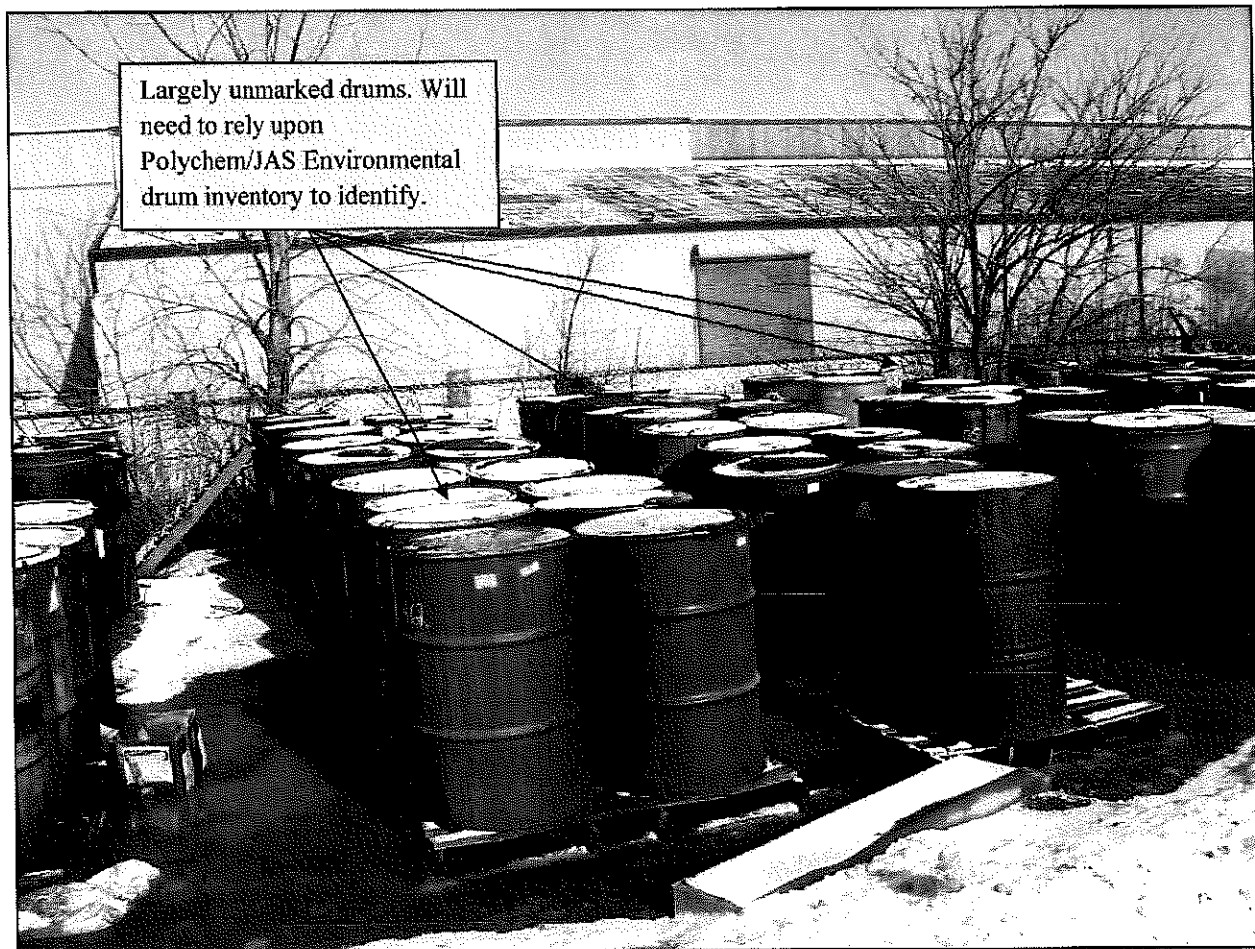
Photo 10 Taken by: Michael Valentino	Polychem Services, Inc.
1/18/12 11:00 am	North side of site. Drums left by Heartland, according to Polychem officials. Did not observe hazardous waste labels here. (Approx. drum count, excluding furthest left row and drums in right background: 46)
Orientation: North

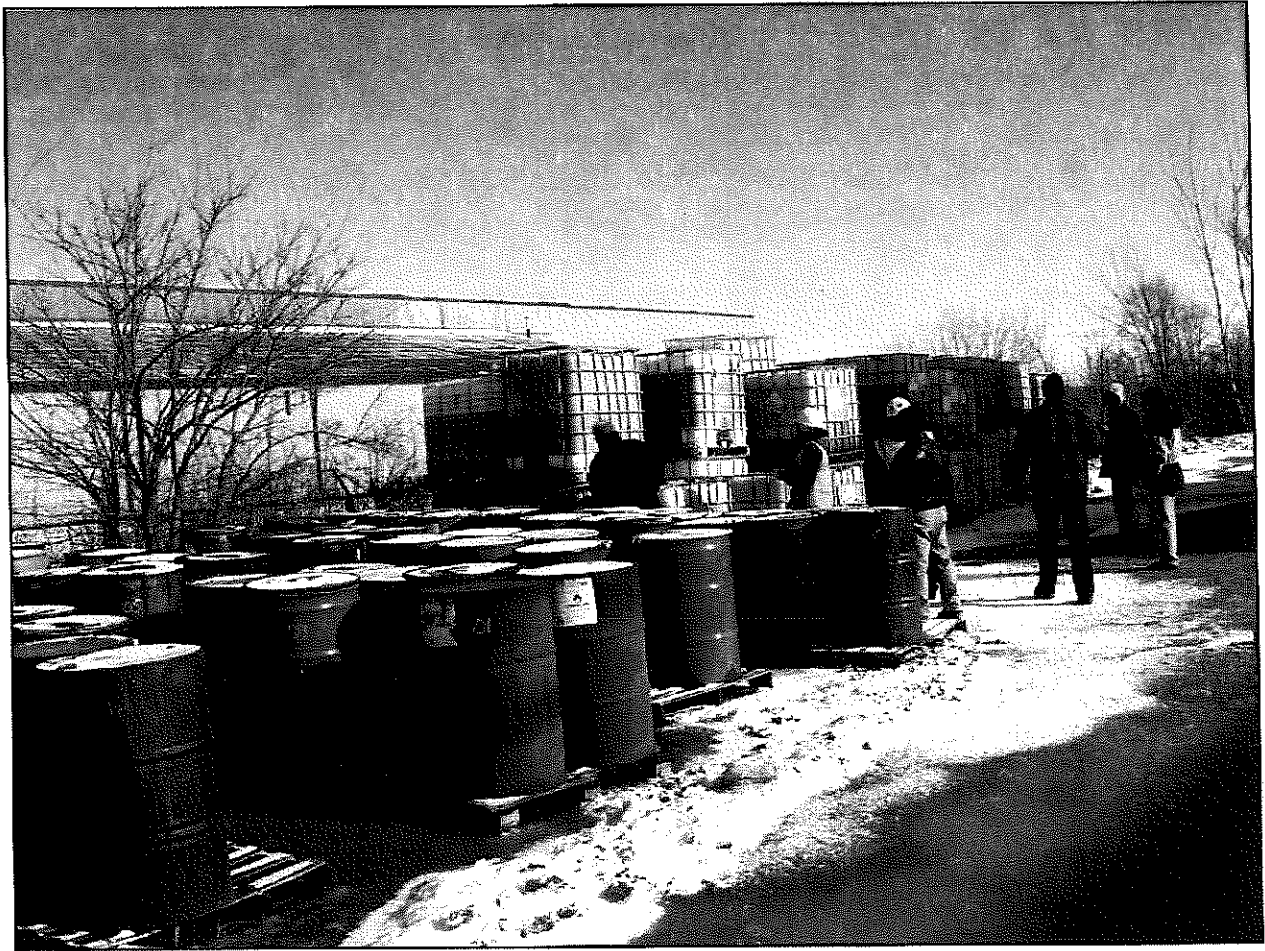
Photo 11	Taken by: Michael Valentino	Polychem Services, Inc.
1/18/12	11:00 am	North/Northeast part of site. Unidentified drums to left,
Orientation: North-Northeast		DMEA totes in rear. Polychem officials claim these drums were left by Heartland. (Approx. drum count, excluding drum "A503" and to its left: 35)

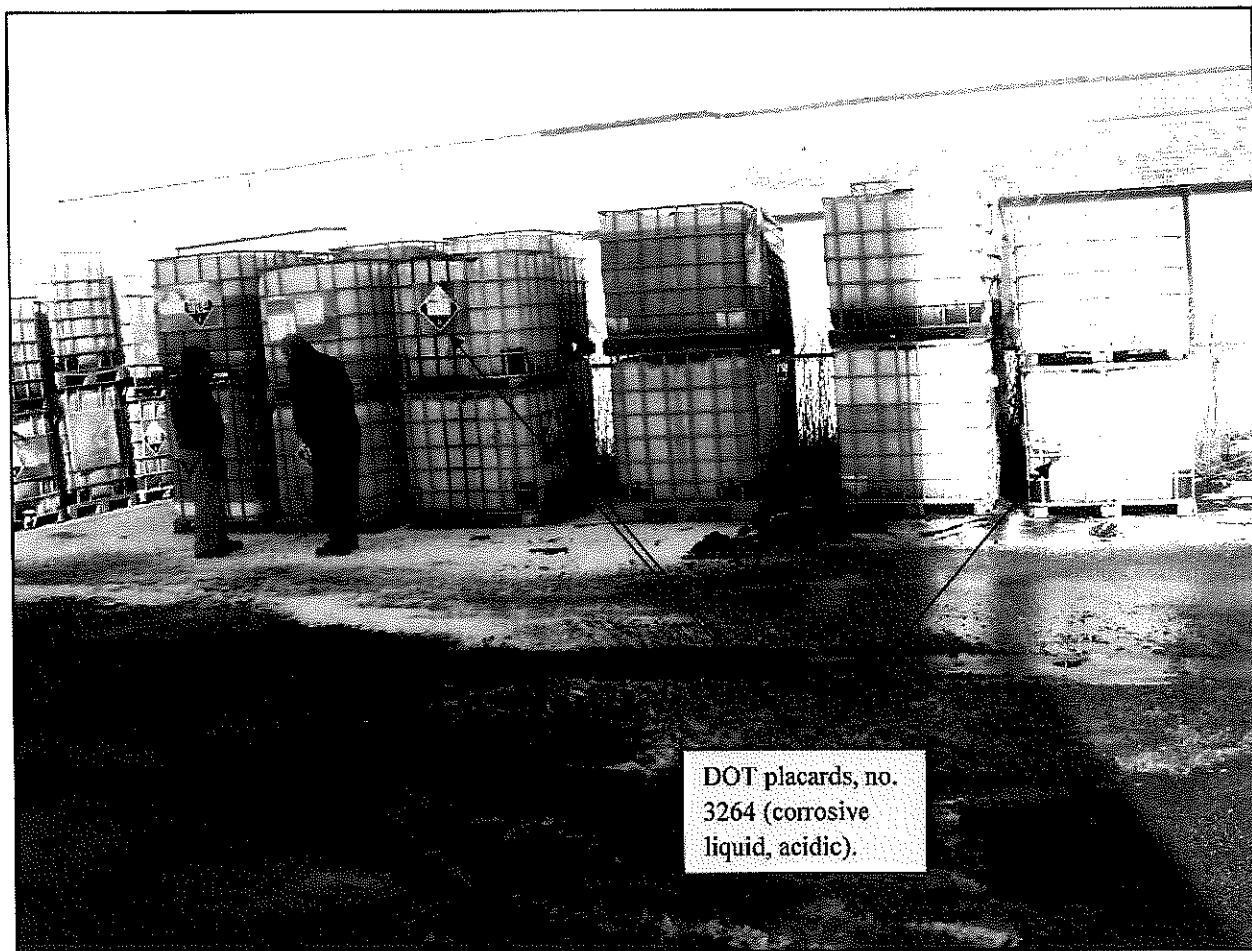
Photo I2 Taken by: Michael Valentino	Polychem Services, Inc.
1/18/12 11:02 am Orientation: North-Northwest	North/Northeast part of site. DMEA totes. Some uncertainty as to labeling (i.e., Rohm & Haas labels on some totes), according to Polychem officials. DOT placard, no. 3264 indicates corrosive liquid, acidic.

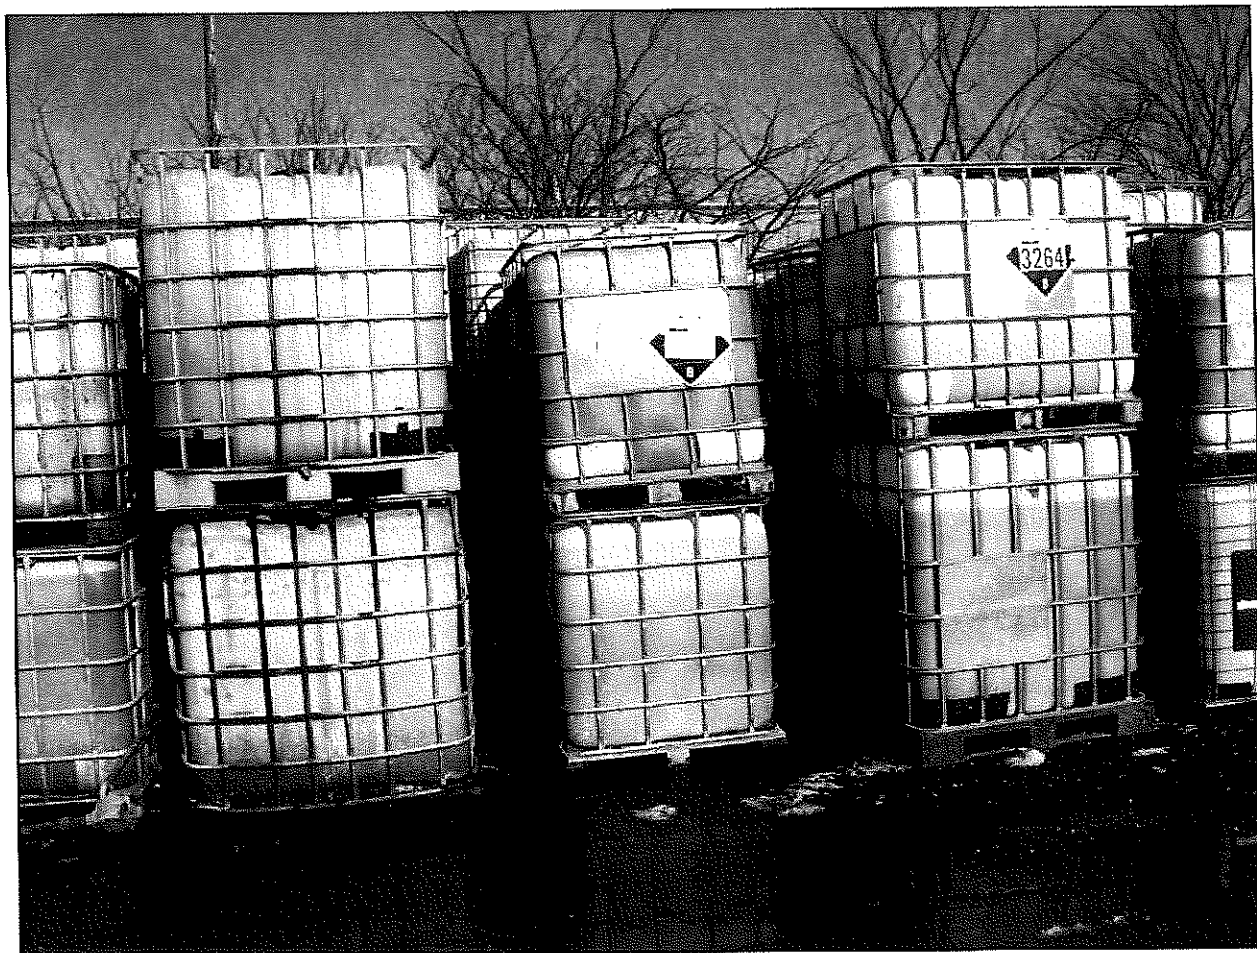
Photo 13	Taken by: Michael Valentino	Polychem Services, Inc.
1/18/12	11:05 am	Northeast corner of site. DMEA totes. DOT placard, no.
Orientation: North		3264 indicates corrosive liquid, acidic.

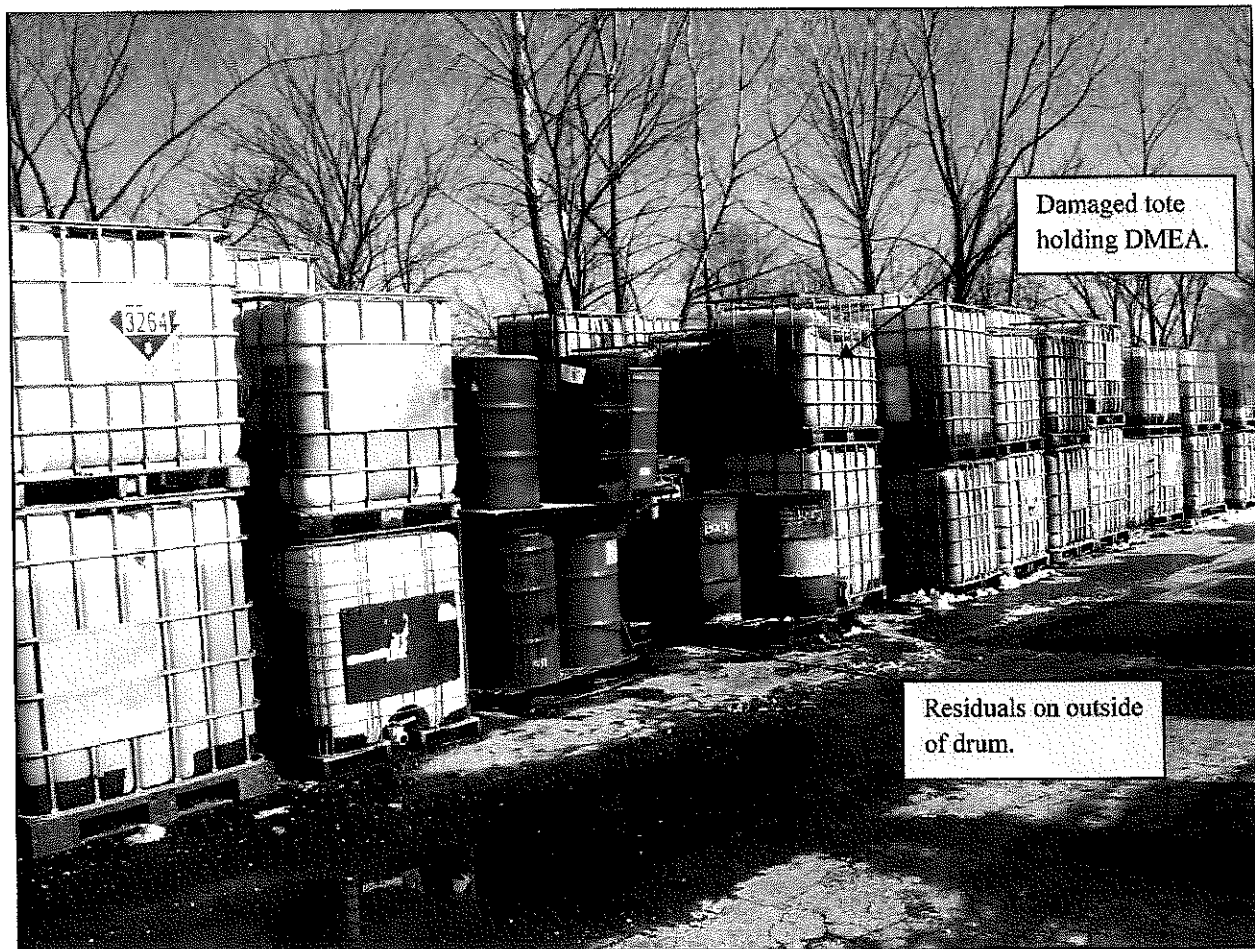
Photo 14 Taken by: Michael Valentino	Polychem Services, Inc.
1/18/12 11:05 am	Northeast corner of site. DMEA totes. DOT placard, no.
Orientation: Northeast	3264 indicates corrosive liquid, acidic. Mixture of
	Heartland materials and Polychem drums (for processing), according to Polychem officials.

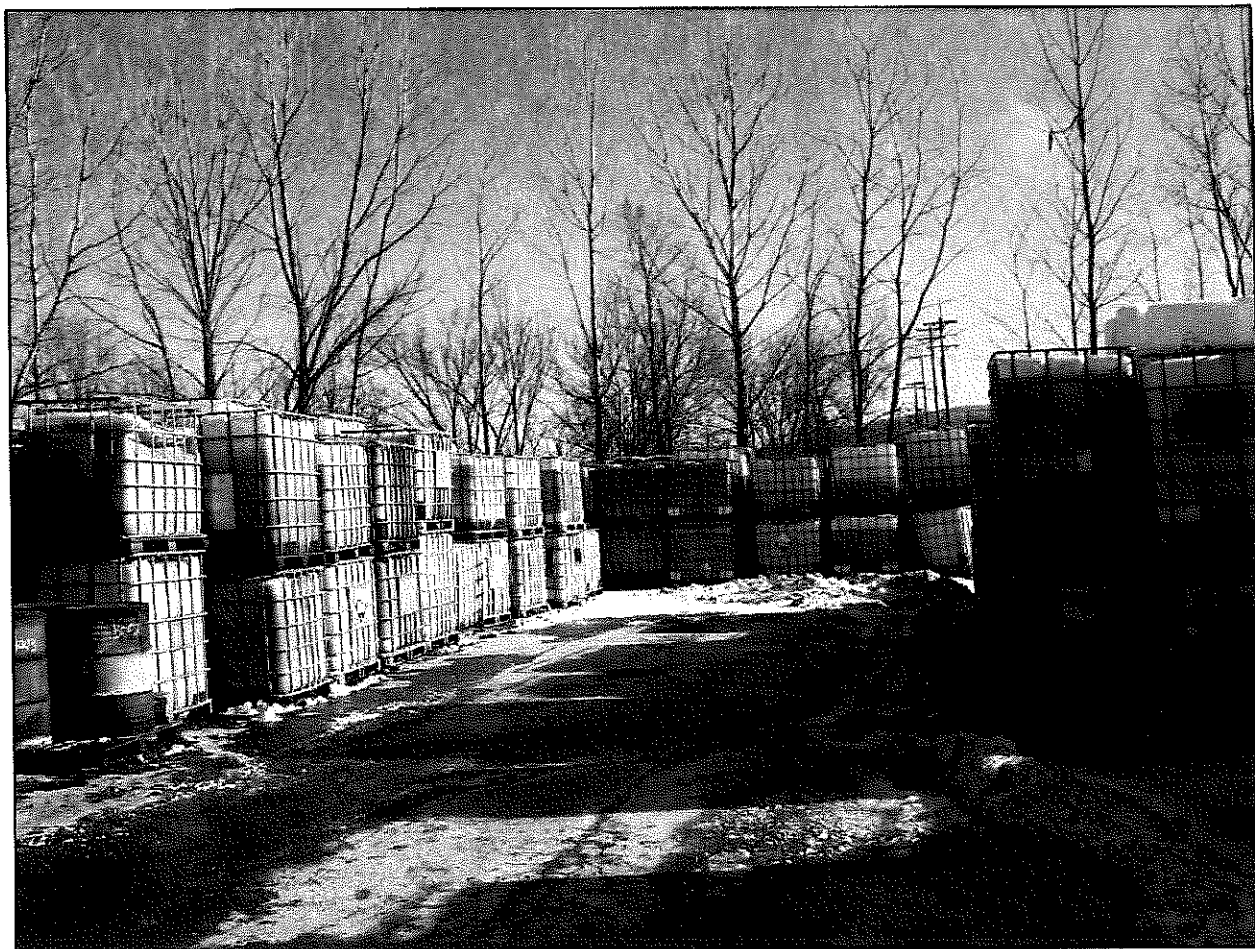
Photo 15	Taken by: Michael Valentino	Polychem Services, Inc.
1/18/12	11:06 am	Northeast corner of site. DMEA totes. Just to south of
Orientation: Northeast		Photo 14.

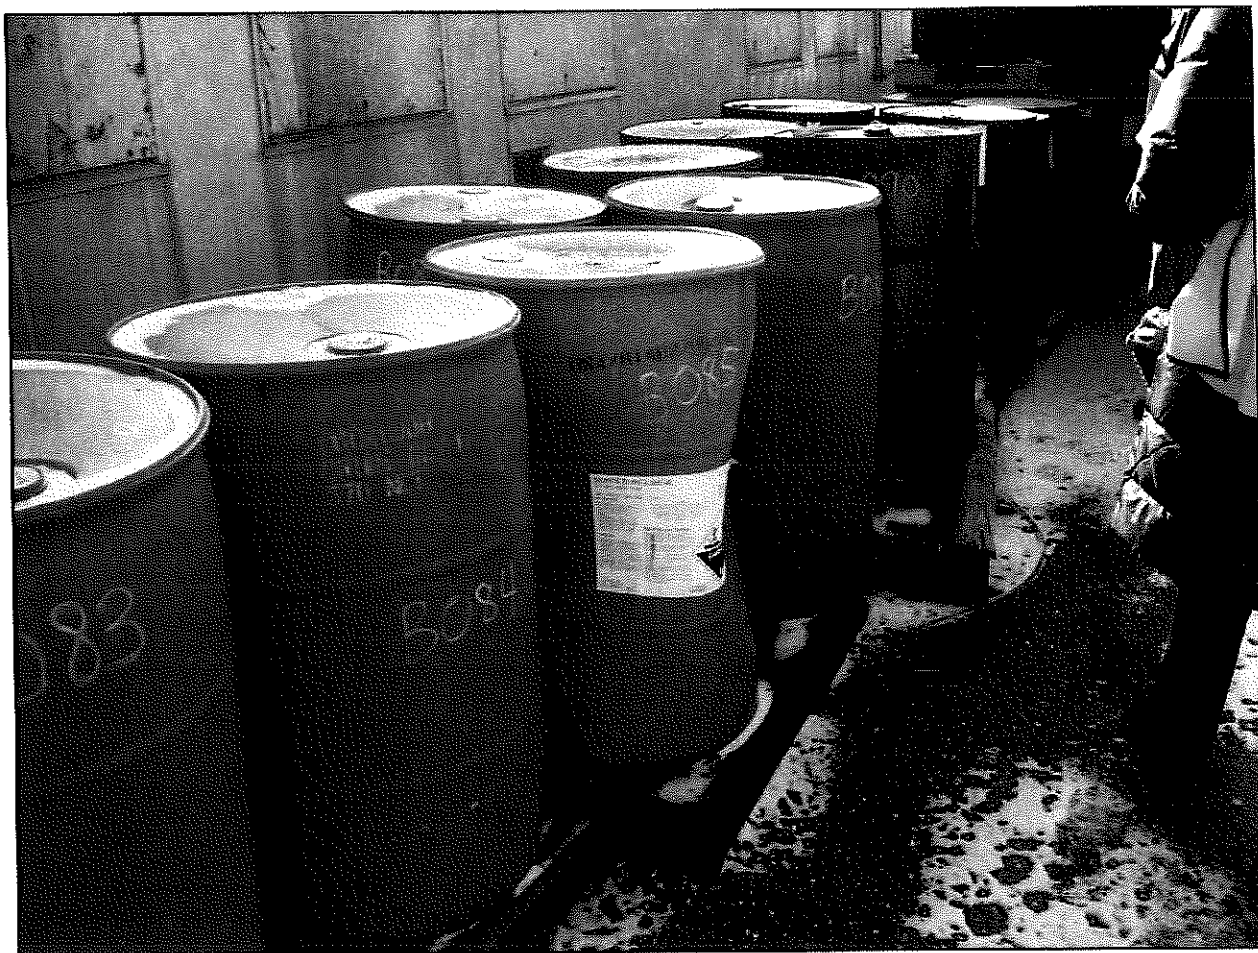
Photo 16 Taken by: Michael Valentino	Polychem Services, Inc.
1/18/12 11:07 am	East end of site, near peroxide storage bldg. Blue poly
Orientation: South-Southeast	drums contain monethanolamine.

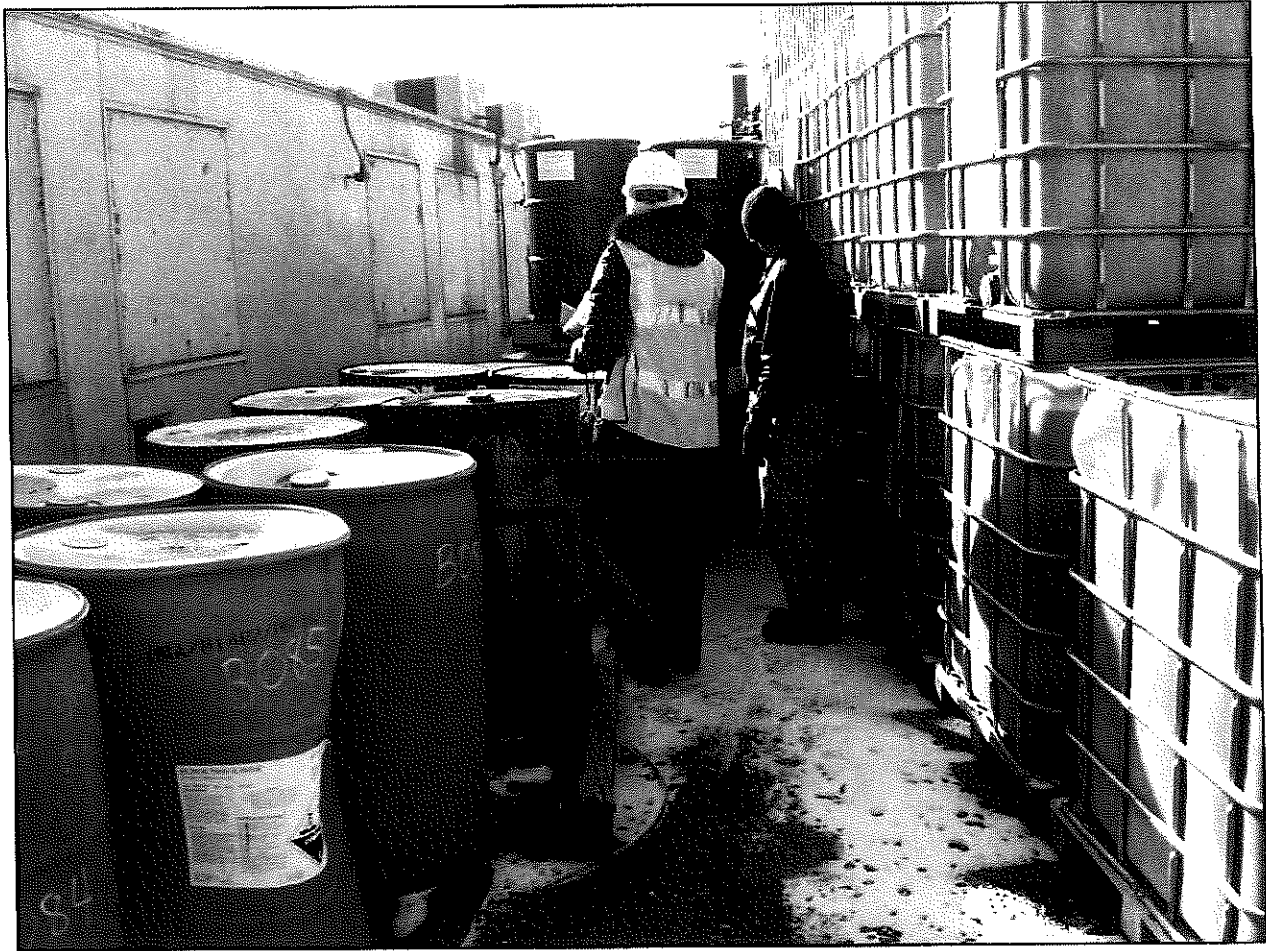
Photo 17 Taken by: Michael Valentino	Polychem Services, Inc.
1/18/12 11:07 am	East end of site, near peroxide storage bldg. Blue poly drums contain monethanolamine. Steel drums behind blue poly are unmarked. Stacked steel drums in rear are filter bags marked as non-hazardous. DMEA totes to right.
Orientation: South

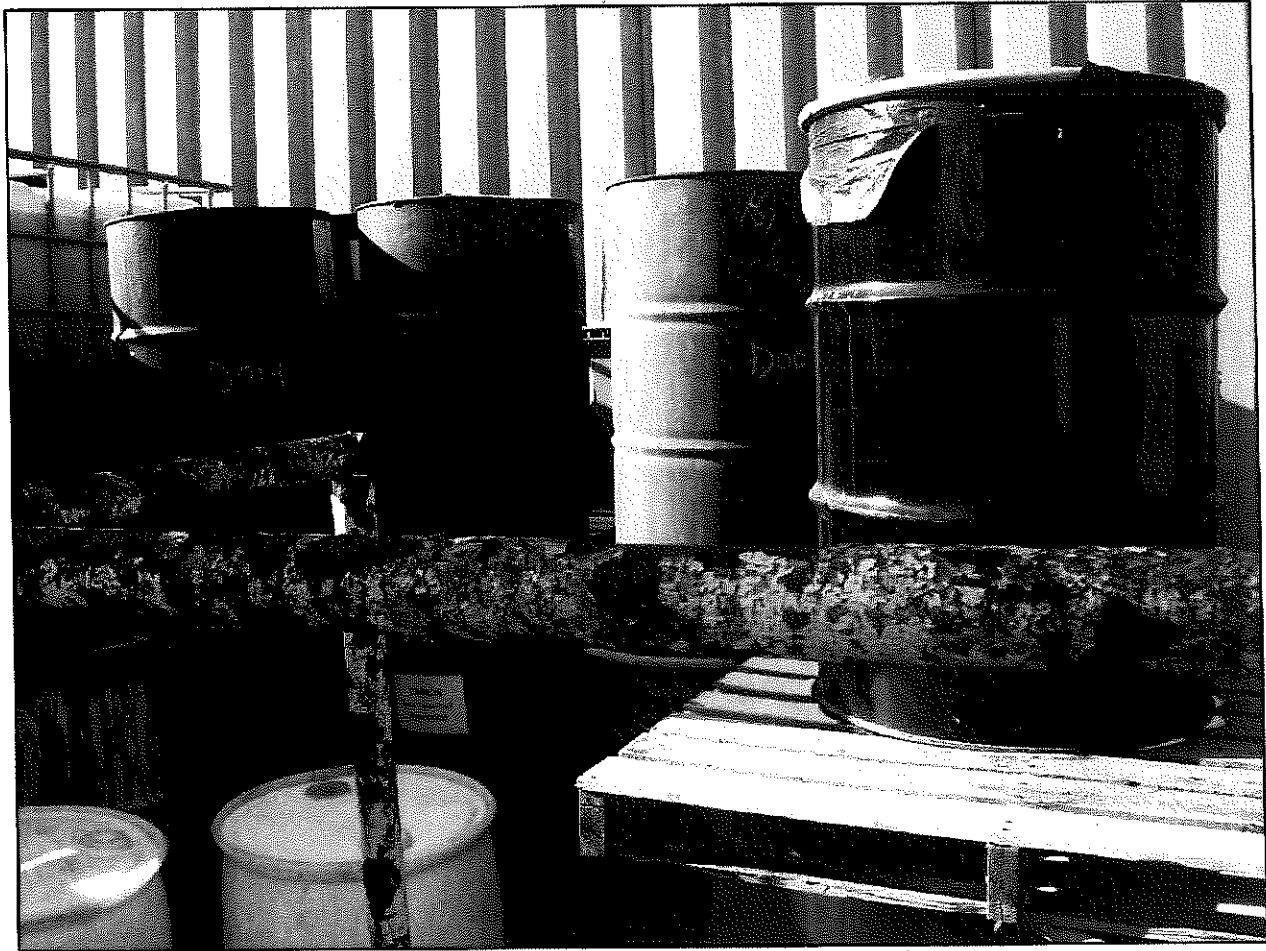
Photo 18	Taken by: Michael Valentino	Polychem Services, Inc.
1/18/12	11:10 am	Just east of warehouse. Mixture of drums, some marked from EPA's March 2011 inspection, others for rework by Polychem, according to Polychem officials.
Orientation: Southwest
