UNITED STATES ENVIRONMENTAL PROTECTION AGENCY
REGION 5
77 W. JACKSON BOULEVARD
CHICAGO, IL 60604

SITE VISIT REPORT - FINAL

INSTALLATION NAME: Polychem Services, Inc., LLC
U.S. EPA ID No.: ILD 980 578 876
LOCATION ADDRESS: 374 E. Joe Orr Road
Chicago Heights, IL 60411
NAICS CODES: 325211 (Plastics, Material and Resin
Manufacturing); 424690 (Other Chemical and
Allied Products Merchant Wholesalers)
DATE OF INSPECTION: January 18, 2012
EPA INSPECTOR: Michael Valentino

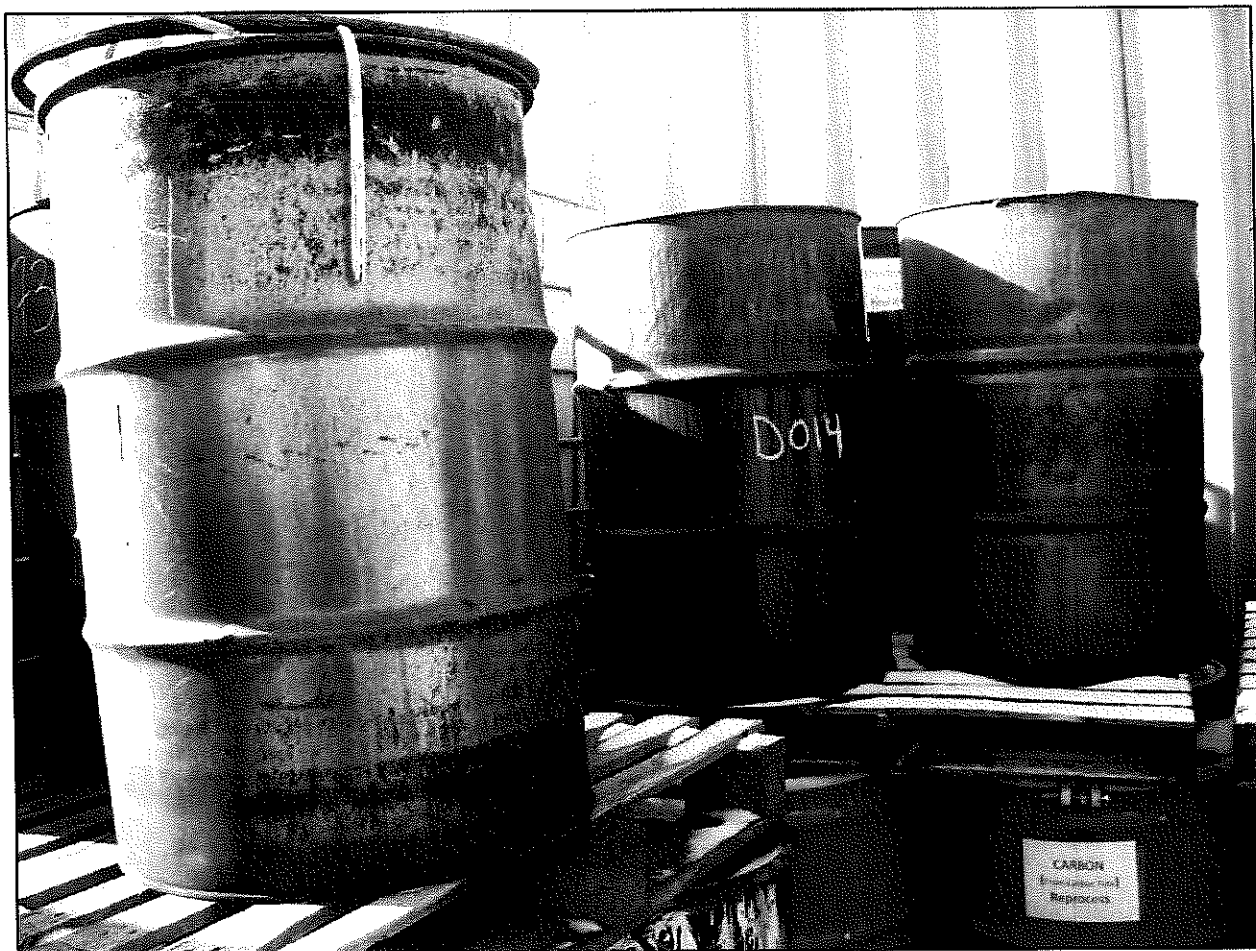
Photo 19	Taken by: Michael Valentino	Polychem Services, Inc.
1/18/12	11:10 am	Just east of warehouse. Mixture of drums, some marked from EPA's March 2011 inspection, others for rework by Polychem, according to Polychem officials.
Orientation: Southwest

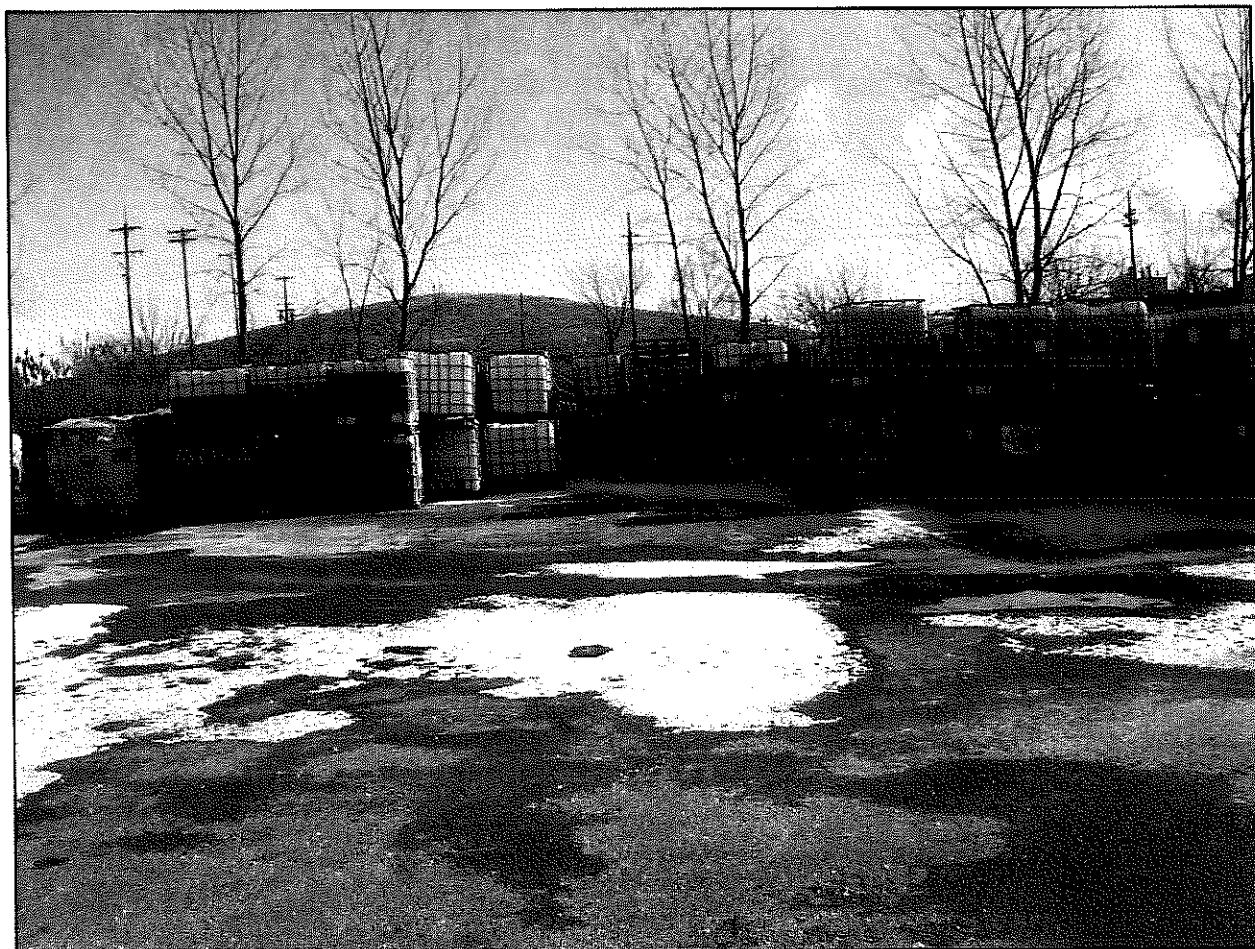
Photo 20	Taken by: Michael Valentino	Polychem Services, Inc.
1/18/12	11:11 am	East side of site. DMEA totes to be processed.
Orientation:	East

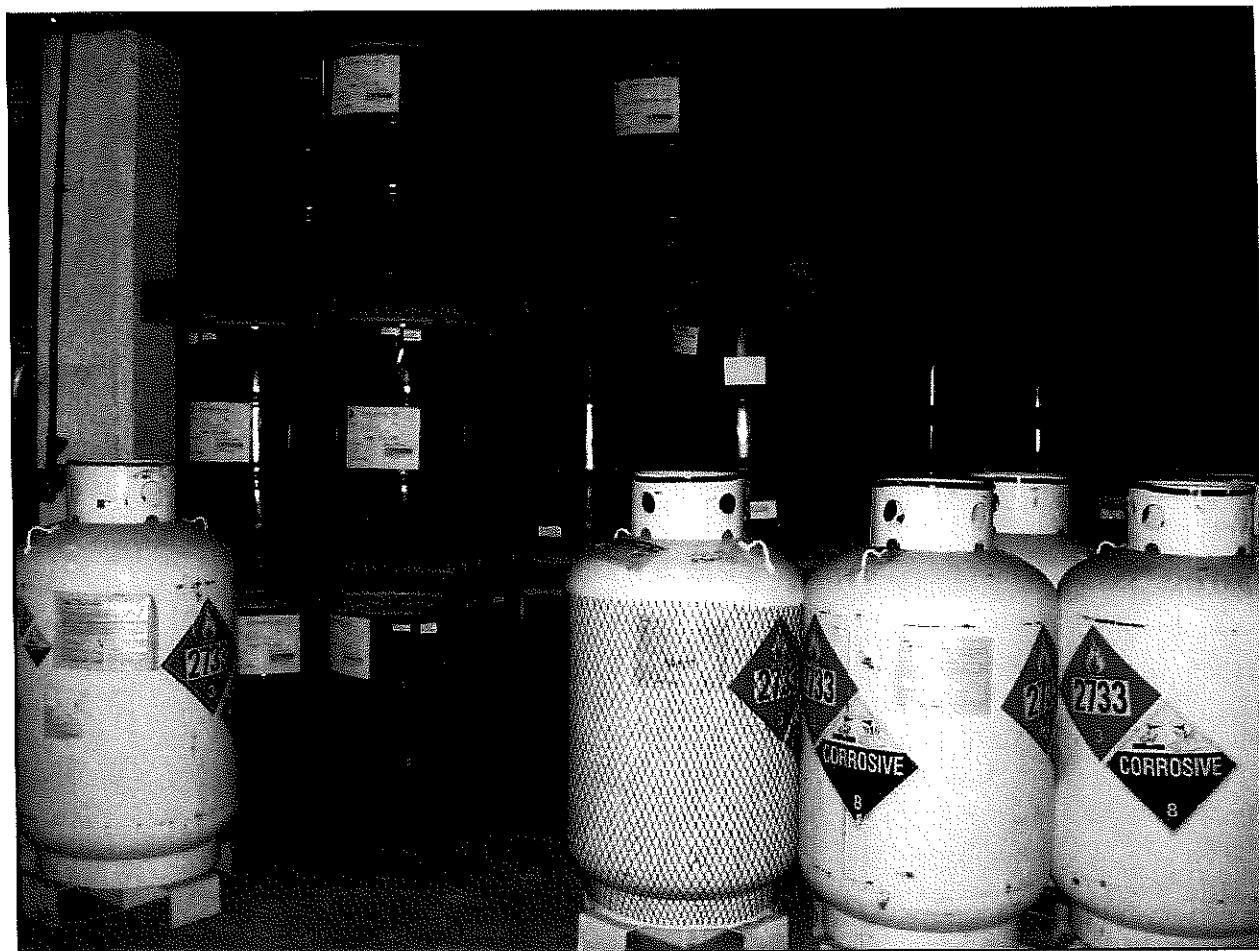
Photo 21	Taken by: Michael Valentino	Polychem Services, Inc.
1/18/12	11:13 am	Inside of warehouse. Drums of alkyd resin (black, 55-gal drums in rear). Steel canisters affixed with DOT placard no. 2733 (amines, flammable, corrosive or polyamines, flammable, corrosive).
Orientation: West

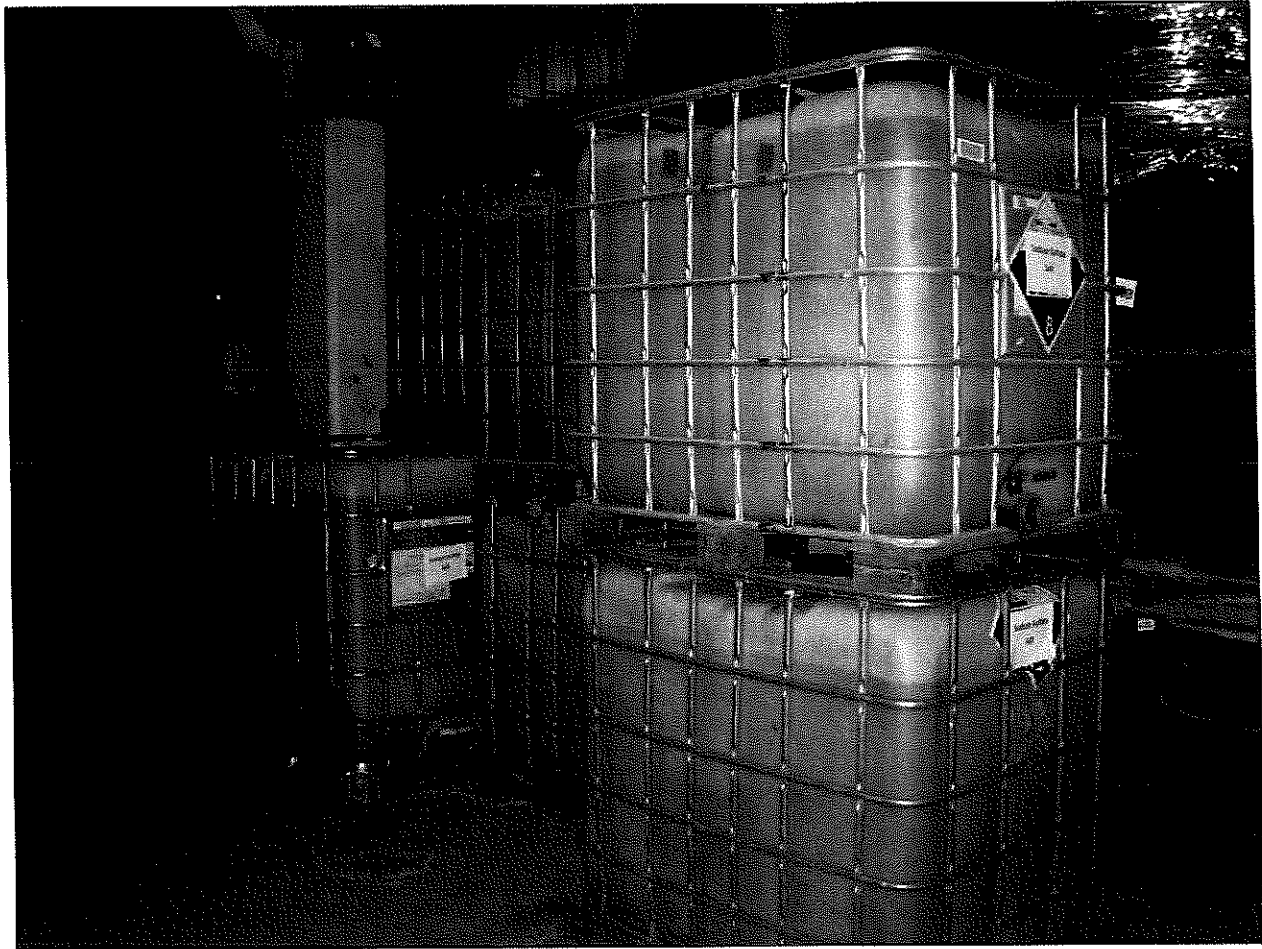
Photo 22	Taken by: Michael Valentino	Polychem Services, Inc.
1/18/12	11:13 am	Inside of warehouse. Totes of sodium sulfate salt solution.
Orientation:	Southwest

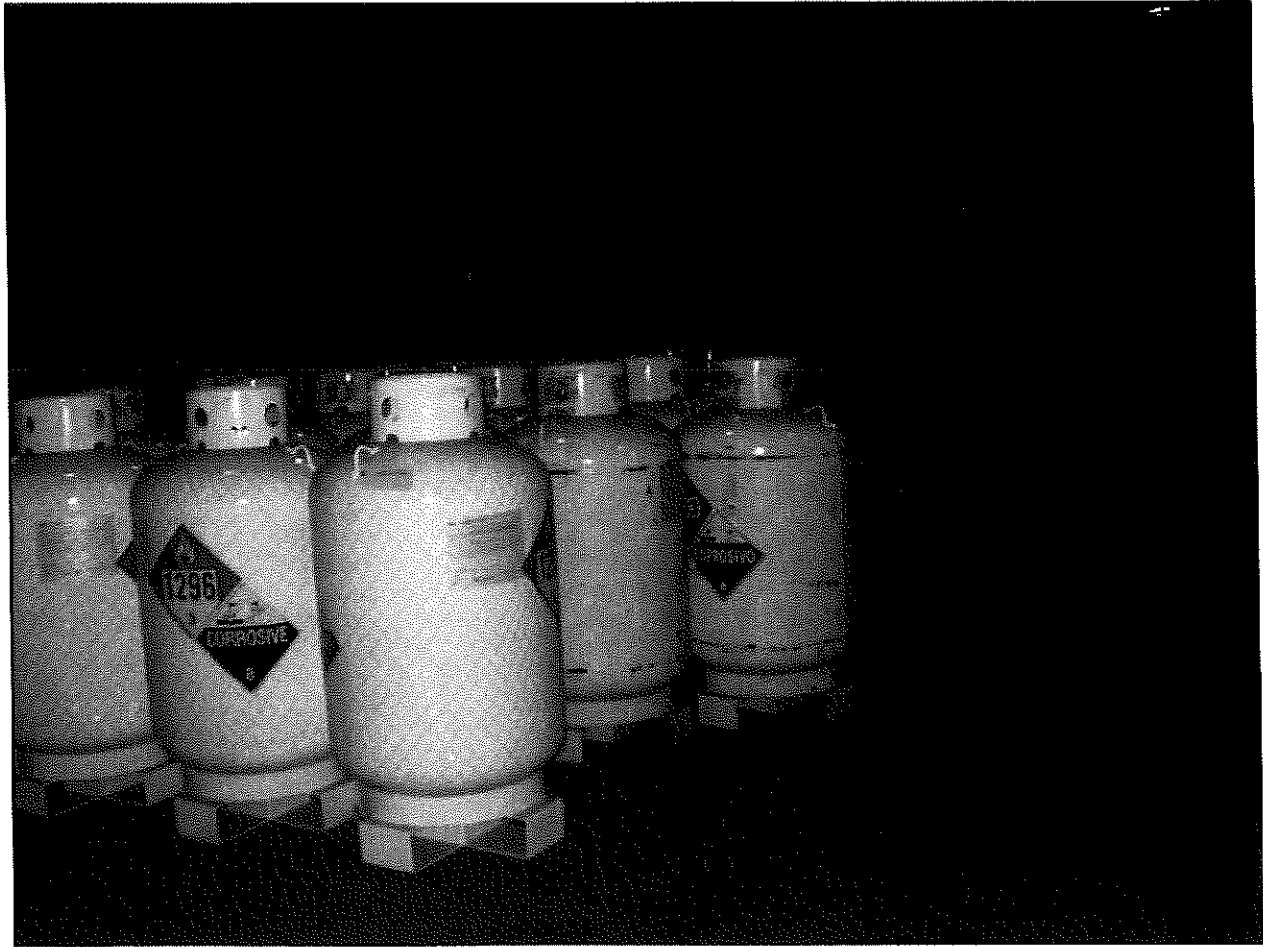
Photo 24	Taken by: Michael Valentino	Polychem Services, Inc.
1/18/12	11:14 am	Inside of warehouse. DOT placard no. 1296,
Orientation: South-Southeast		triethylamine, flammable, corrosive.

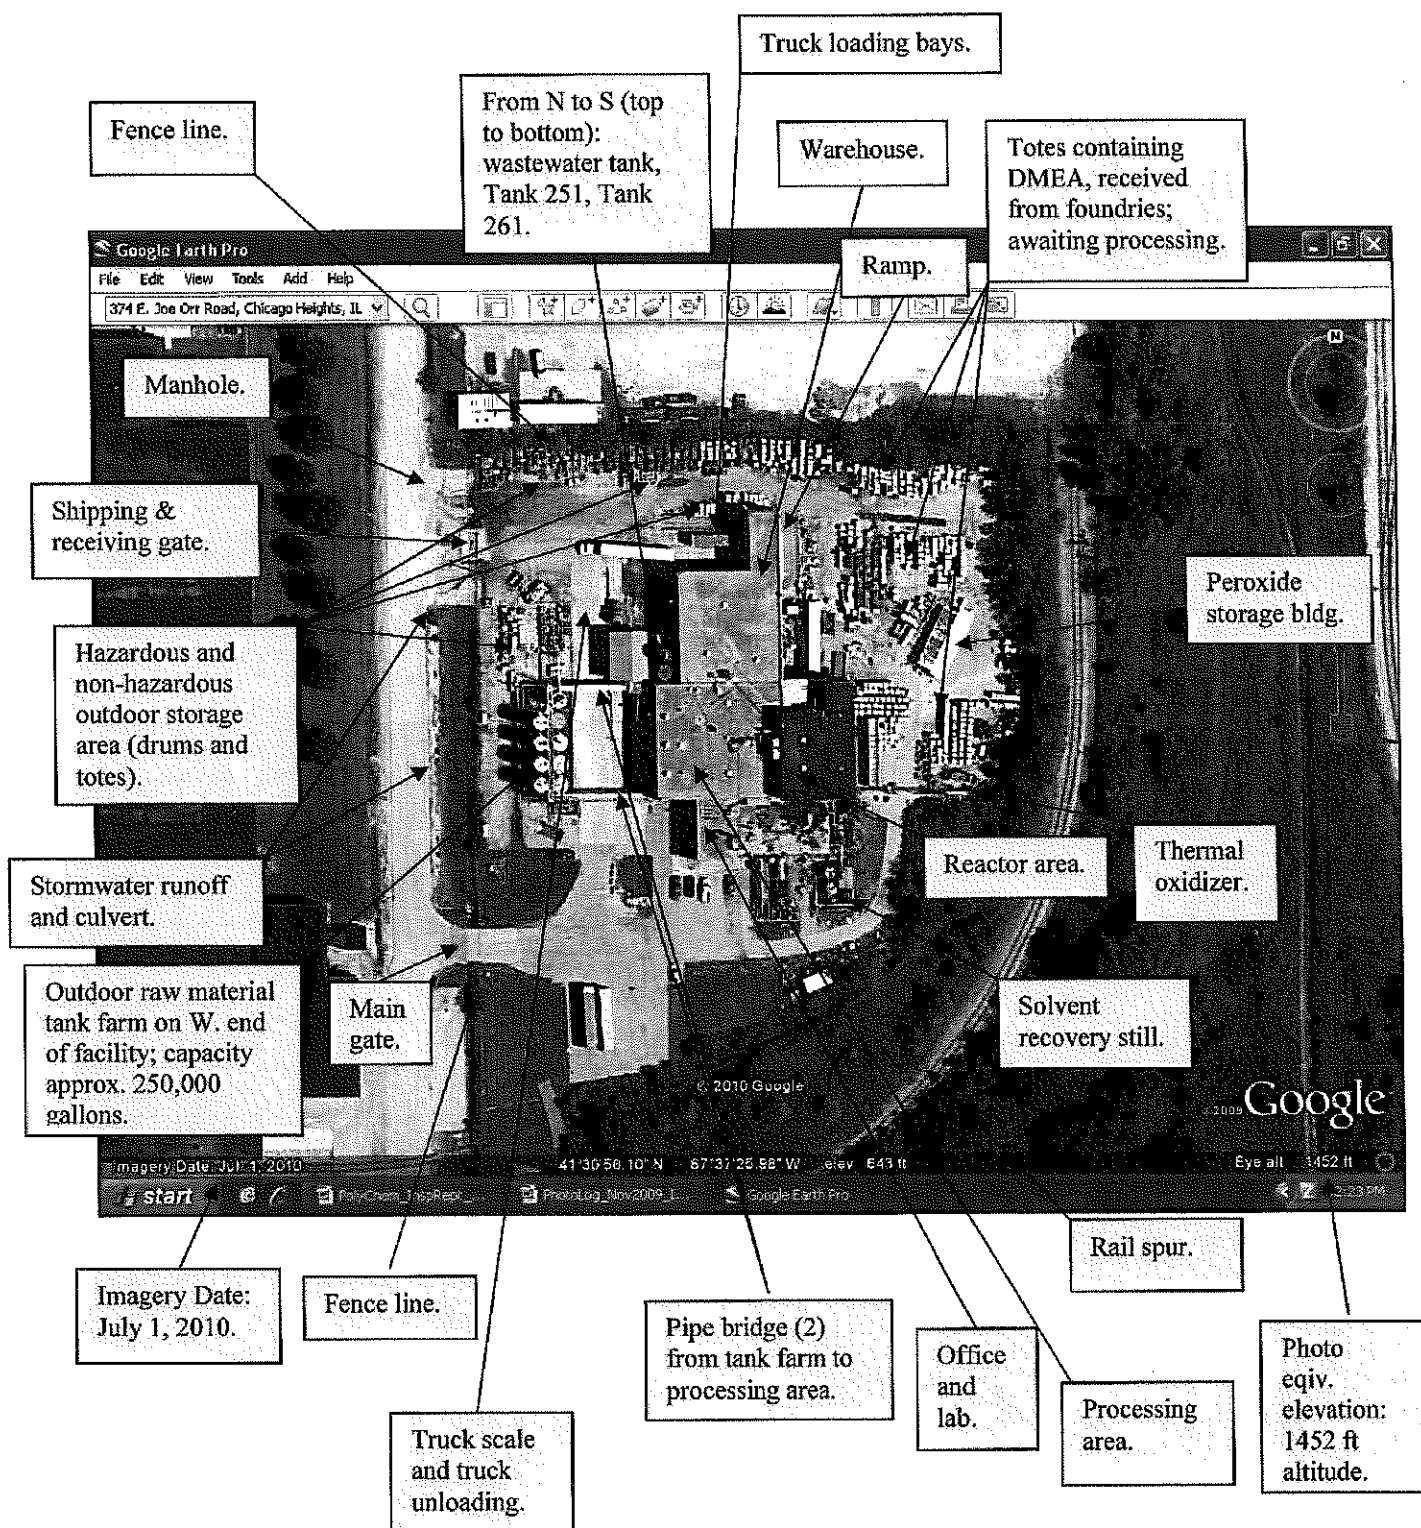
AERIAL PHOTO OF POLYCHEM FACILITY CIRCA JULY 2010

A comparison of aerial photos circa July 2010 (Attachment 1) and early Spring 2012¹ (Attachment 2) show the presence of more DMEA totes in northeastern and eastern sections of the site and less DMEA totes in the northern and east-central sections of the site in 2012.

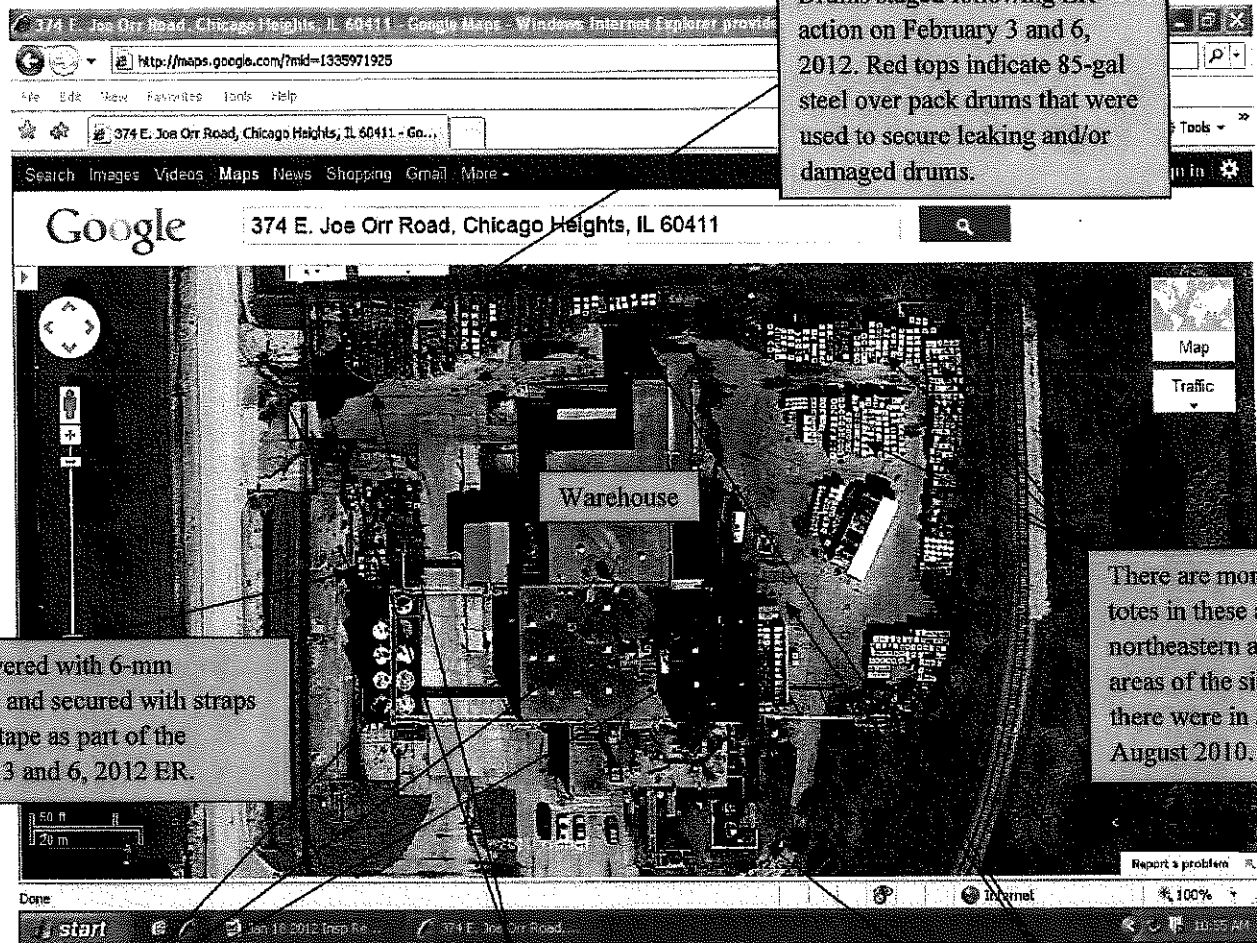
AERIAL PHOTO OF POLYCHEM FACILITY CIRCA MARCH 2012 (EST.)

Drums staged following ER action on February 3 and 6, 2012. Red tops indicate 85-gal steel over pack drums that were used to secure leaking and/or damaged drums.

There are more DMEA totes in these areas of the northeastern and eastern areas of the site than there were in July-August 2010.

Totes covered with 6-mm Visqueen and secured with straps and duct tape as part of the February 3 and 6, 2012 ER.

Absorbent booms placed along western fence line and immediately southwest of staged drums on February 1, 2012 during the ER action.

There are less DMEA totes in these areas of the northeastern and eastern areas of the site than there were in July-August 2010.
