Evaluation of the Sunnyside Cogeneration Associates Draft Groundwater Discharge Permit

Stephen T. Nelson

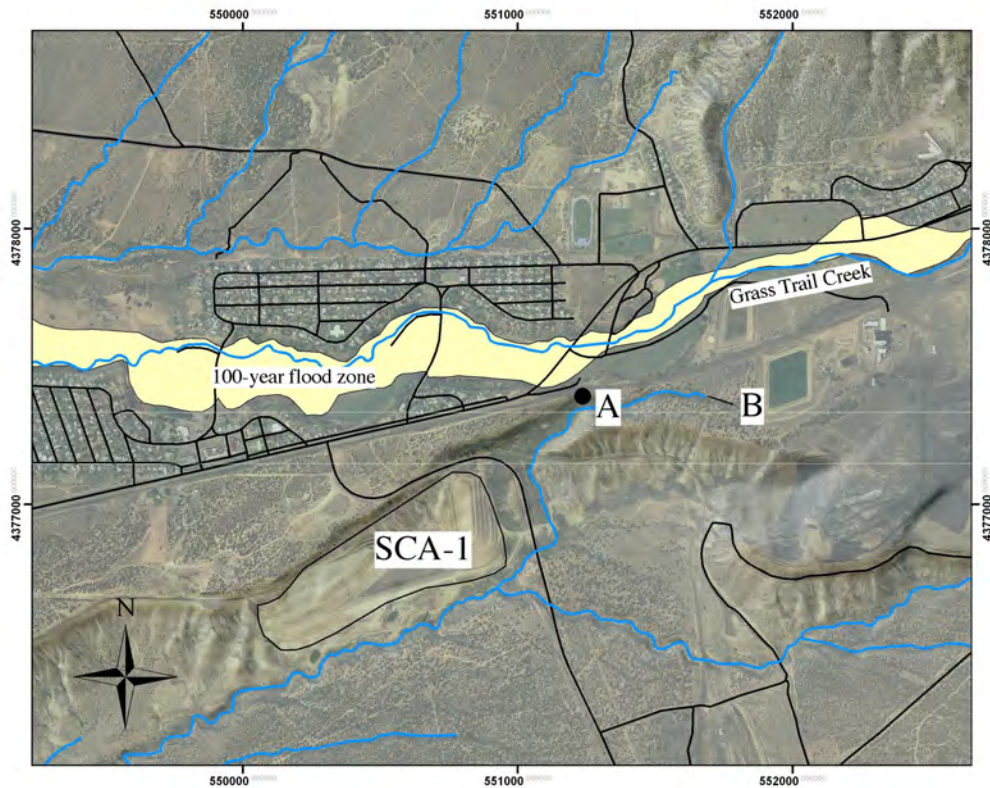
The stream network in the vicinity of SCA-1 causes me considerable concern. Figure 2 illustrates the FEMA 100-year floodplain along Grass Trail Creek just north of the landfill. At point A (Fig. 2) the floodplain is within about 70 meters of Drainage B. Figure 3 further illustrates that, within the resolution of Google Earth data, there is little by way of a topographic barrier to flood waters being diverted into Drainage B in this area (Fig. 3).

Stream capture or stream piracy is a well-known phenomenon by which drainage networks are modified by capturing flows of one system and diverting them into another. A significant stream flow/flood event at or upstream of point A (Fig. 2) could divert flows from Grass Trail Creek, and its entire collection system, into the stream networks south of the cliff, and do so permanently. Were such an event to occur at point A, high stream flows would inevitably, and directly, impact the integrity of the pile. Were Grass Trail Creek captured at or any point up gradient from point A, high flow events might compromise the southern (and down-slope) side of the pile via widening and down cutting of the channel. Given the proximity of Drainage B and Grass Trail Creek, diversion of the latter stream south of the cliff seems likely if not inevitable in the near geologic future². It appears as if a 100-year flood event may approach diversion.

Figure 2. Map of SCA-1 relative to surface drainages and a selected FEMA 100-year flood plains (yellow) digitized from <https://msc.fema.gov/webapp/wcs/stores/servlet/mapstore/homepage/MapSearch.html>. Black lines show roads and blue lines drainages (data from Utah Automated Geographic Reference Center, <http://gis.utah.gov/data/>) with orthoimagery (<http://gis.utah.gov/data/>) superimposed upon a hillshade generated from NED data (<http://viewer.nationalmap.gov/viewer/>). Perimeter ticks represent positions and distances in meters (UTM projection NAD83, Zone 12S).

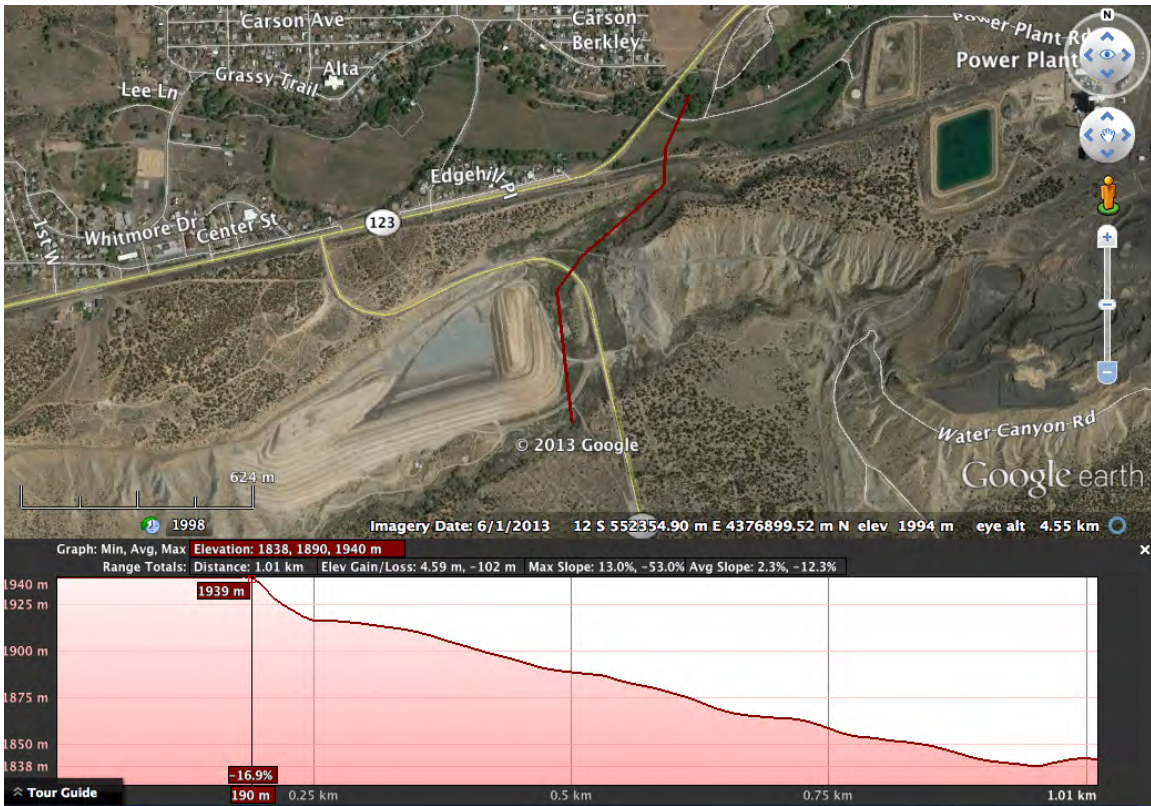
Figure 3. Google Earth aerial image and topographic profile (red) in the vicinity of SCA-1.

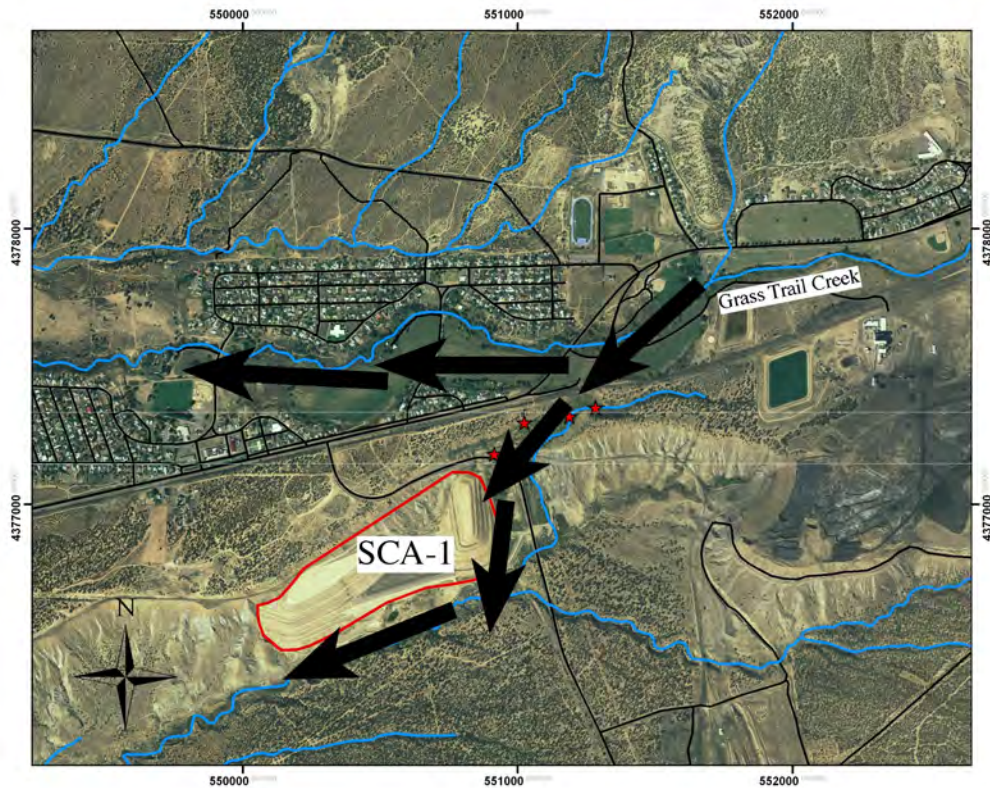
Underflow (i.e., shallow groundwater flow in alluvium parallel to the overlying stream) beneath Grass Trail Creek is clearly being partially diverted at point A down the cliff face and into the drainage south of SCA-1 (Fig. 4). This is evidenced by phreatophytes (e.g., willows, marsh grasses, etc.) growing along in the cliff face, as well as mapped seeps and springs. Furthermore, this flow system is clearly impacting (bringing water into or beneath?) the eastern end of SCA-1. Phreatophytes and seeps mapped by SCA (see map in Sample Analysis Plan) indicate that there is an active flow system to receive seepage from the pile and to transport it further down gradient.

If piracy of Grass Trail Creek were to occur, all of its underflow may be diverted along and beneath the stream network to the east and south of SCA-1. In other words, the broad, verdant riparian zone along Grass Trail Creek in the town of East Carbon north of SCA-1 (Fig. 4) may be abandoned and reestablished south of the SCA-1 piles, yet becoming vulnerable to seepage from the landfill.

Figure 4. Map illustrating selected features of shallow groundwater flow systems in the vicinity of SCA-1. Bold, black arrows show the diversion of underflow from Grass Trail Creek along the east edge of SCA-1 and into the stream south of the landfill. Black lines show roads, blue lines drainages, and red stars seeps and springs (data from Utah Automated Geographic Reference Center, <http://gis.utah.gov/data/>) with orthoimagery (<http://gis.utah.gov/data/>) draped over the hillshade image. Perimeter ticks represent positions and distances in meters (UTM projection NAD83, Zone 12S)

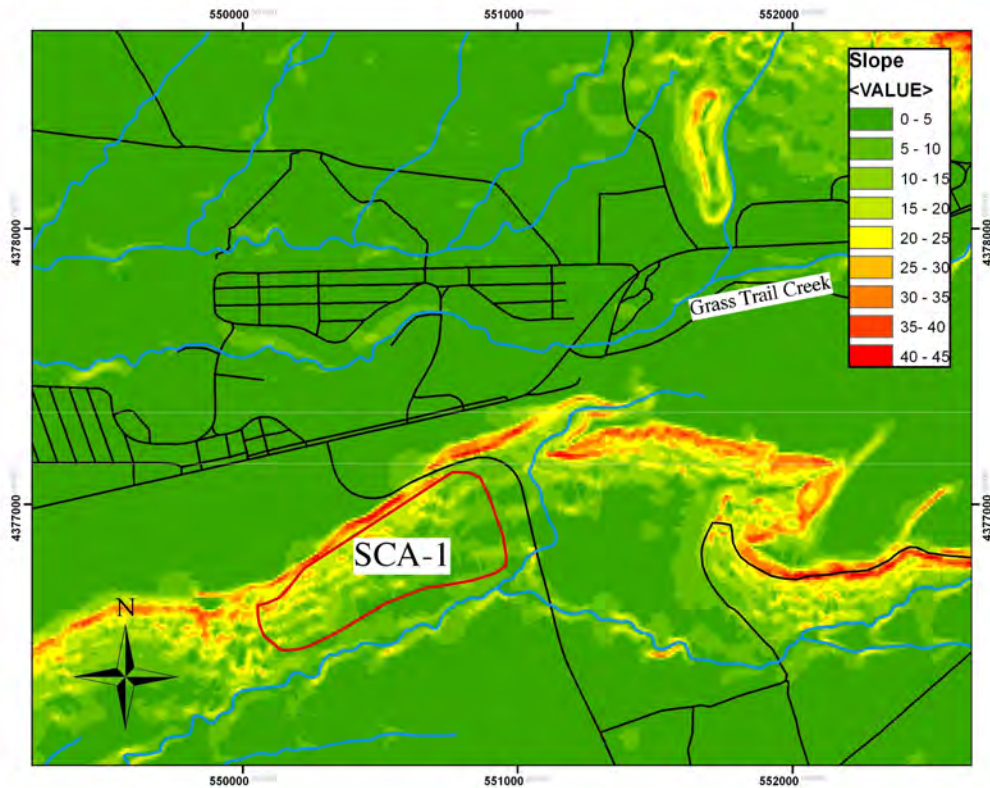
As mentioned above, SCA-1 is largely built into a south-facing cliff, which is in places quite steep (e.g., Fig. 1). Figure 5 indicates that the slopes of the cliff in the vicinity of SCA-1 commonly exceed 20 to 25°. When coupled with surface and groundwater flow discussed above, the wisdom of building this facility into the cliff face comes into question. Loading of groundwater into the east end of SCA-1, erosion of the pile by stream piracy, or undercutting of the pile by present or diverted stream flows to the south of the pile may make this facility vulnerable to slope failure.

Figure 5. Slope map of the cliff into which SCA-1 is constructed. Topographic data obtained from the US Geological Survey (<http://viewer.nationalmap.gov/viewer/>) were used to generate slope values (in degrees; see key) using ArcMap (ESRI, v. 10). Black lines show roads and blue lines drainages (data from Utah Automated Geographic Reference Center, (<http://gis.utah.gov/data/>); UTM projection NAD83, Zone 12S).

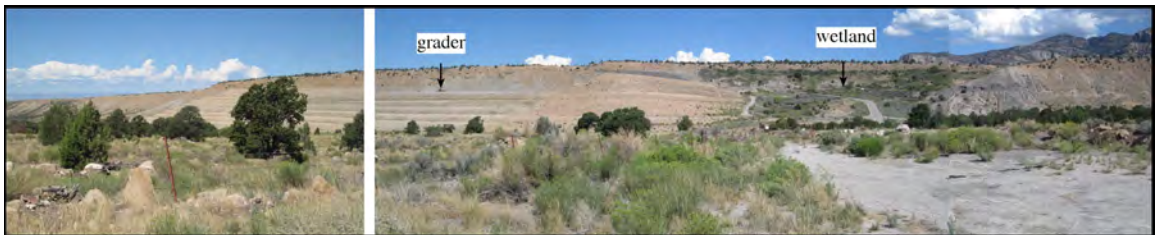
A photo panorama shows the spatial scale of the SCA-1 landfill as well as its development near and into the cliff (Fig. A2). A grader working the landfill is indicated for scale, as well as the wetland that manifests diverted groundwater flow from beneath Grass Trail Creek. This wetland could also mark the path of diverted stream flow if/when stream piracy occurs. It is already occupied by an ephemeral drainage.

Figure A2. Photo panorama taken from Highway 124 northward toward SCA-1. A grader is indicated for scale.

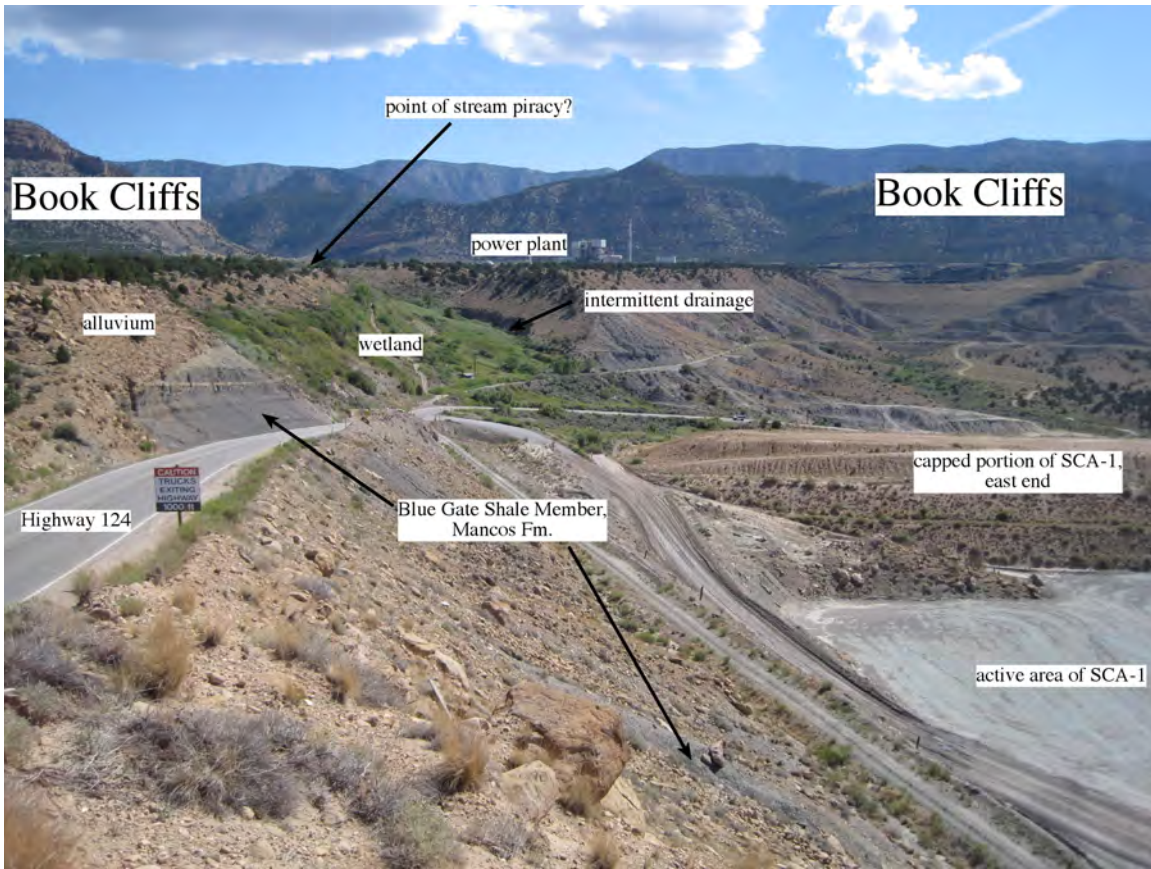
Figure A3 shows a number of important details. The power plant is shown in its relationship to SCA-1 in the foreground (power plant at intermediate distance) and the Book Cliffs in the background. At its east end, the capped portion of SCA-1 is offset somewhat from the natural slope of the cliff. However, toward the west, new areas of excavation are directly on the cliff (Fig. A4). The Blue Gate Shale Member of the Mancos Formation is seen in the slopes, overlain by capping alluvium “holding up” the soft shale. Especially prominent are the diverted underflow and intermittent drainage. Here, the diverted underflow is readily apparent in the vegetation, whereas the path for the potential diversion of Grass Creek Trail is also obvious.

Figure A3. Annotated photograph of the east end of the SCA-1 landfill and SCA power plant. View is to the east.

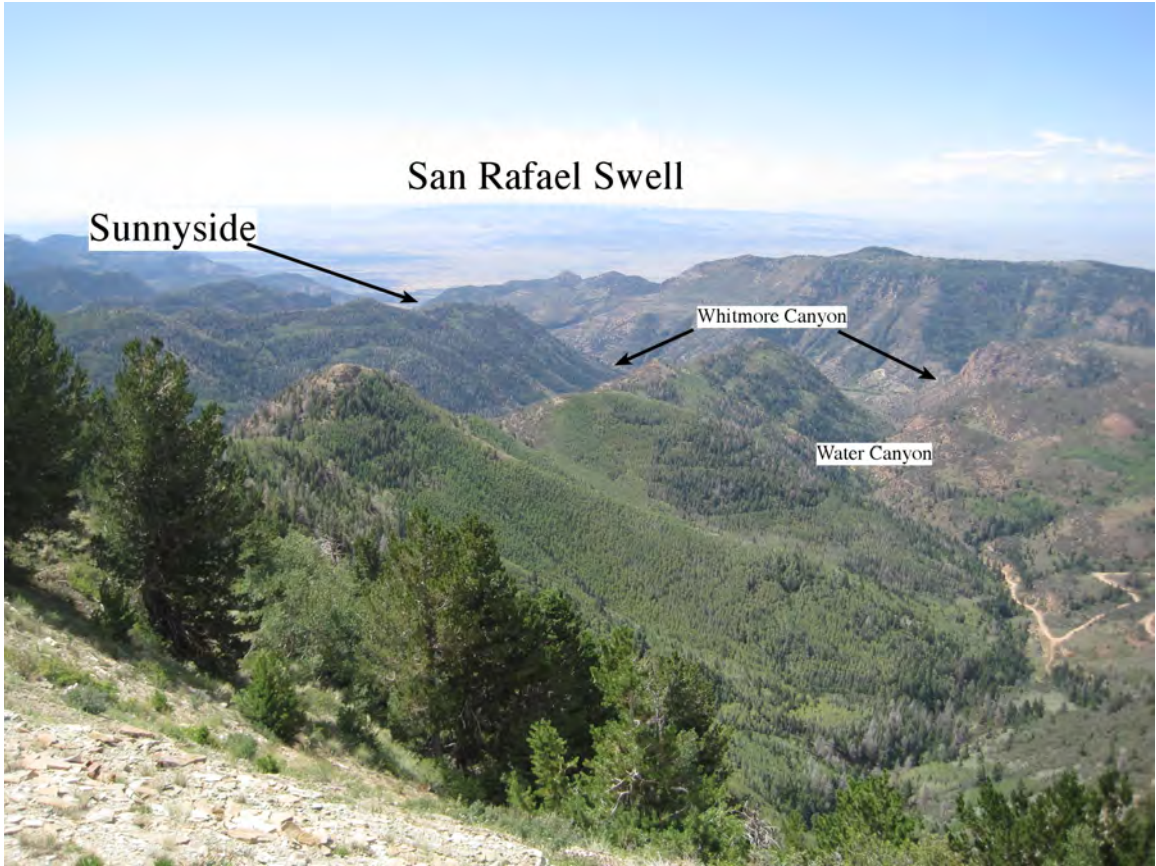
After inspecting the power plant and SCA-1 area, I traveled into the Book Cliffs via Whitmore Canyon, then driving up the Water Canyon Road to Bruin Point. Figure A5 is a view from the crest at an elevation of >10,000' back toward Sunnyside. With the San Rafael Swell and Sunnyside in the distance, the large system of canyons at high elevation is apparent. The high elevations provide an orographic trap for both summer monsoon moisture and winter cyclonic precipitation. Combined with the large drainage system of canyon networks that feed Grass Trail Creek, the potential for episodic flash floods is readily apparent. This provides important perspective to the SCA-1 site given the potential for stream piracy to divert flows beneath and across the landfill. Also worth noting is the potential for debris flows, which could be enhanced if wildfires were to affect this drainage system.

Figure A5. View to the southwest from near Bruin Point on the crest of the Book Cliffs back toward Sunnyside, Utah.
