UNITED STATES ENVIRONMENTAL PROTECTION AGENCY  
REGION 5  
77 W. JACKSON BOULEVARD  
CHICAGO, IL 60604

SITE VISIT REPORT - FINAL

INSTALLATION NAME: Polychem Services, Inc., LLC  
U.S. EPA ID No.: ILD 980 578 876  
LOCATION ADDRESS: 374 E. Joe Orr Road  
Chicago Heights, IL 60411  
NAICS CODES: 325211 (Plastics, Material and Resin  
Manufacturing); 424690 (Other Chemical and  
Allied Products Merchant Wholesalers)  
DATE OF INSPECTION: January 18, 2012  
EPA INSPECTOR: Michael Valentino

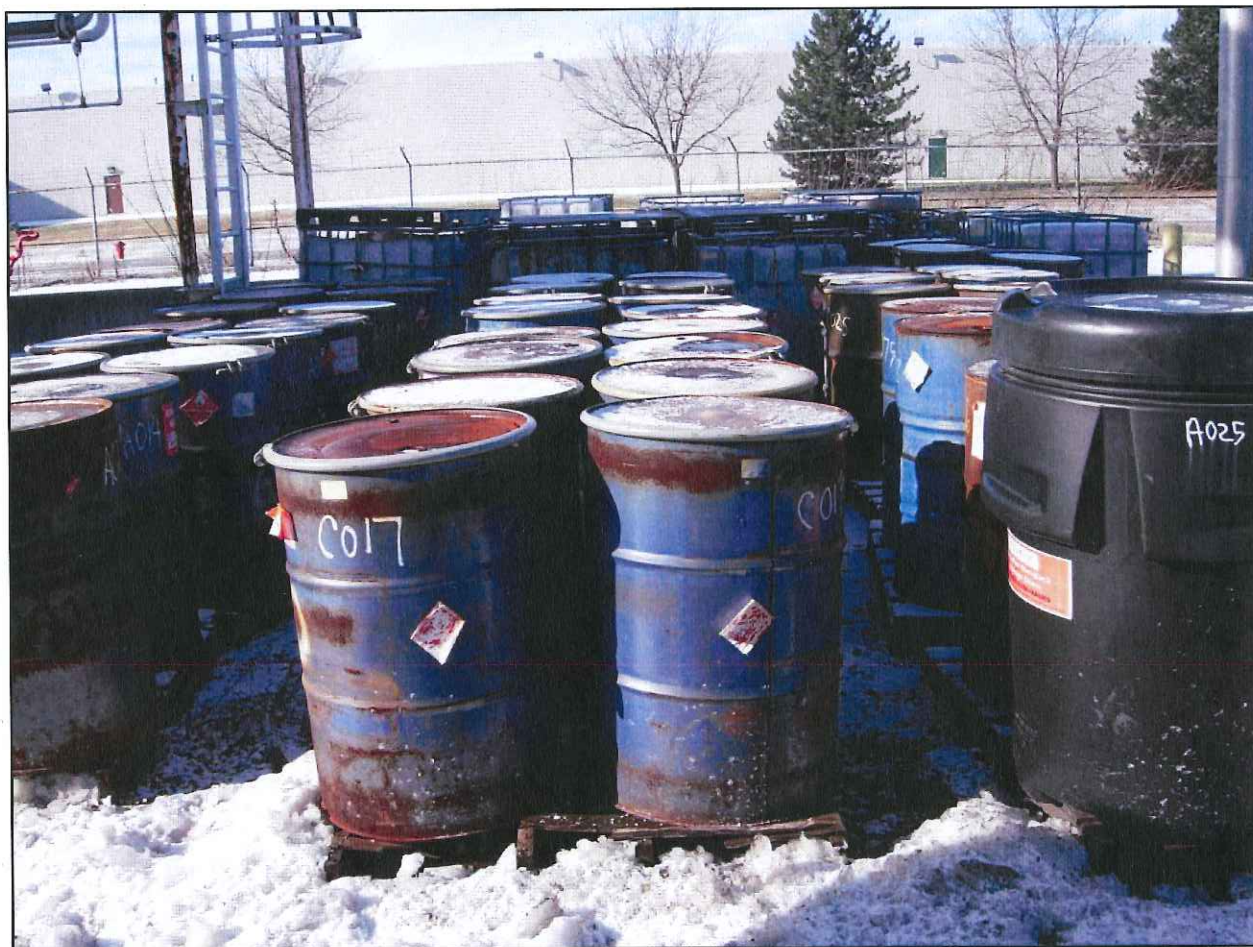
Photo 1 Taken by: Michael Valentino	Polychem Services, Inc.
1/18/12 10:52 am	West of production building just north of product tank farm. Photo shows rows of hazardous waste drums
Orientation: West	affixed with hazardous waste labels and flammable
	decals. Alpha-numeric markings on drums (e.g., "A025,
	C017") are from EPA during its March 2011
	investigation. Overpack drum (R. foreground) is from
	EPA's March 2011 investigation. (Approx. drum count: 48)

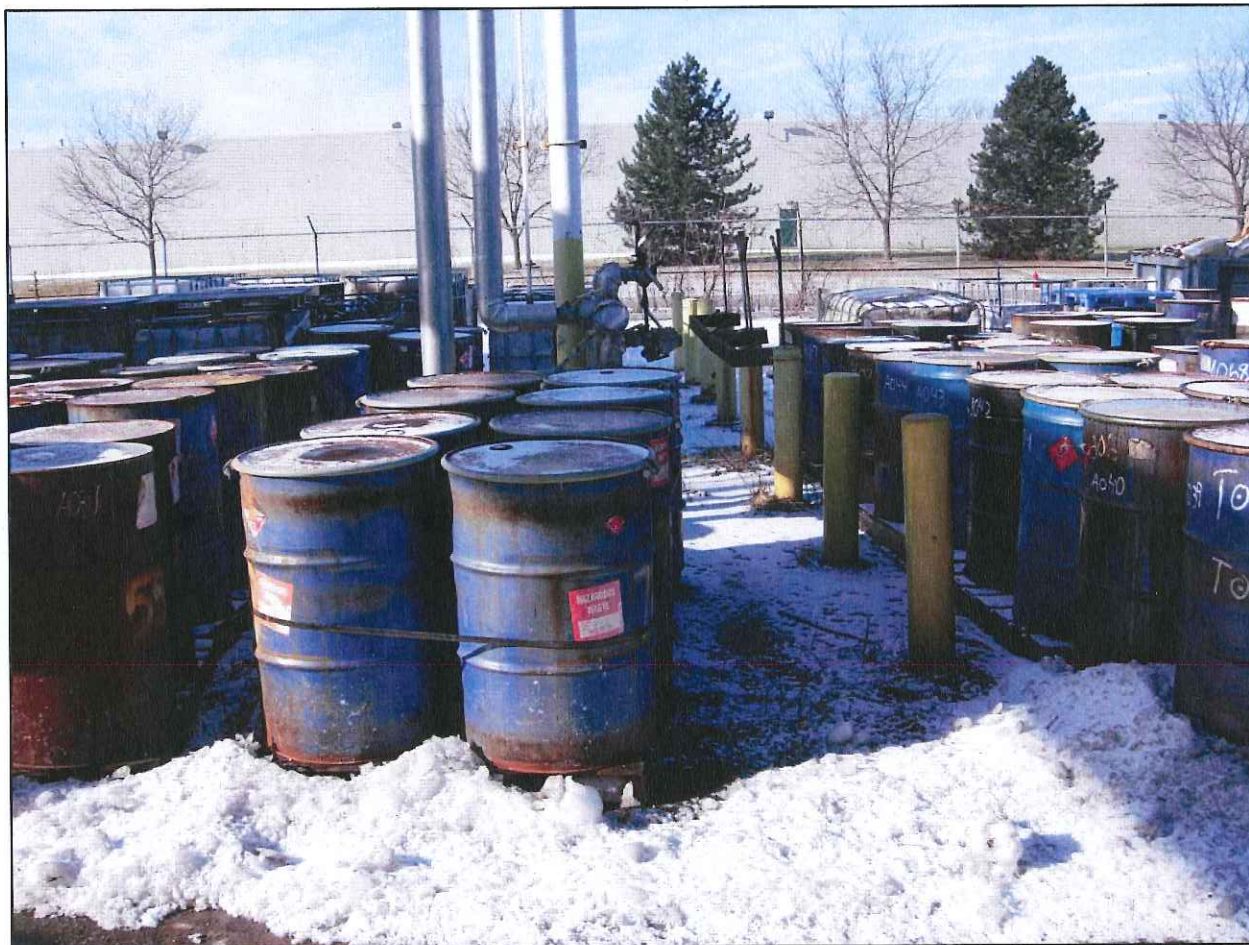
<p>Photo 2 Taken by: Michael Valentino  1/18/12 10:52 am  Orientation: West</p>	<p>Polychem Services, Inc.  West of production building just north of product tank farm. Just north of where Photo 1 was taken. More rows of hazardous waste drums. Painted numbers (e.g., "55") on furthest left drum in foreground are indicative of JAS Environmental drum identification used in developing its waste inventory for Heartland. (Drum count, center pallets only: 8)</p>
---	---

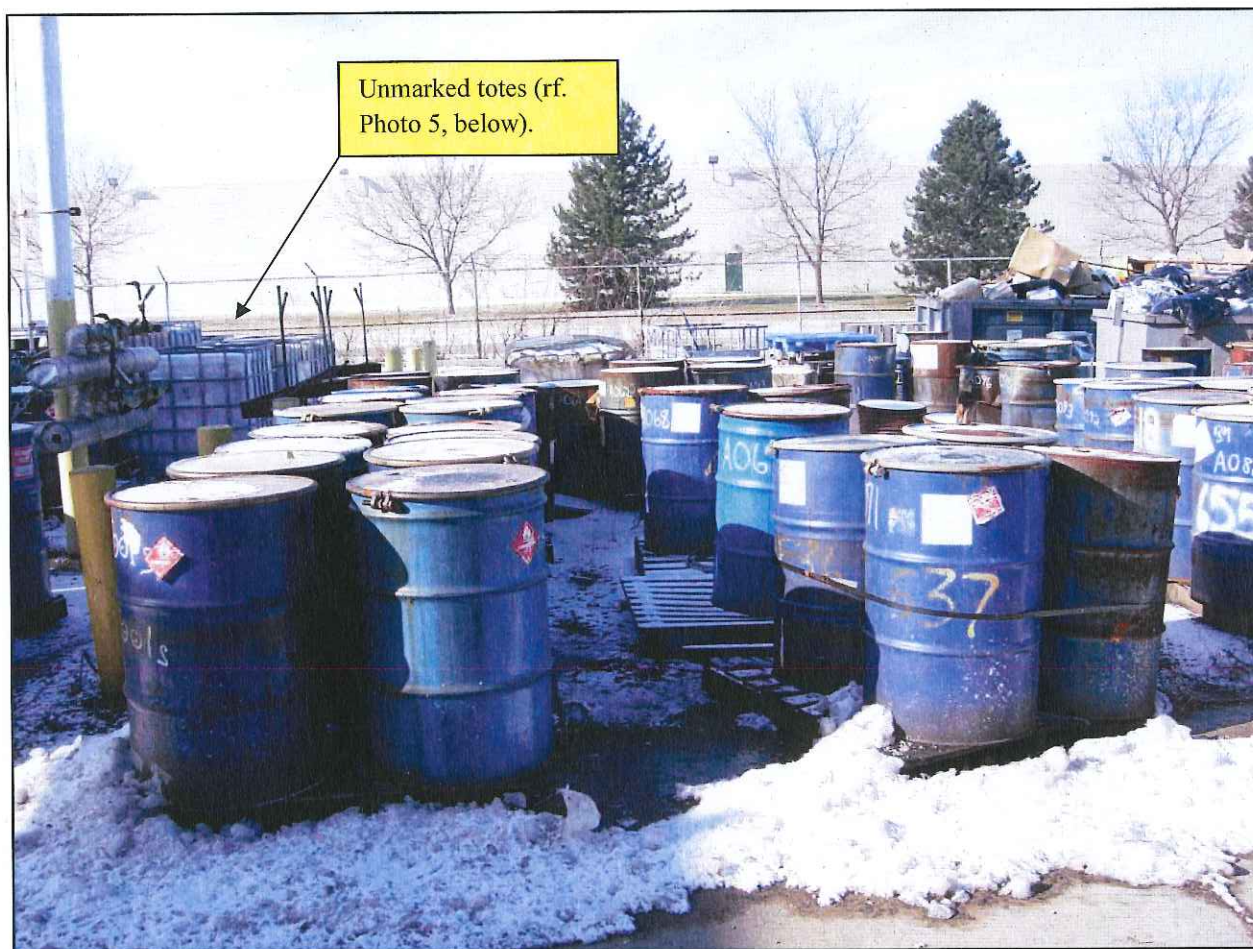
Photo 3	Taken by: Michael Valentino	Polychem Services, Inc.
1/18/12	10:52 am	West of production building just north of product tank farm. Just north of where Photo 2 was taken. (Approx. drum count, left and center-right pallets only: 27)
Orientation: West

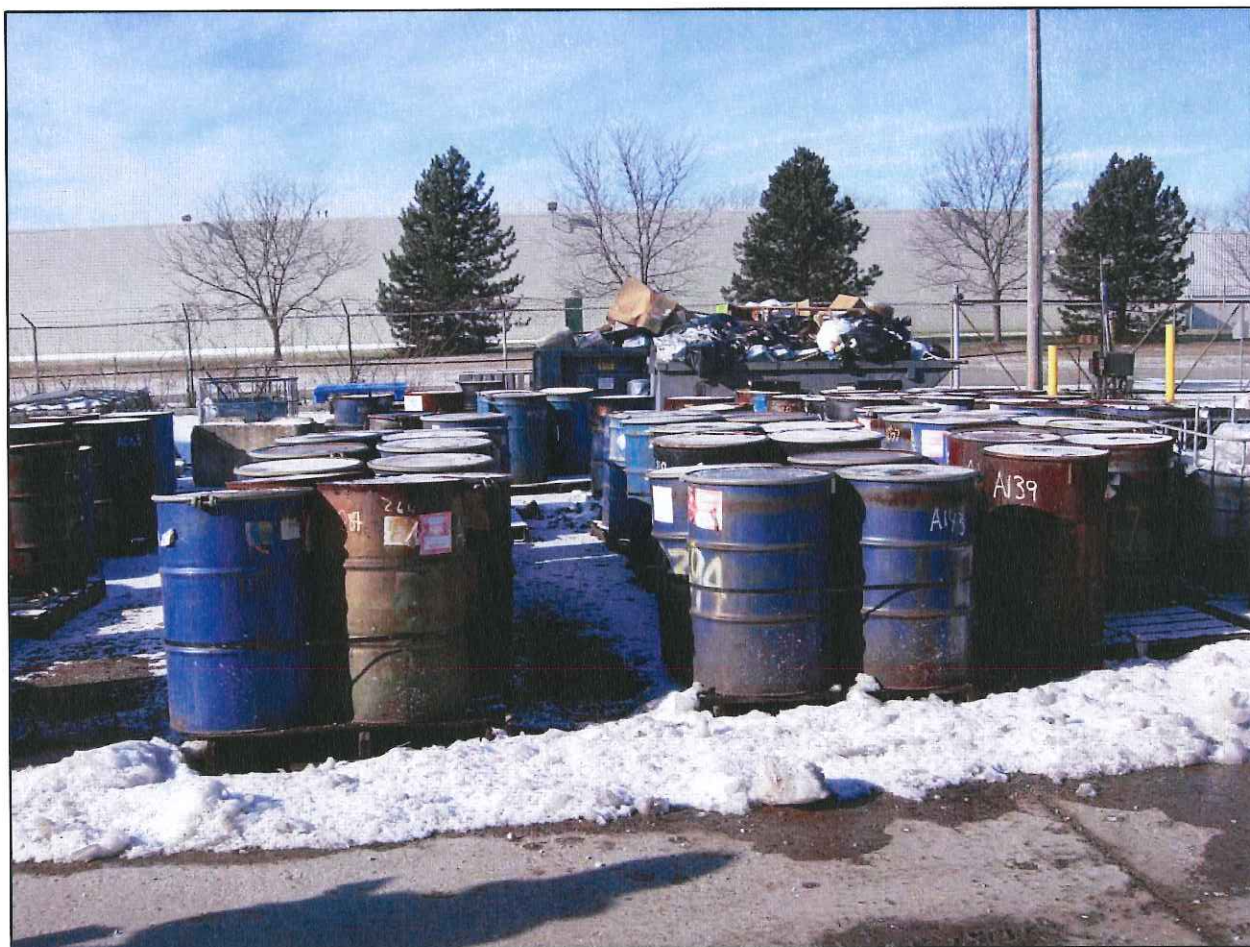
Photo 4 Taken by: Michael Valentino	Polychem Services, Inc.
1/18/12 10:53 am	West of production building just north of product tank farm. Just north of where Photo 3 was taken. (Approx. drum count, excluding furthest left pallets: 47)
Orientation: West

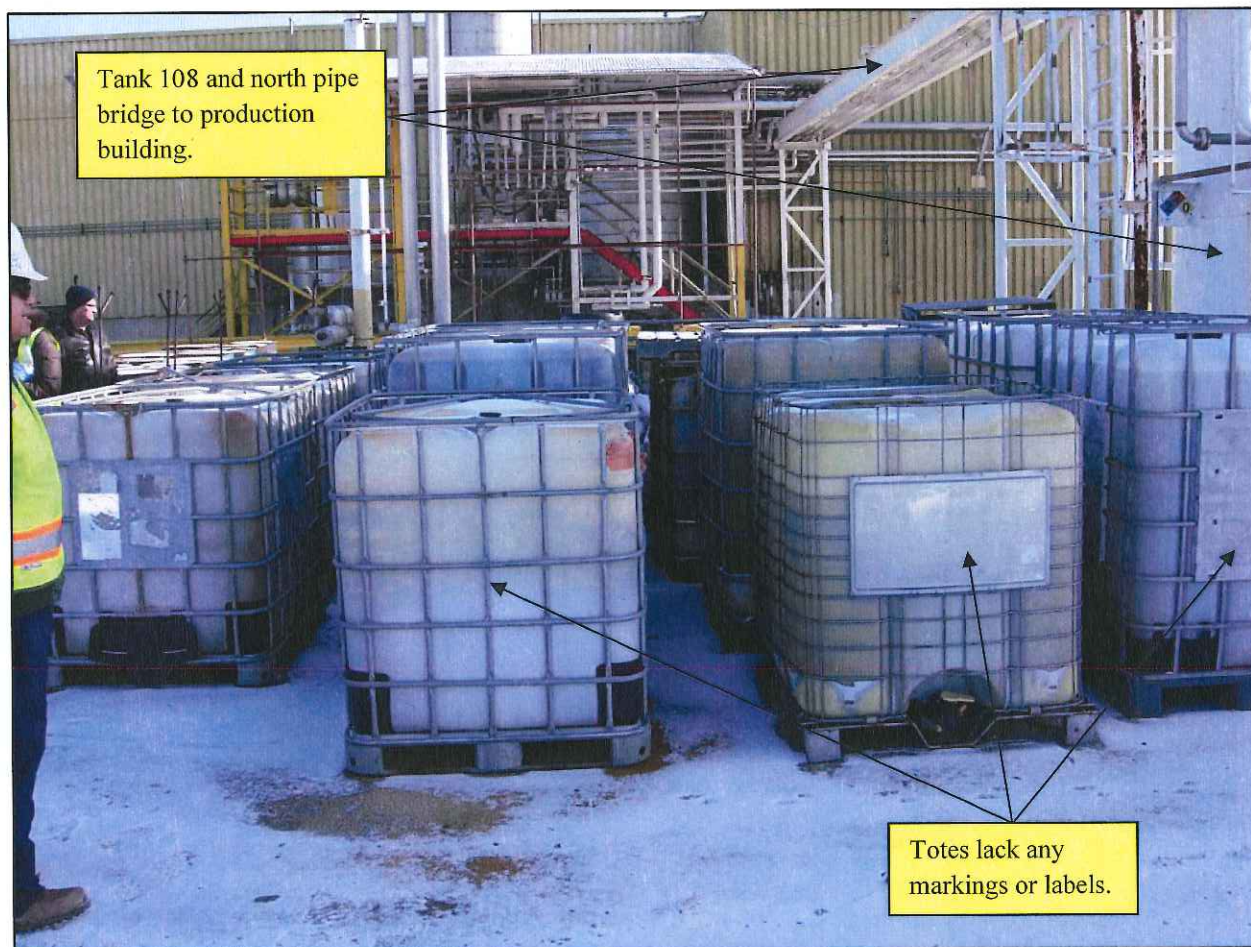
Photo 5 Taken by: Michael Valentino  
 1/18/12 10:56 am  
 Orientation: East

Polychem Services, Inc.  
 West of production building just north of product tank farm. Unmarked totes possibly containing hardened sodium sulfate salt, according to Polychem officials.

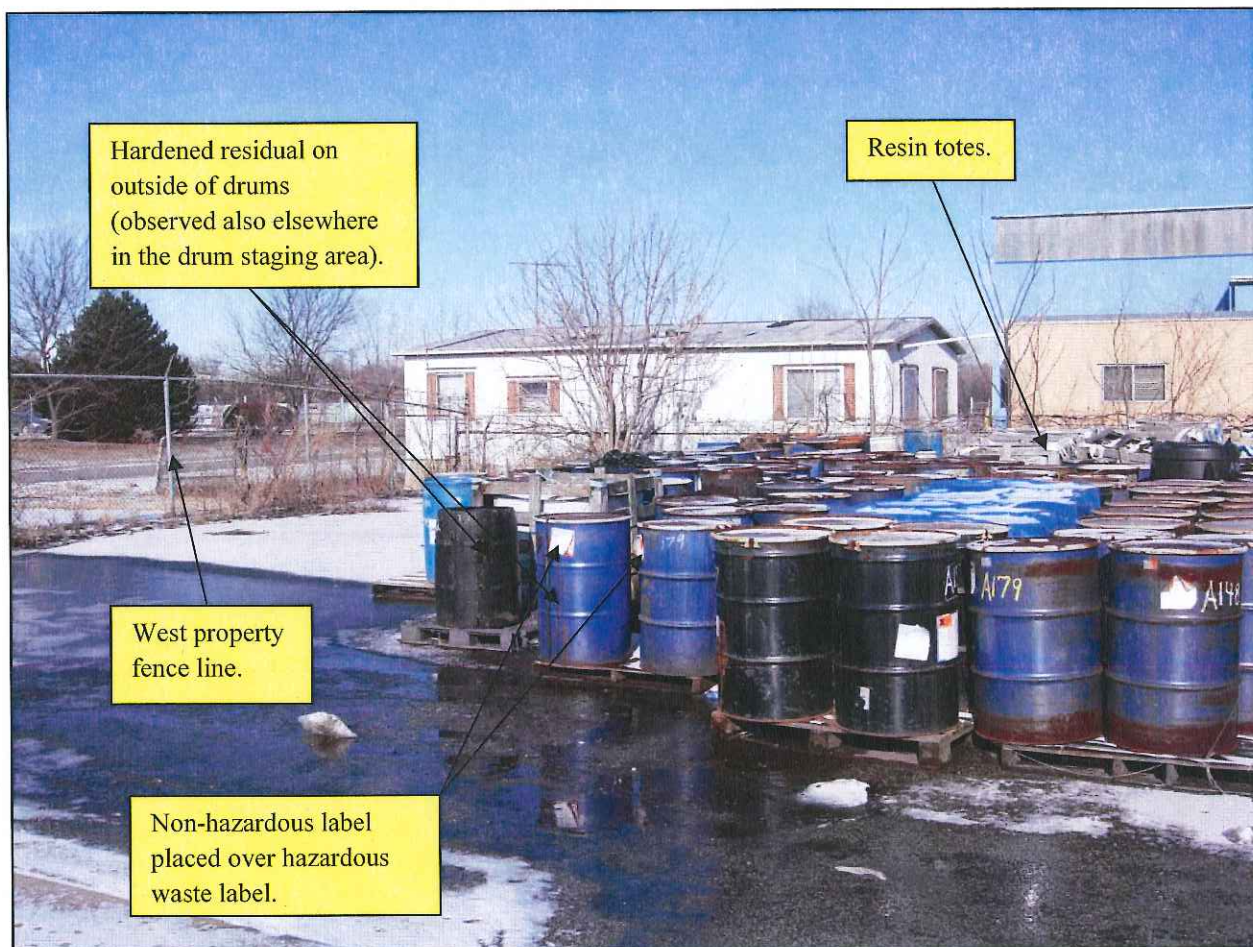
Photo 6	Taken by: Michael Valentino	Polychem Services, Inc.
1/18/12	10:58 am	Northwest corner of site. Mixture of hazardous and non-hazardous (predominantly) drums, resin totes left by Heartland, according to Polychem officials. (Approx. drum count, to the left of drum "A179" in right foreground: 34)
Orientation: Northwest

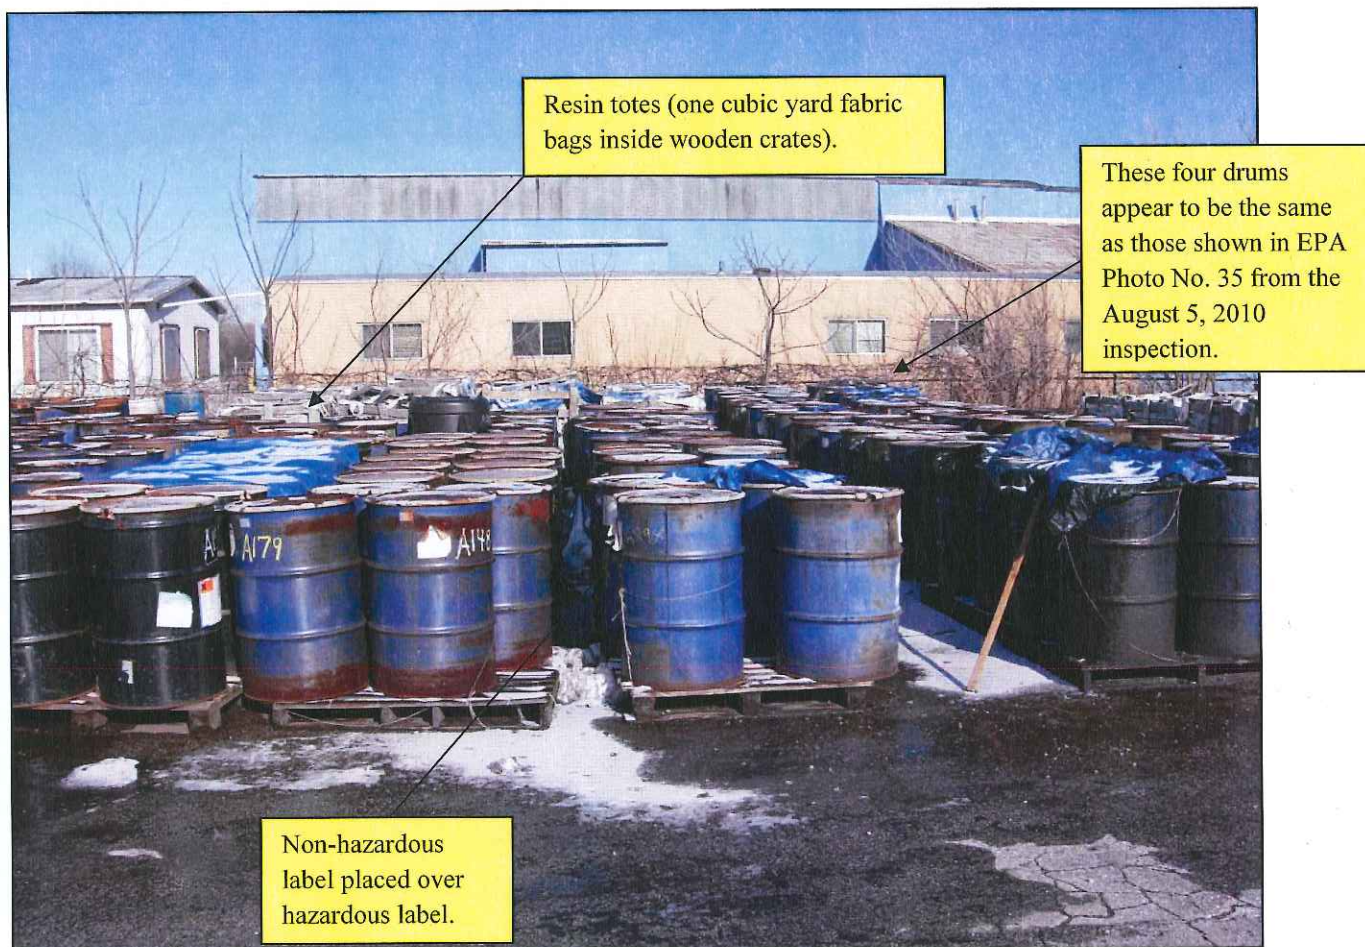
Photo 7 Taken by: Michael Valentino	Polychem Services, Inc.
1/18/12 10:58 am	Northwest corner of site. Mixture of hazardous and non-hazardous (predominantly) drums, resin totes left by Heartland, according to Polychem officials. Just east of Photo 6. (Approx. drum count, from drum "A179" to the row of full pallets to the right: 70)
Orientation: North

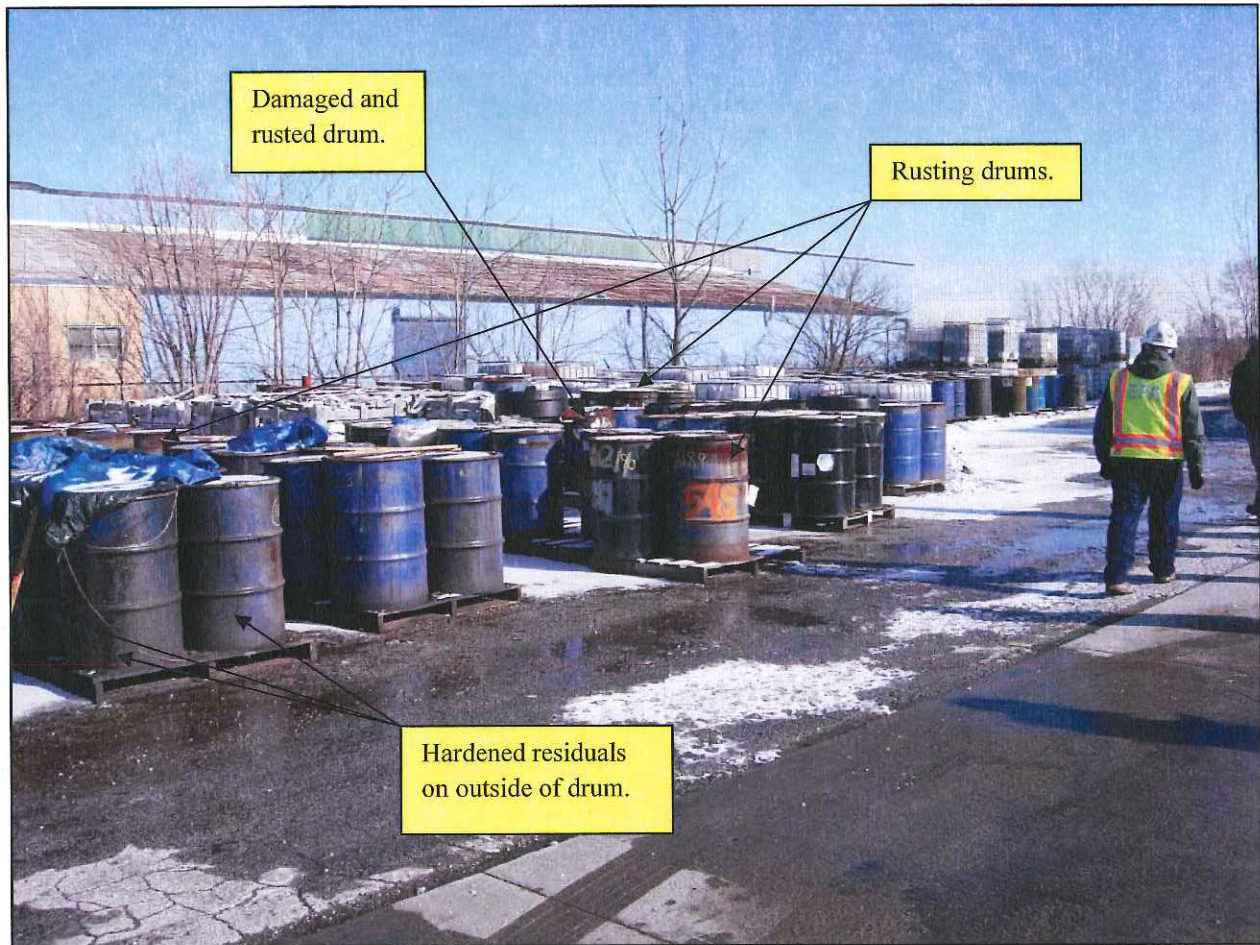
Photo 8	Taken by: Michael Valentino	Polychem Services, Inc.
1/18/12	10:58 am	North side of site. Mixture of hazardous and non-hazardous (predominantly) drums, resin totes left by Heartland, according to Polychem officials. Just east of Photo 7. (Approx. drum count, to the right of drums "211/A190" and "545/A189": 42)
Orientation: Northeast

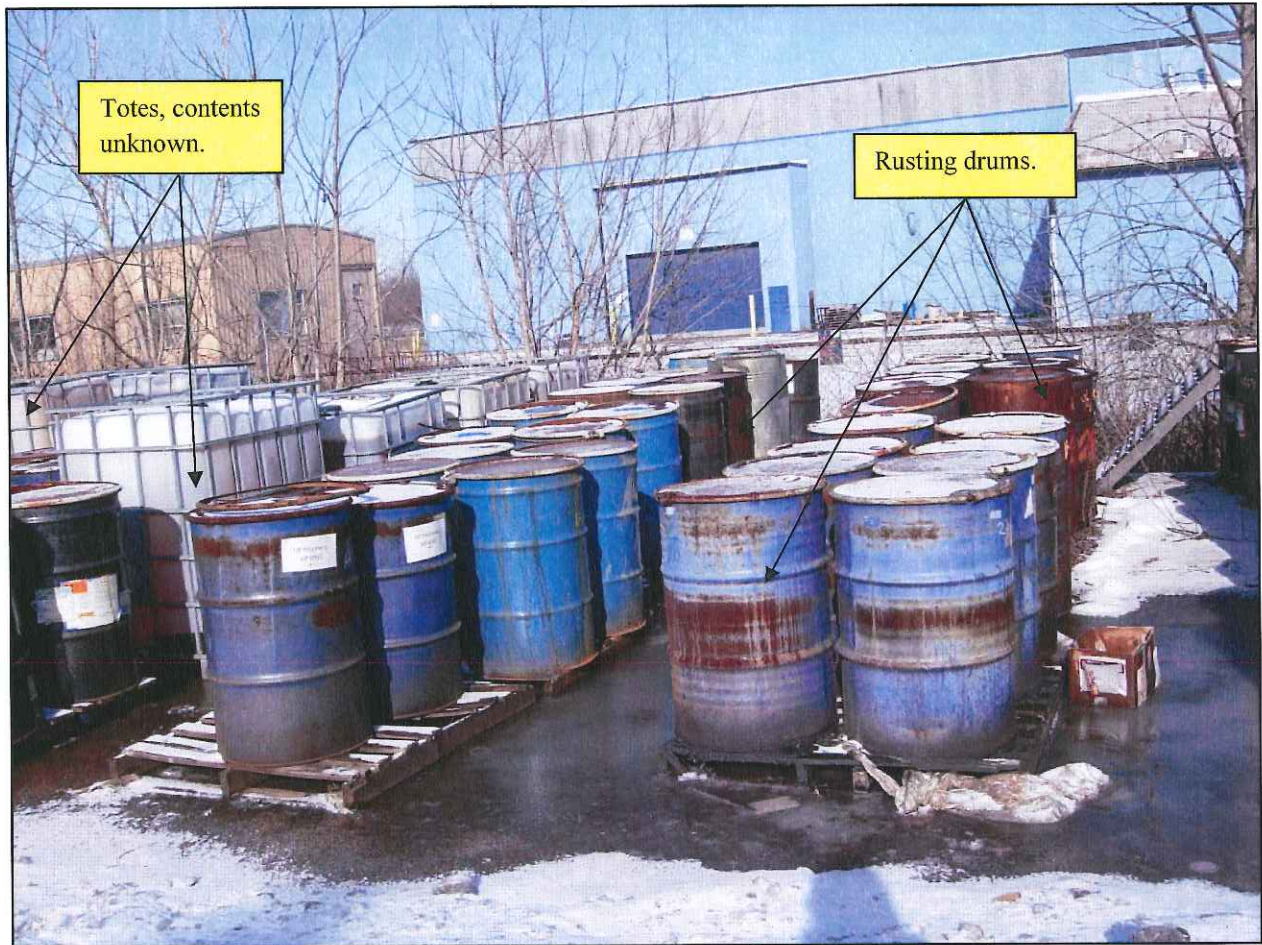
Photo 9 Taken by: Michael Valentino  
 1/18/12 11:00 am  
 Orientation: North-Northwest

North end of site. Non-hazardous drums from Heartland, according to Polychem officials. Includes some product material. Uncertain regarding content of totes in left background. Just east of Photo 8. (Approx. drum count: 38)

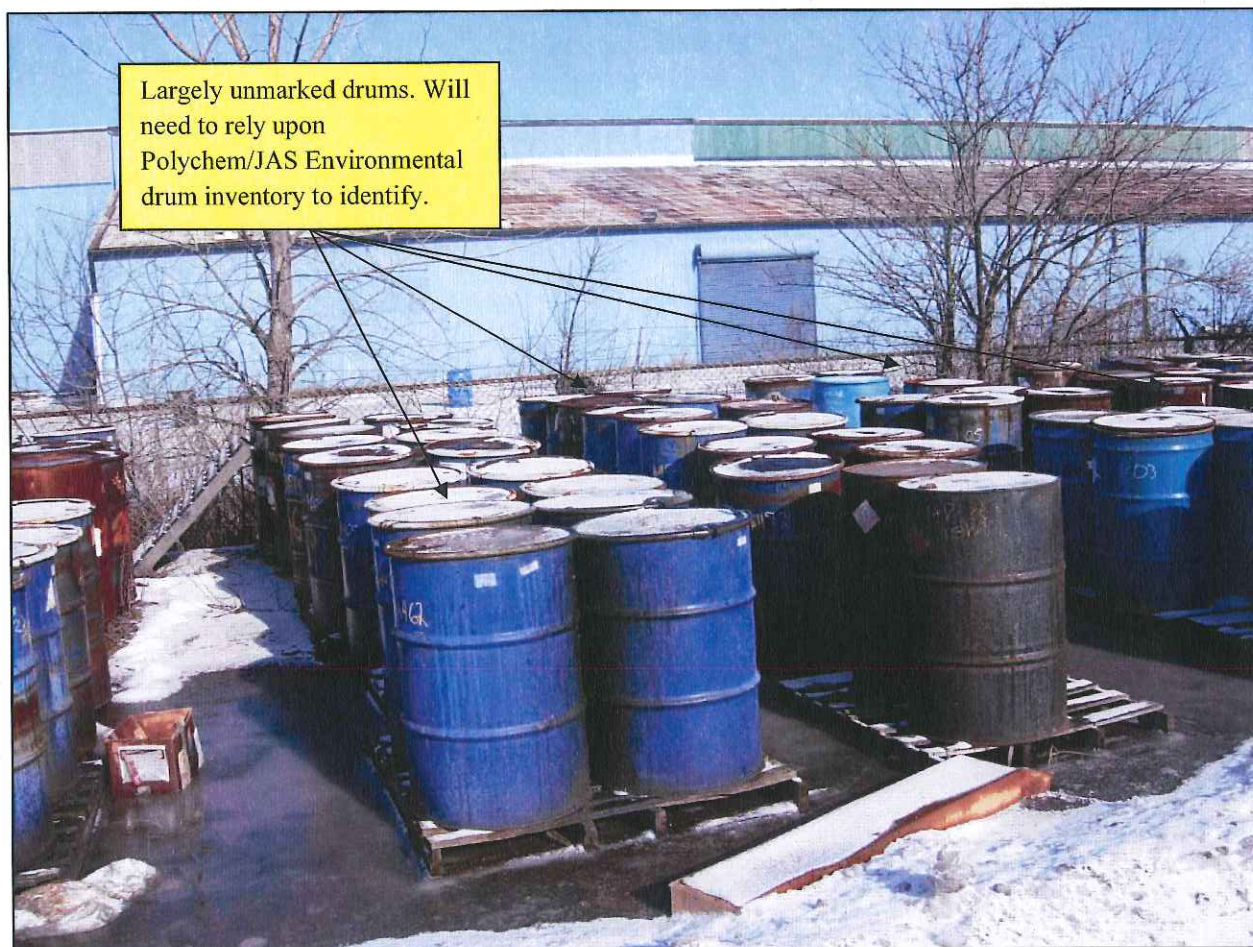
Photo 10	Taken by: Michael Valentino	Polychem Services, Inc.
1/18/12	11:00 am	North side of site. Drums left by Heartland, according to Polychem officials. Did not observe hazardous waste labels here. (Approx. drum count, excluding furthest left row and drums in right background: 46)
Orientation: North

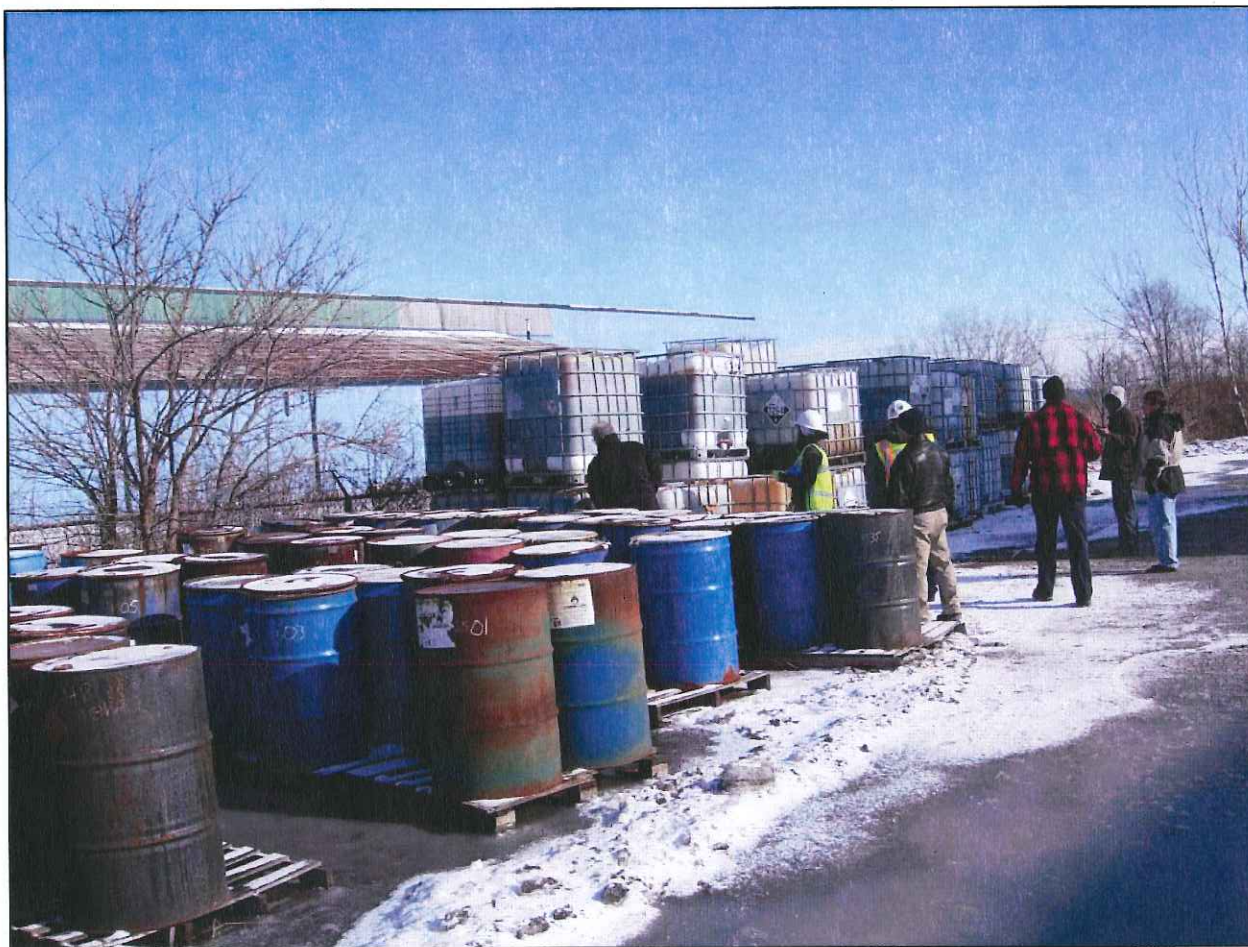
Photo 11	Taken by: Michael Valentino	Polychem Services, Inc.
1/18/12	11:00 am	North/Northeast part of site. Unidentified drums to left,
Orientation: North-Northeast		DMEA totes in rear. Polychem officials claim these drums were left by Heartland. (Approx. drum count, excluding drum "A503" and to its left: 35)

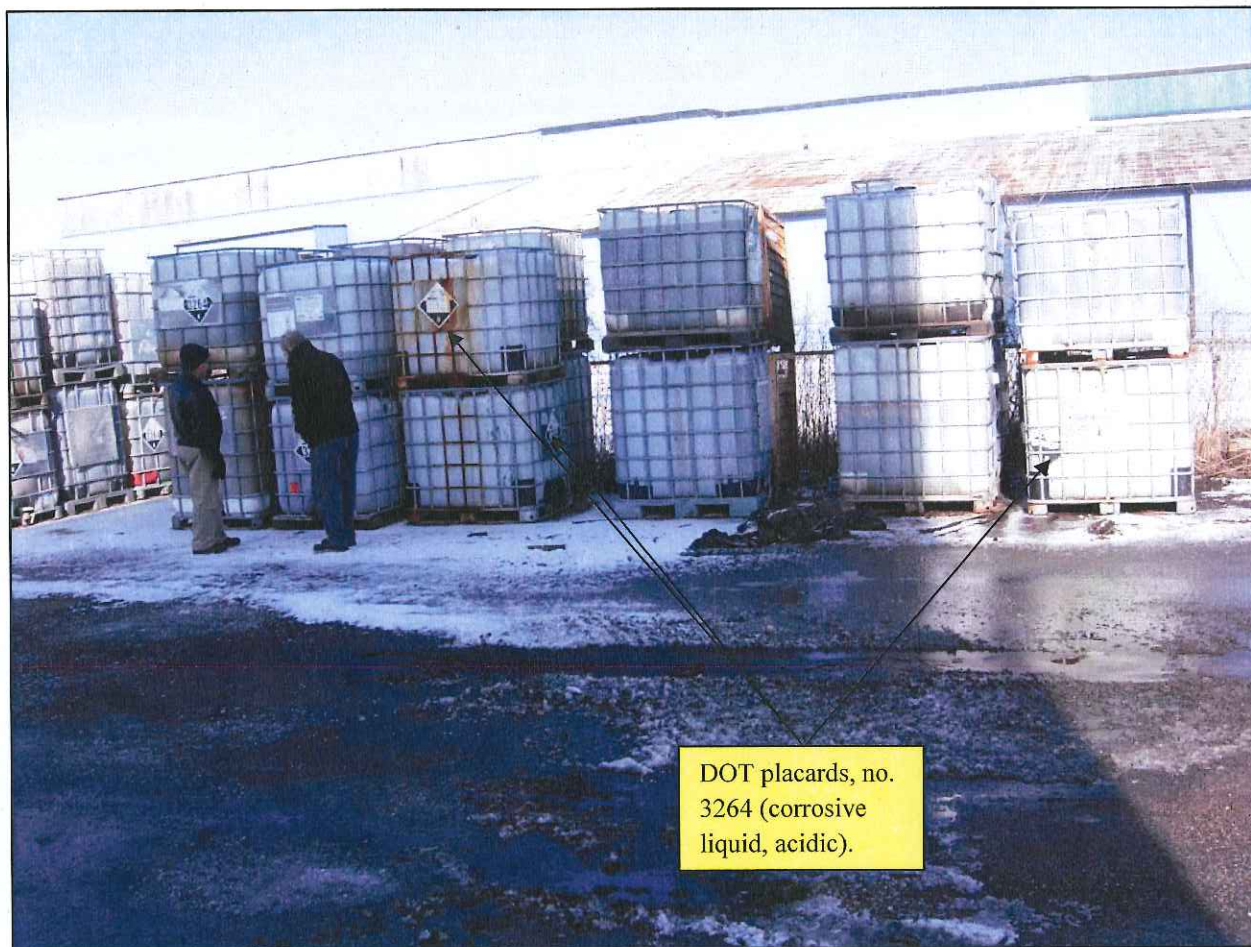
Photo 12 Taken by: Michael Valentino	Polychem Services, Inc.
1/18/12 11:02 am	North/Northeast part of site. DMEA totes. Some uncertainty as to labeling (i.e., Rohm & Haas labels on some totes), according to Polychem officials. DOT placard, no. 3264 indicates corrosive liquid, acidic.
Orientation: North-Northwest

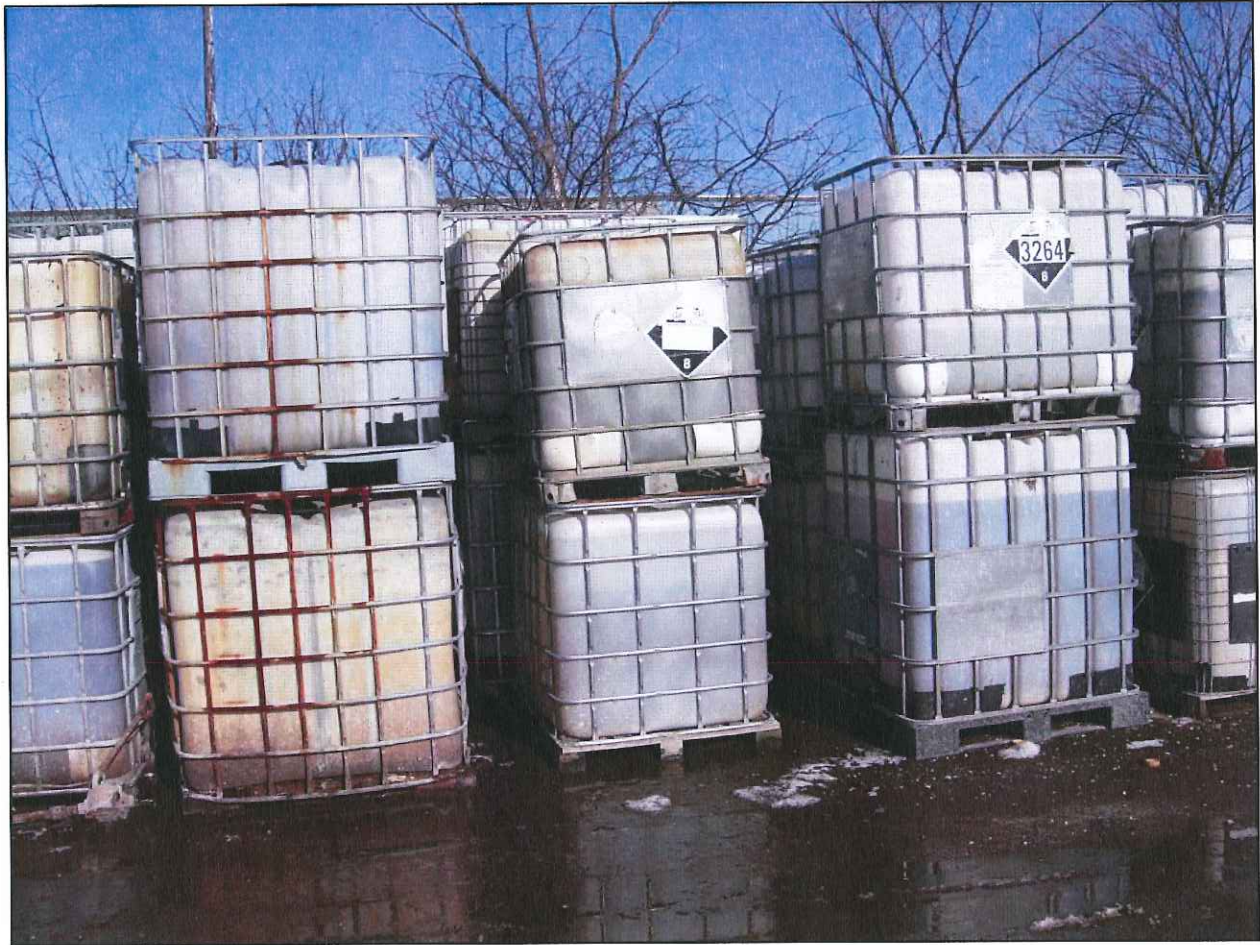
Photo 13	Taken by: Michael Valentino	Polychem Services, Inc.
1/18/12	11:05 am	Northeast corner of site. DMEA totes. DOT placard, no.
Orientation: North		3264 indicates corrosive liquid, acidic.

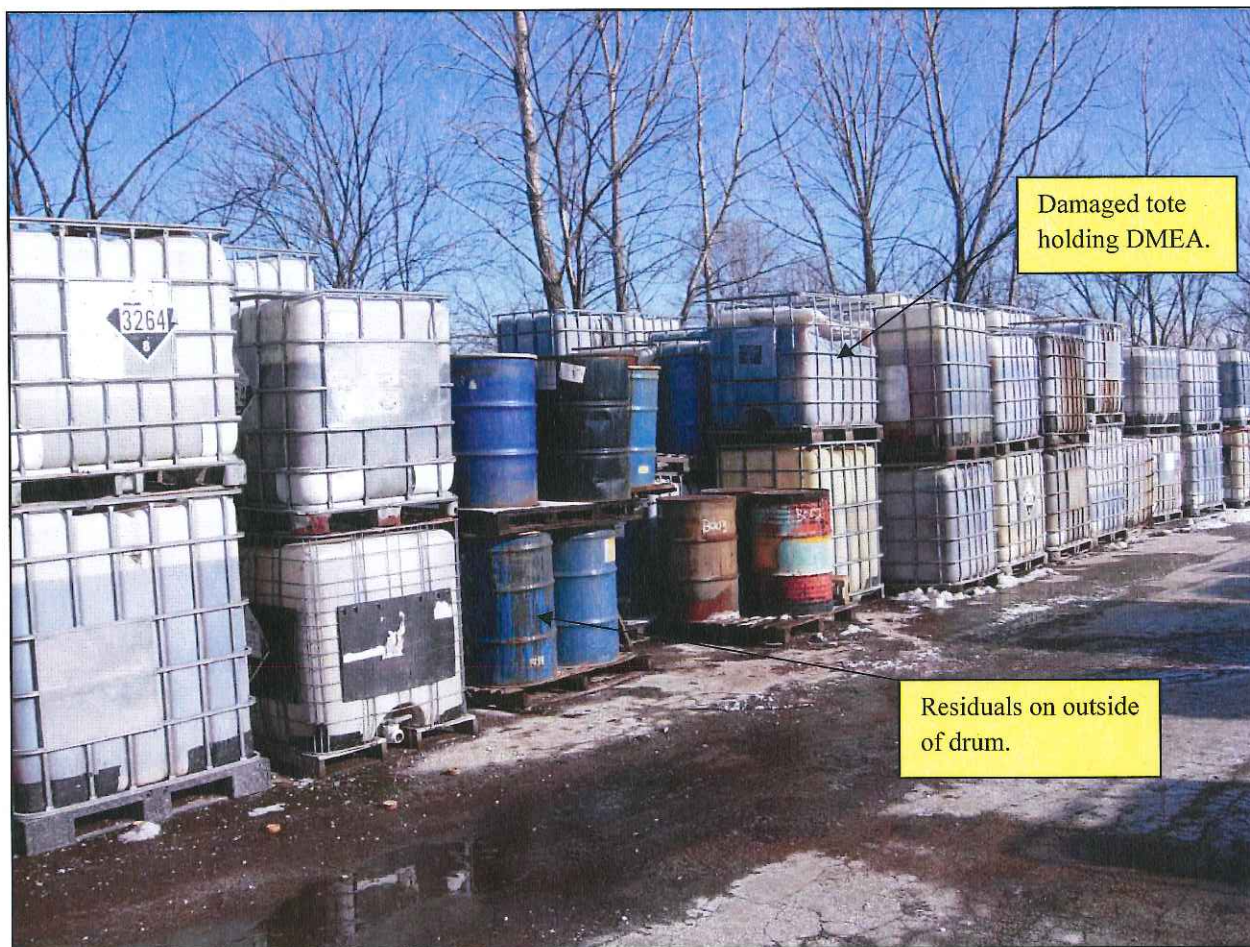
Photo 14 Taken by: Michael Valentino	Polychem Services, Inc.
1/18/12 11:05 am	Northeast corner of site. DMEA totes. DOT placard, no.
Orientation: Northeast	3264 indicates corrosive liquid, acidic. Mixture of Heartland materials and Polychem drums (for processing), according to Polychem officials.

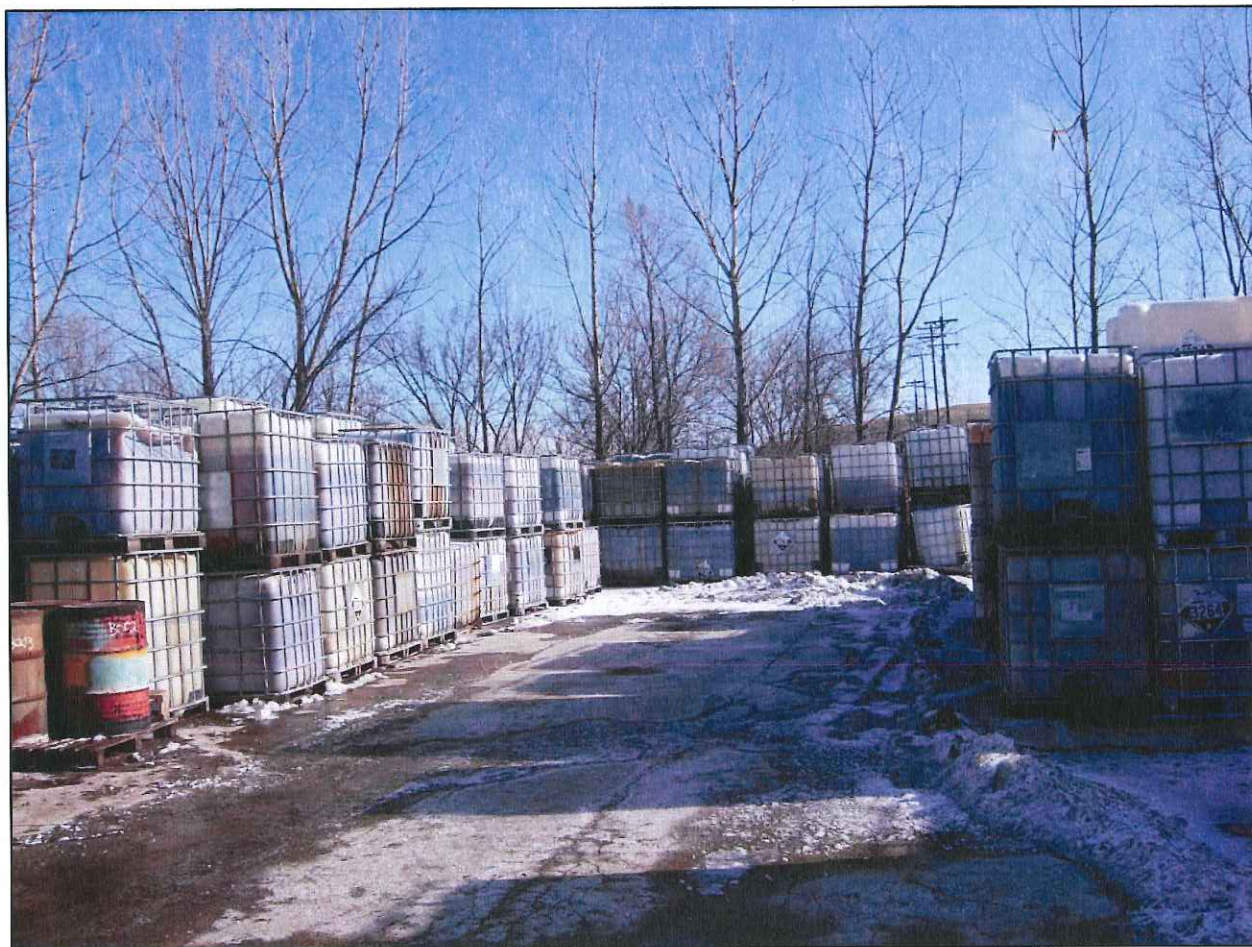
Photo 15	Taken by: Michael Valentino	Polychem Services, Inc.
1/18/12	11:06 am	Northeast corner of site. DMEA totes. Just to south of Photo 14.
Orientation: Northeast

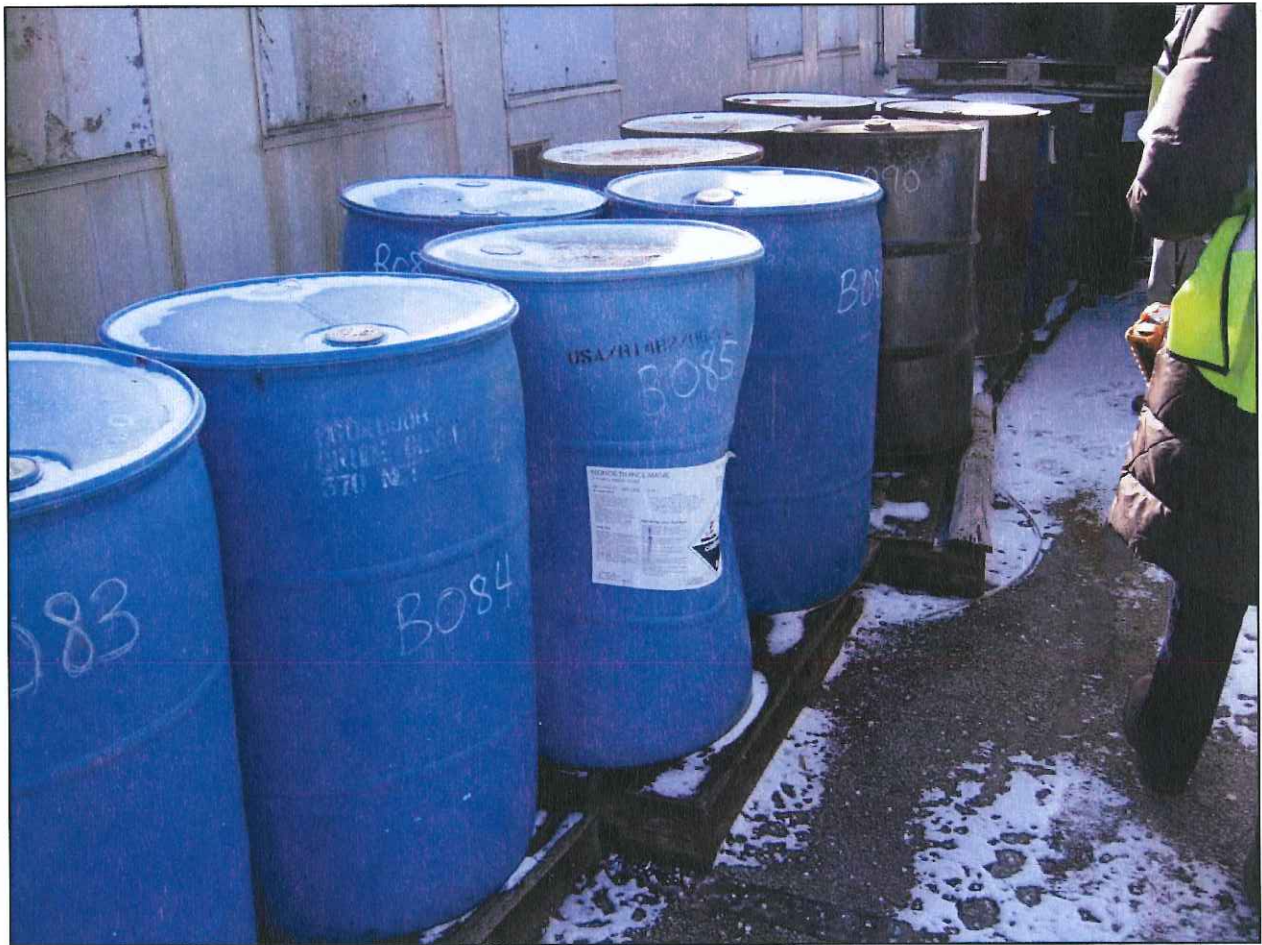
Photo 16	Taken by: Michael Valentino	Polychem Services, Inc.
1/18/12	11:07 am	East end of site, near peroxide storage bldg. Blue poly drums contain monethanolamine.
Orientation: South-Southeast

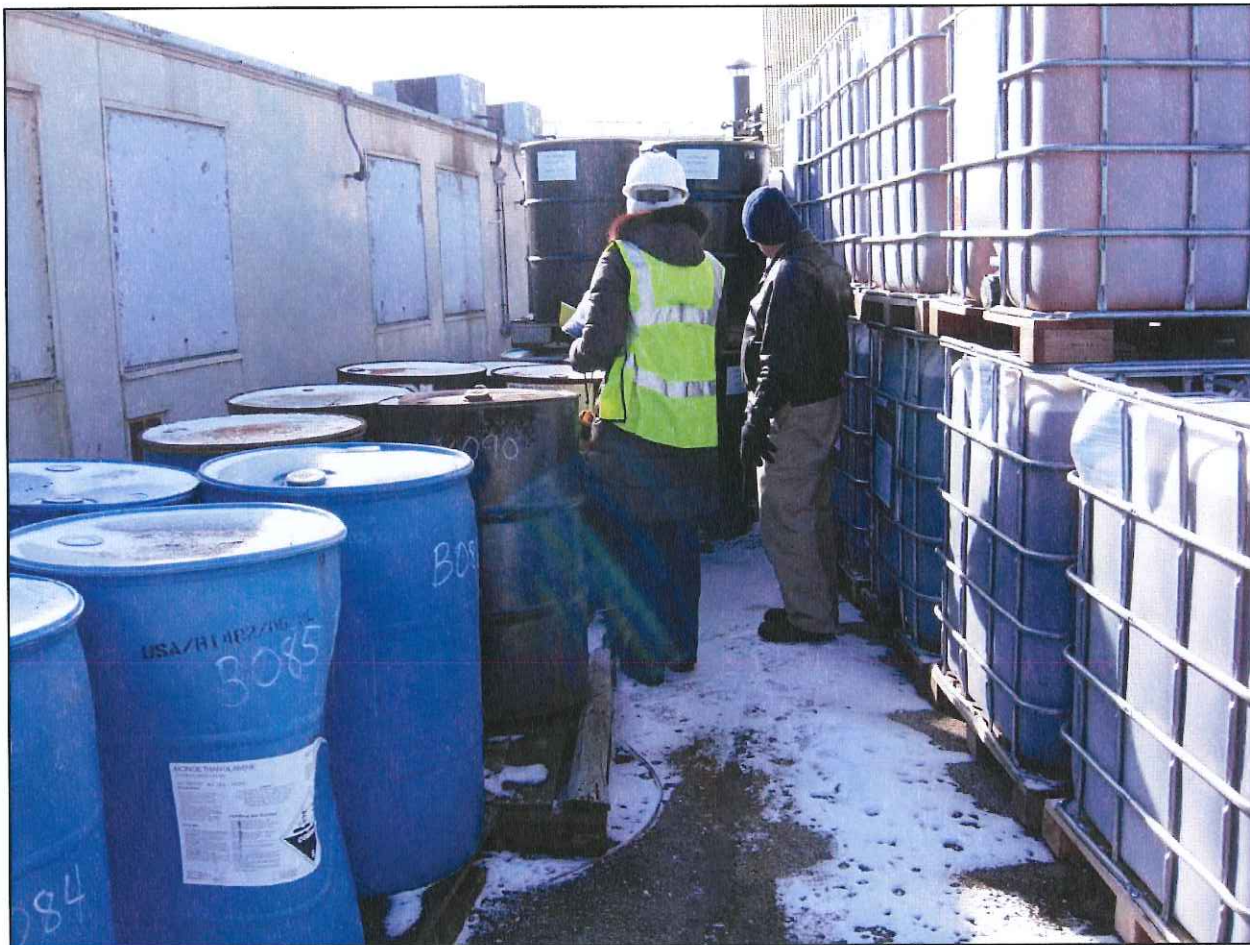
Photo 17 Taken by: Michael Valentino	Polychem Services, Inc.
1/18/12 11:07 am	East end of site, near peroxide storage bldg. Blue poly
Orientation: South	drums contain monethanolamine. Steel drums behind
	blue poly are unmarked. Stacked steel drums in rear are filter bags marked as non-hazardous. DMEA totes to right.

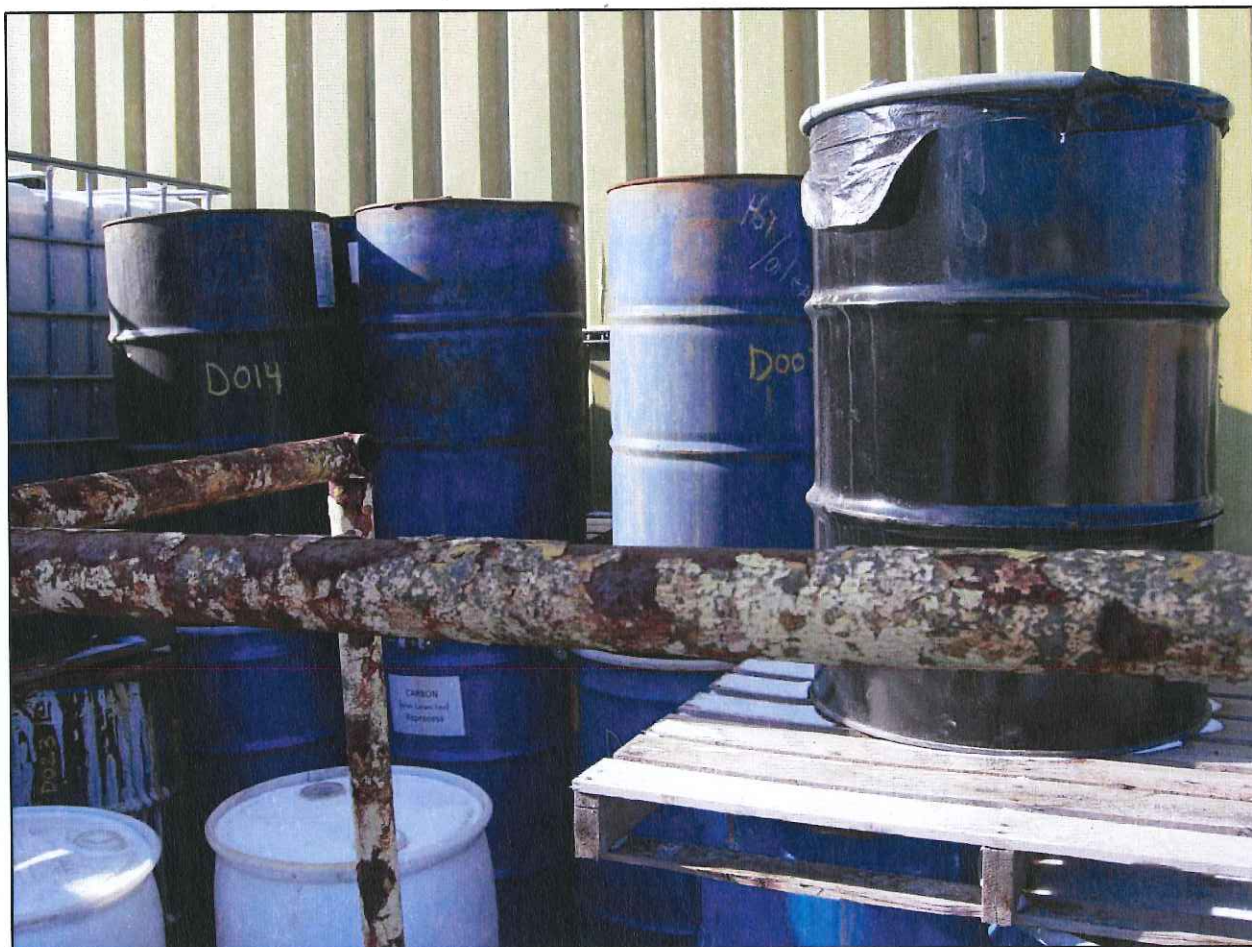
Photo 18	Taken by: Michael Valentino	Polychem Services, Inc.
1/18/12	11:10 am	Just east of warehouse. Mixture of drums, some marked from EPA's March 2011 inspection, others for rework by Polychem, according to Polychem officials.
Orientation: Southwest
