UNITED STATES ENVIRONMENTAL PROTECTION AGENCY  
REGION 5  
77 W. JACKSON BOULEVARD  
CHICAGO, IL 60604

SITE VISIT REPORT - FINAL

INSTALLATION NAME: Polychem Services, Inc., LLC  
U.S. EPA ID No.: ILD 980 578 876  
LOCATION ADDRESS: 374 E. Joe Orr Road  
Chicago Heights, IL 60411  
NAICS CODES: 325211 (Plastics, Material and Resin  
Manufacturing); 424690 (Other Chemical and  
Allied Products Merchant Wholesalers)  
DATE OF INSPECTION: January 18, 2012  
EPA INSPECTOR: Michael Valentino

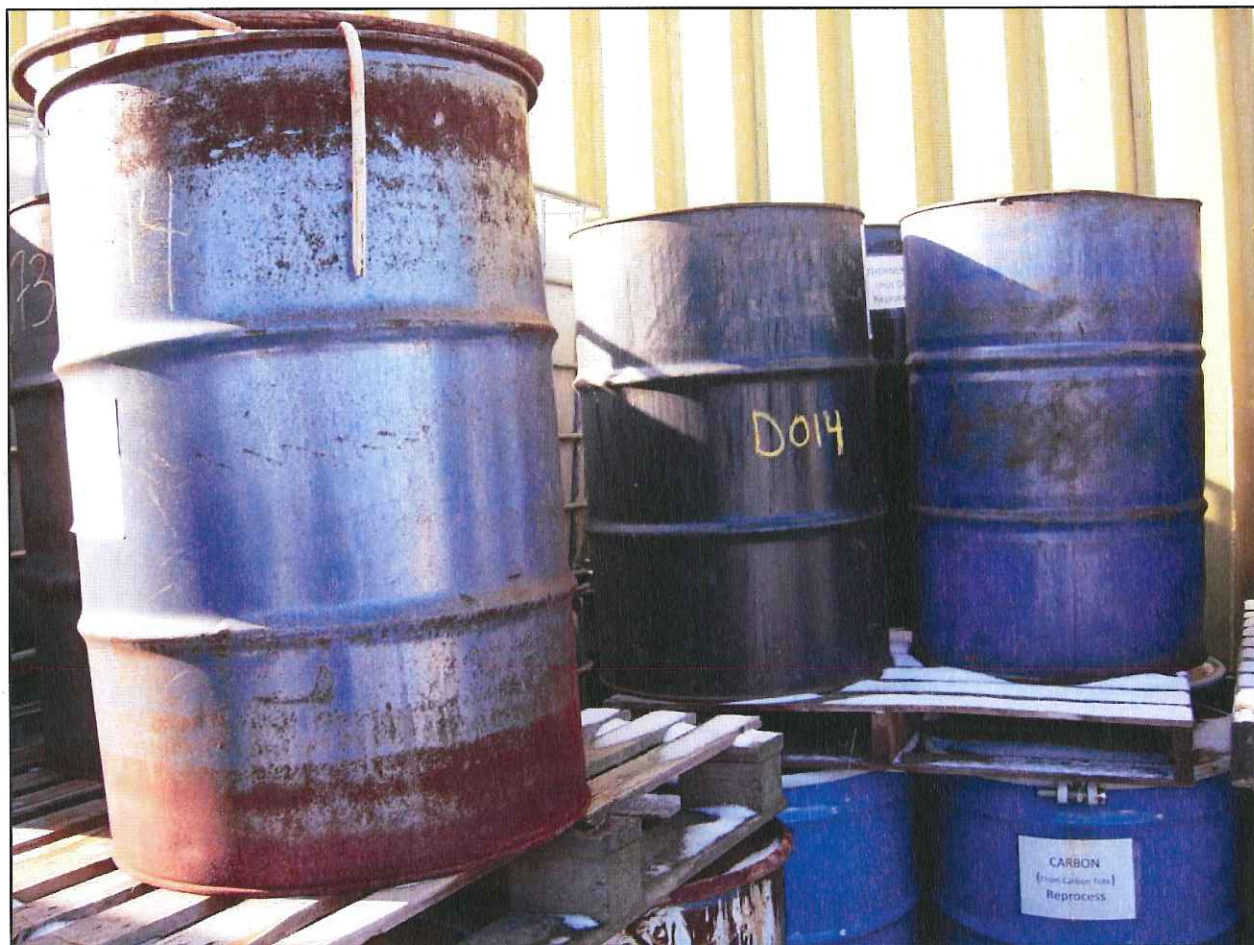
Photo 19	Taken by: Michael Valentino	Polychem Services, Inc.
1/18/12	11:10 am	Just east of warehouse. Mixture of drums, some marked from EPA's March 2011 inspection, others for rework by Polychem, according to Polychem officials.
Orientation: Southwest

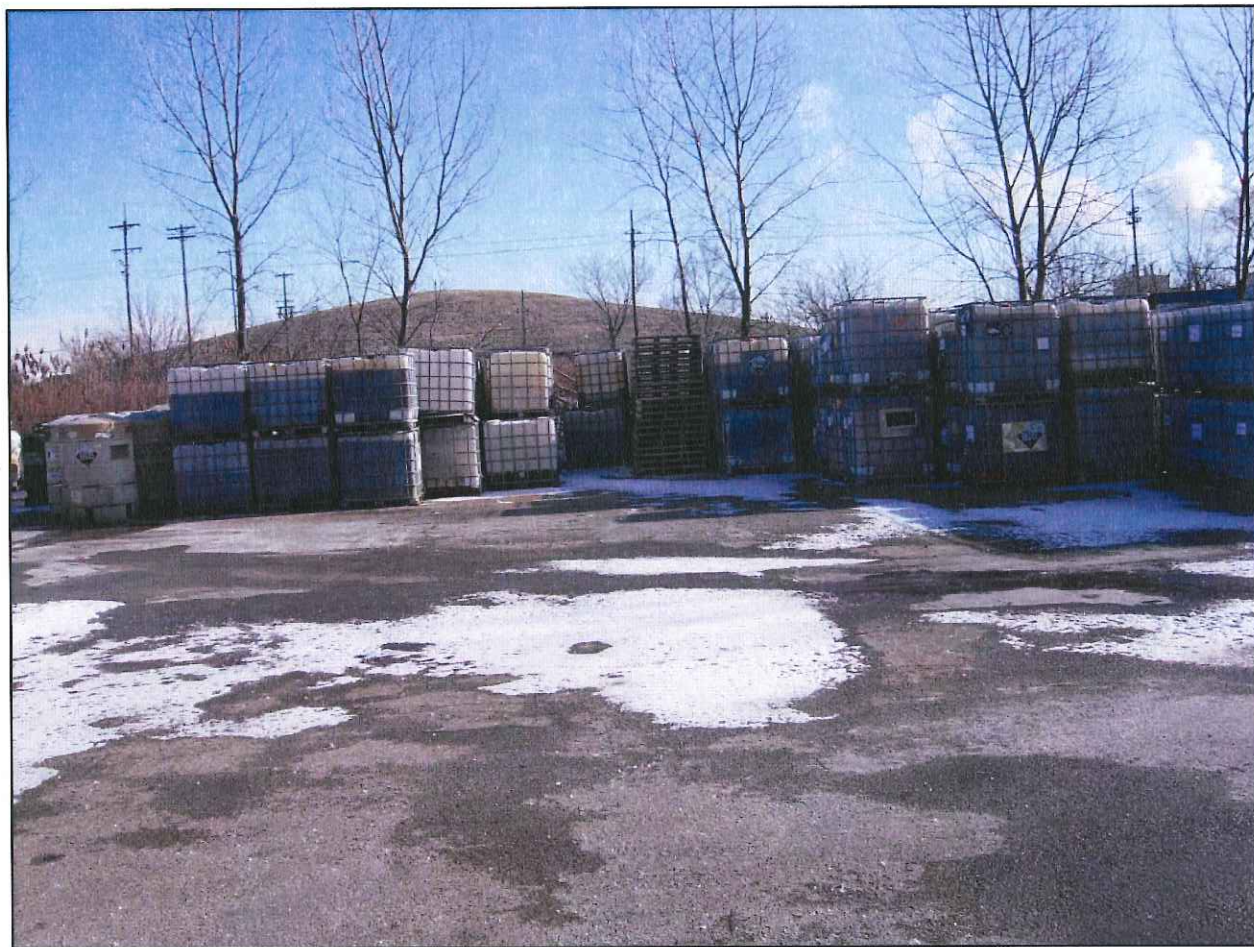
Photo 20	Taken by: Michael Valentino	Polychem Services, Inc.
1/18/12	11:11 am	East side of site. DMEA totes to be processed.
Orientation:	East

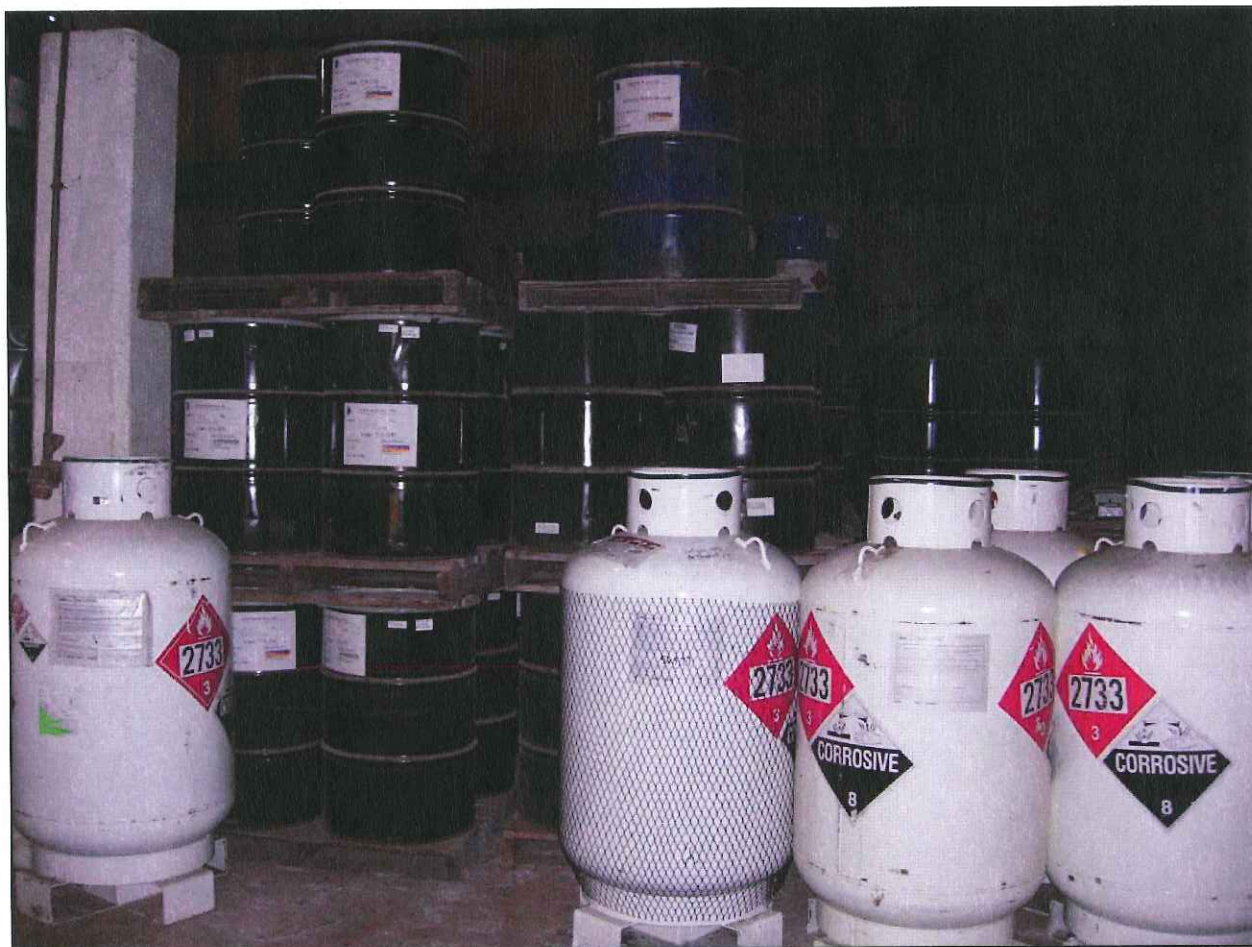
Photo 21	Taken by: Michael Valentino	Polychem Services, Inc.
1/18/12	11:13 am	Inside of warehouse. Drums of alkyd resin (black, 55-gal drums in rear). Steel canisters affixed with DOT placard no. 2733 (amines, flammable, corrosive or polyamines, flammable, corrosive).
Orientation: West

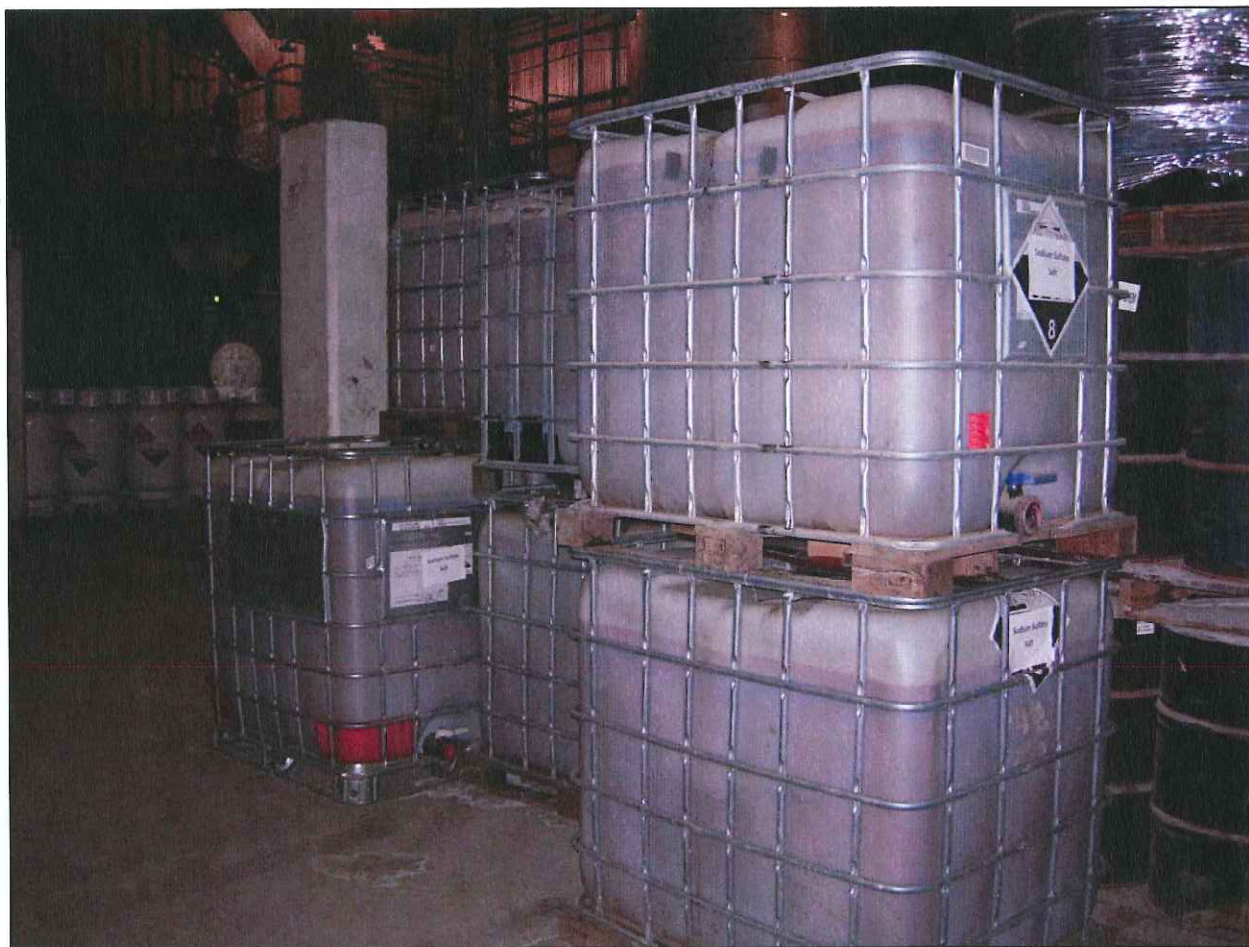
Photo 22	Taken by: Michael Valentino	Polychem Services, Inc.
1/18/12	11:13 am	Inside of warehouse. Totes of sodium sulfate salt solution.
Orientation: Southwest

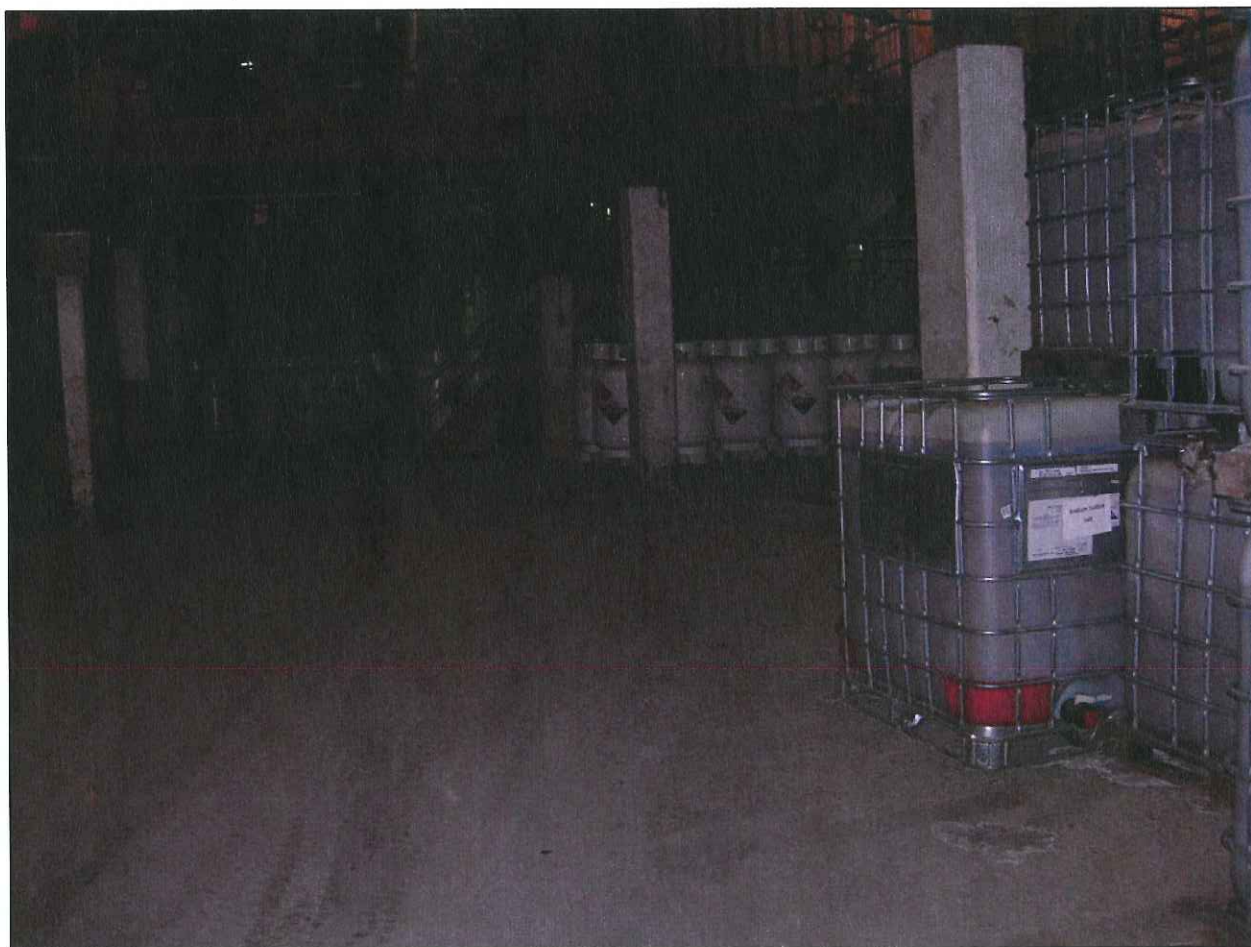
Photo 23	Taken by: Michael Valentino	Polychem Services, Inc.
1/18/12	11:14 am	Inside of warehouse. Just north of where Photo 22 was taken.
Orientation:	South

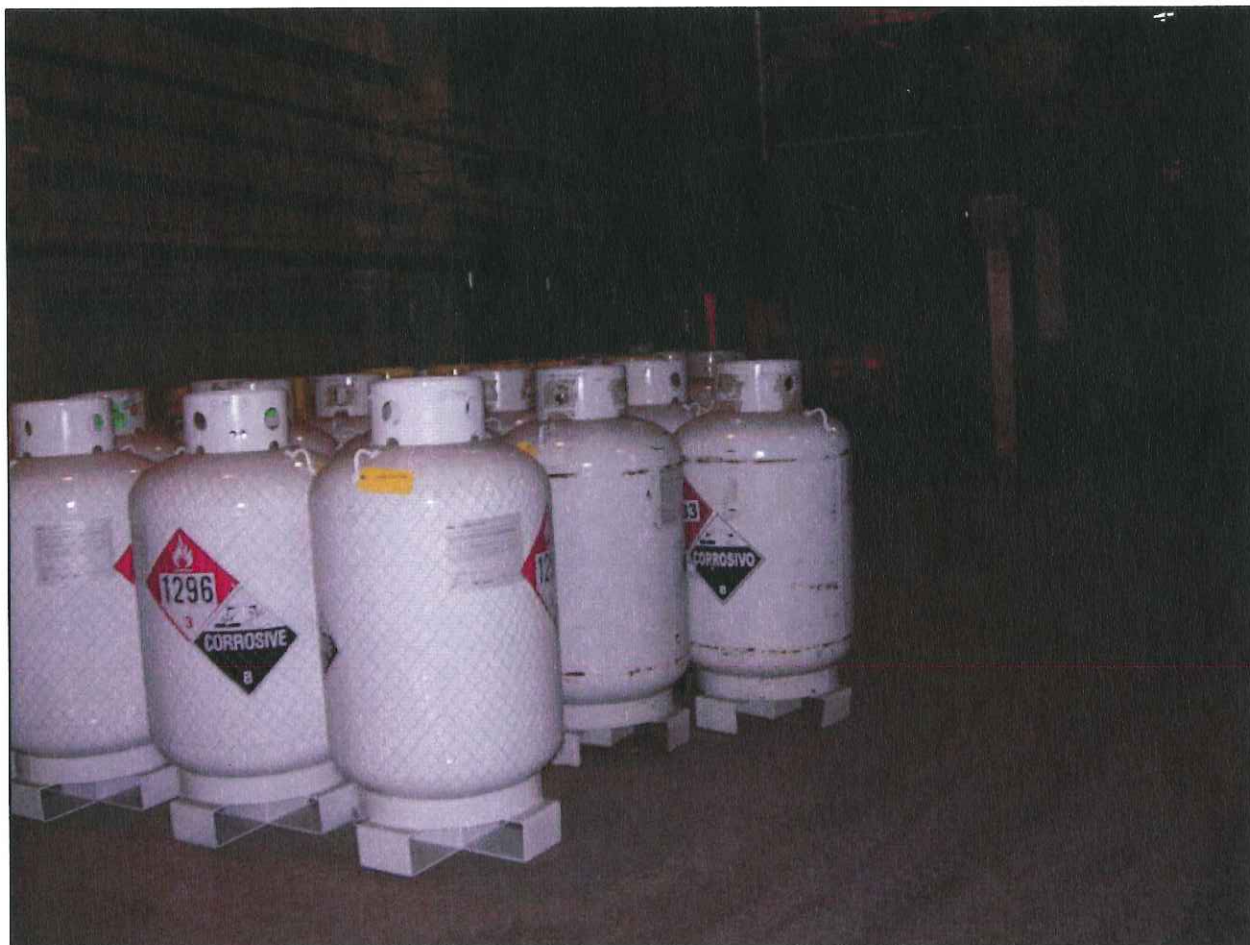
Photo 24	Taken by: Michael Valentino	Polychem Services, Inc.
1/18/12	11:14 am	Inside of warehouse. DOT placard no. 1296,
Orientation: South-Southeast		triethylamine, flammable, corrosive.

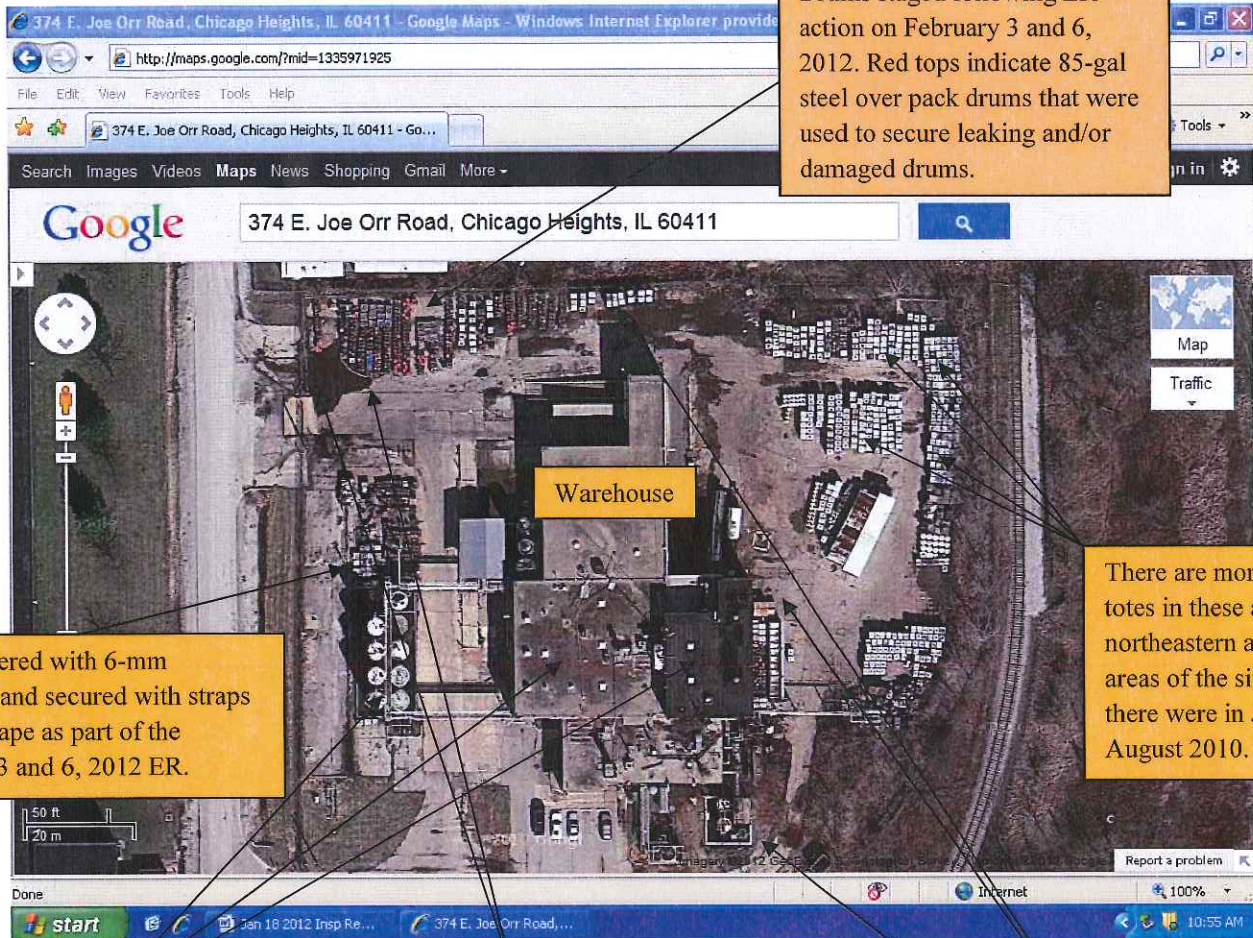
AERIAL PHOTO OF POLYCHEM FACILITY CIRCA MARCH 2012 (EST.)

Drums staged following ER action on February 3 and 6, 2012. Red tops indicate 85-gal steel over pack drums that were used to secure leaking and/or damaged drums.

Totes covered with 6-mm Visqueen and secured with straps and duct tape as part of the February 3 and 6, 2012 ER.

There are more DMEA totes in these areas of the northeastern and eastern areas of the site than there were in July-August 2010.

Absorbent booms placed along western fence line and immediately southwest of staged drums on February 1, 2012 during the ER action.

There are less DMEA totes in these areas of the northeastern and eastern areas of the site than there were in July-August 2010.
