Summit pipeline estimated route (in red) overlaid on Figure 5 from "West Fork Des Moines River Water Trail Plan, 2019".

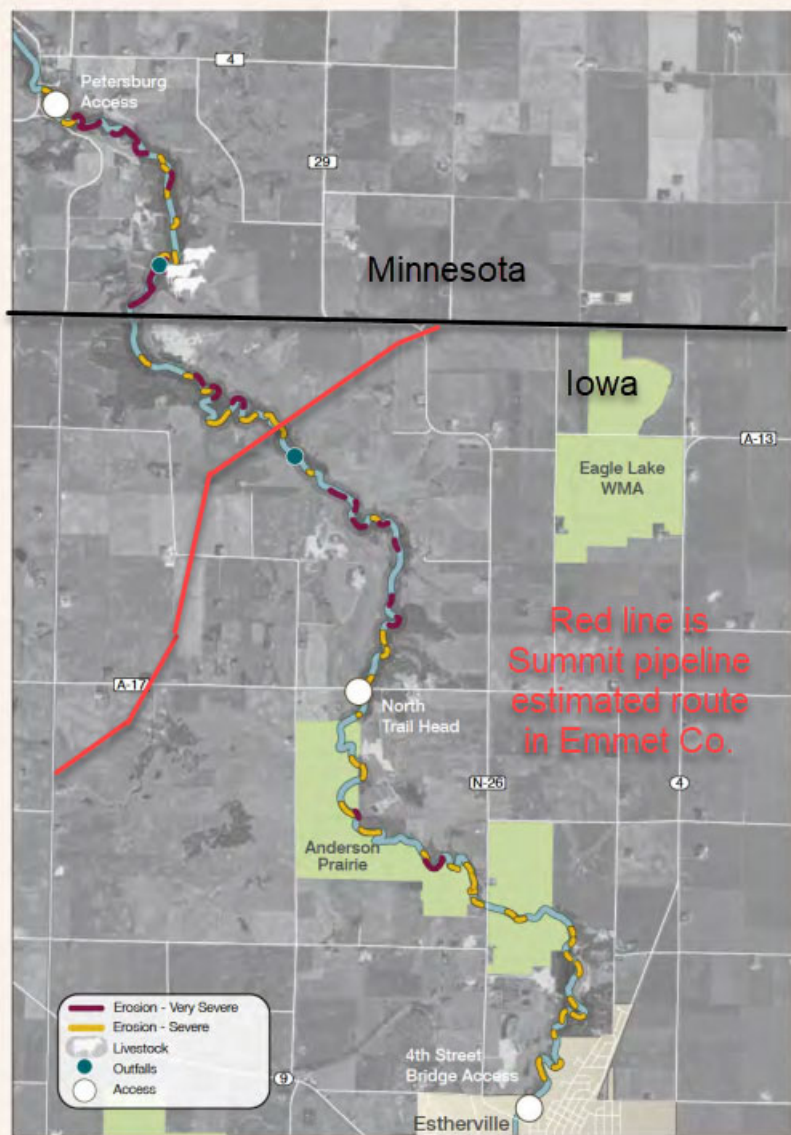
Figure 5

Very severe streambank erosion, shown in red above, are common on outside bends of the river upstream of the North Trailhead Access. Cattle were observed in and near the river and contribute to streambank instability and increased nutrient and bacteria loading.
