The 2022 Hunga Tonga-Hunga Ha'apai Eruption

Water Levels & Community Impacts on Pacific Island (Pasifika)
Coasts

Talofa J. Fe'a

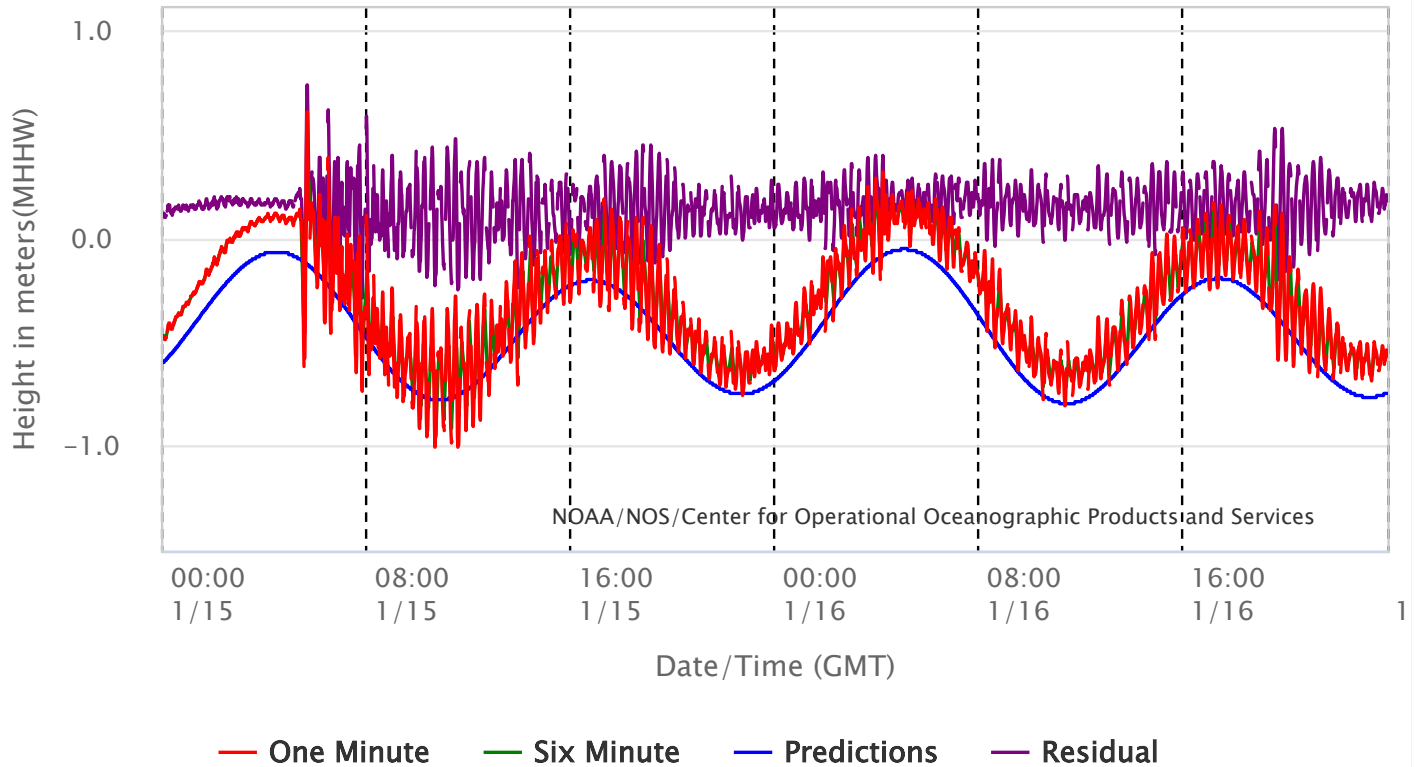
Station ID 1770000

NOAA/NOS/CO-OPS Tsunami Water Levels at 1770000, Pago Pago, American Samoa, American Samoa

From 01/15/2022 00:00 to 01/17/2022 00:00 GMT

CO-OPS first observed the tsunami wave at its station in Pago Pago, American Samoa. Essentially the “watchstander” of CO-OPS, CORMS (Continuous Operational Real-Time Monitoring System) automated software and oceanographic technicians promptly detected high sea levels around 5:30 UTC (5:30 GMT on graph). Peak one-minute water level was 1.8 feet/0.74 m above Mean Higher High Water (MHHW) at 1/15/2022 5:38 UTC.
