FOCUSED SITE ASSESSMENT INSPECTION REPORT

INSTALLATION NAME: Polychem Services, Inc., LLC
U.S. EPA ID No.: ILD 980 578 876
LOCATION ADDRESS: 374 E. Joe Orr Road
Chicago Heights, IL 60411
NAICS CODES: 325211 (Plastics, Material and Resin
Manufacturing); 424690 (Other Chemical
and Allied Products Merchant Wholesalers)
DATE OF INSPECTION: December 26, 2012
EPA INSPECTOR: Michael Valentino

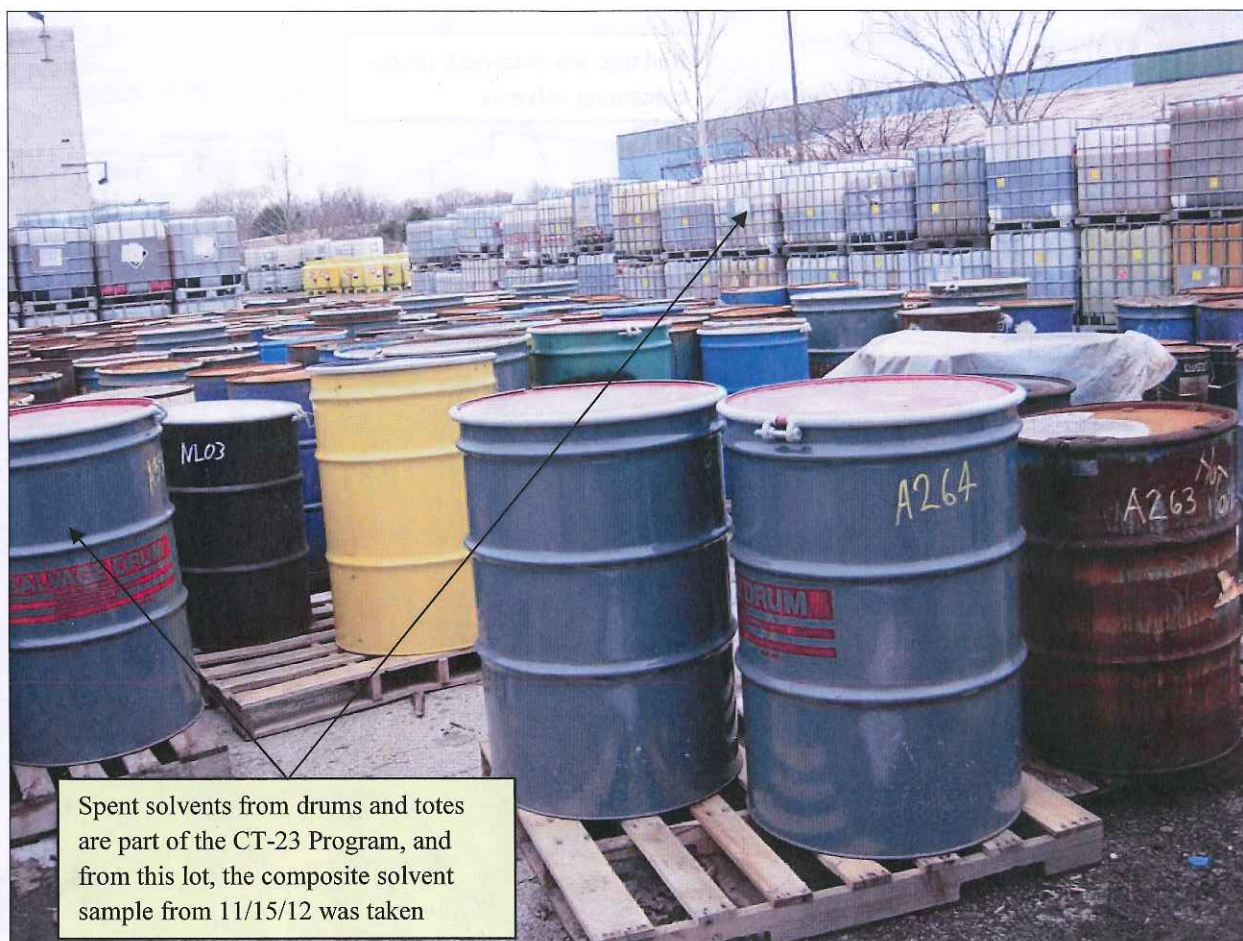
PHOTO 10

10	12/26/12	10:34 am	M. Valentino	NW	Area 4 drums (L. of photo) for CT-23 Program; Area 2 totes (R. of photo) for CT-23 Program.
11	12/26/12	10:34 am	M. Valentino	W	Area 4 solvent drums (CT-23 Program). Amine product (DMEA, DMIPA, TEA) tankers in rear of photo.
12	12/26/12	10:35 am	M. Valentino	NW	Area 2 totes (resin and solvent mixtures) for CT-23 Program.
13	12/26/12	10:35 am	M. Valentino	N	Area 2 totes (resin and solvent mixtures) for CT-23 Program.

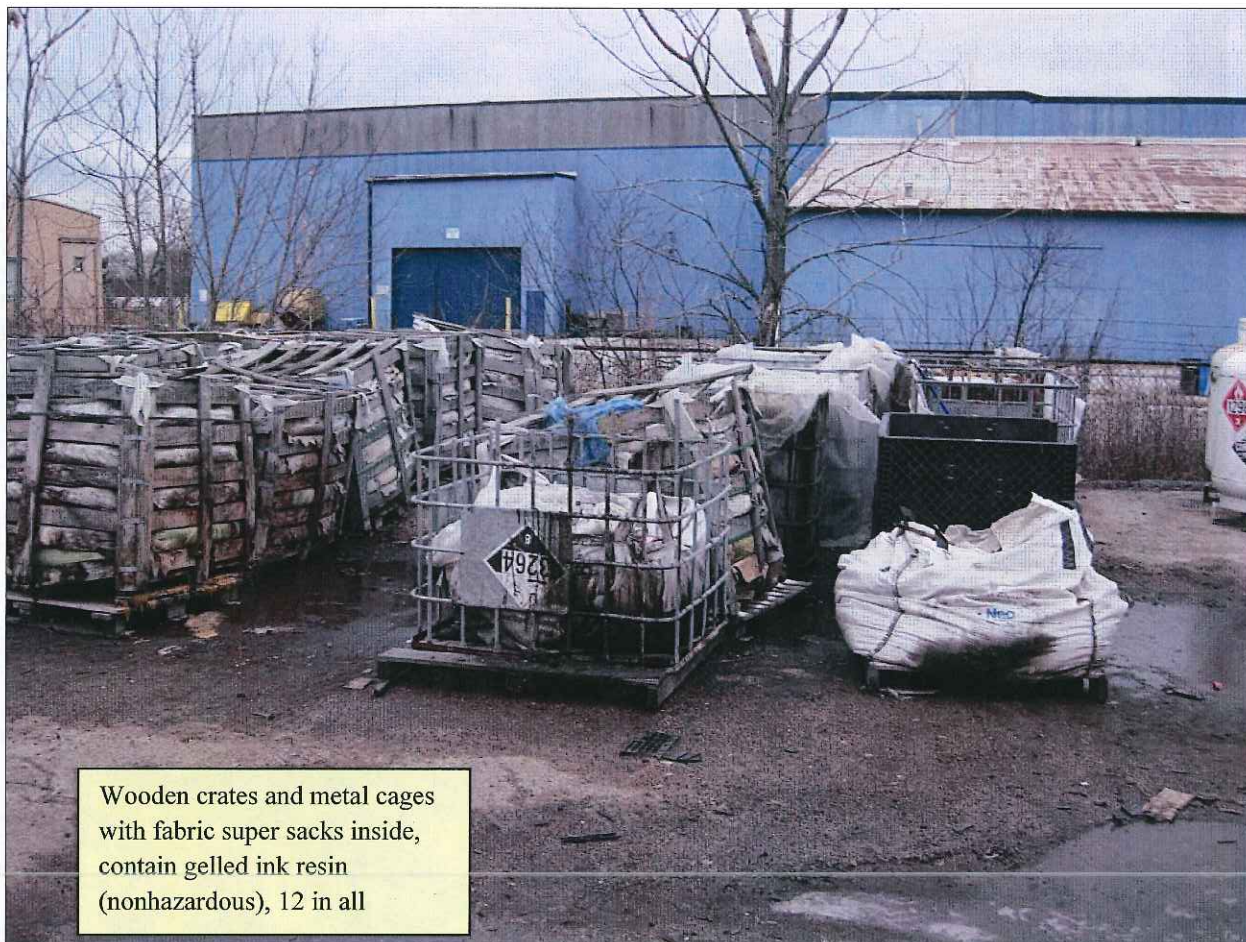
PHOTO 25

25	12/26/12	10:44 am	M. Valentino	NNW	Area 1. Fabric super sacks in wooden frames contain gelled ink resin (nonhazardous).
26	12/26/12	10:45 am	M. Valentino	NW	Far northwestern corner of facility. Drums stored here previously have been relocated on-site (to Areas 4 and 7 or to the west-central part of the facility where Heartland drums are stored).
27	12/26/12	10:45 am	M. Valentino	SW	West-central area, north of raw material tank farm. Heartland drums.
28	12/26/12	10:45 am	M. Valentino	SW	West-central area, north of raw material tank farm. Heartland drums. Close-up of Photo 27.
29	12/26/12	10:46 am	M. Valentino	SSW	Raw material tanks on west end of facility. Secondary containment had a small amount of standing liquid on the day of the December 26, 2012 inspection.
30	12/26/12	10:47 am	M. Valentino	SW	Raw material tanks on west end of facility. Tank 107 (styrene).
31	12/26/12	10:47 am	M. Valentino	SW	Raw material tanks on west end of facility. Tank 101 (xylene).
