**From:** Kristen Schlemmer <kristen@bayoucitywaterkeeper.org>  
**Sent:** Friday, September 18, 2020 4:41 PM  
**To:** Davidson, John P II CIV USARMY CESWG (USA); lee.hardy@usace.army.mil; CESWG Regulatory Inbox  
**Cc:** Jordan Macha; jingleheimer53@gmail.com  
**Subject:** [Non-DoD Source] Oaks Texas City LLC development in Hitchcock, Texas (Galveston County)  
**Attachments:** Letter to Corps re Hitchcock wetlands.pdf

September 18, 2020

RE: Oaks Texas City LLC development in Hitchcock, Texas (Galveston County)

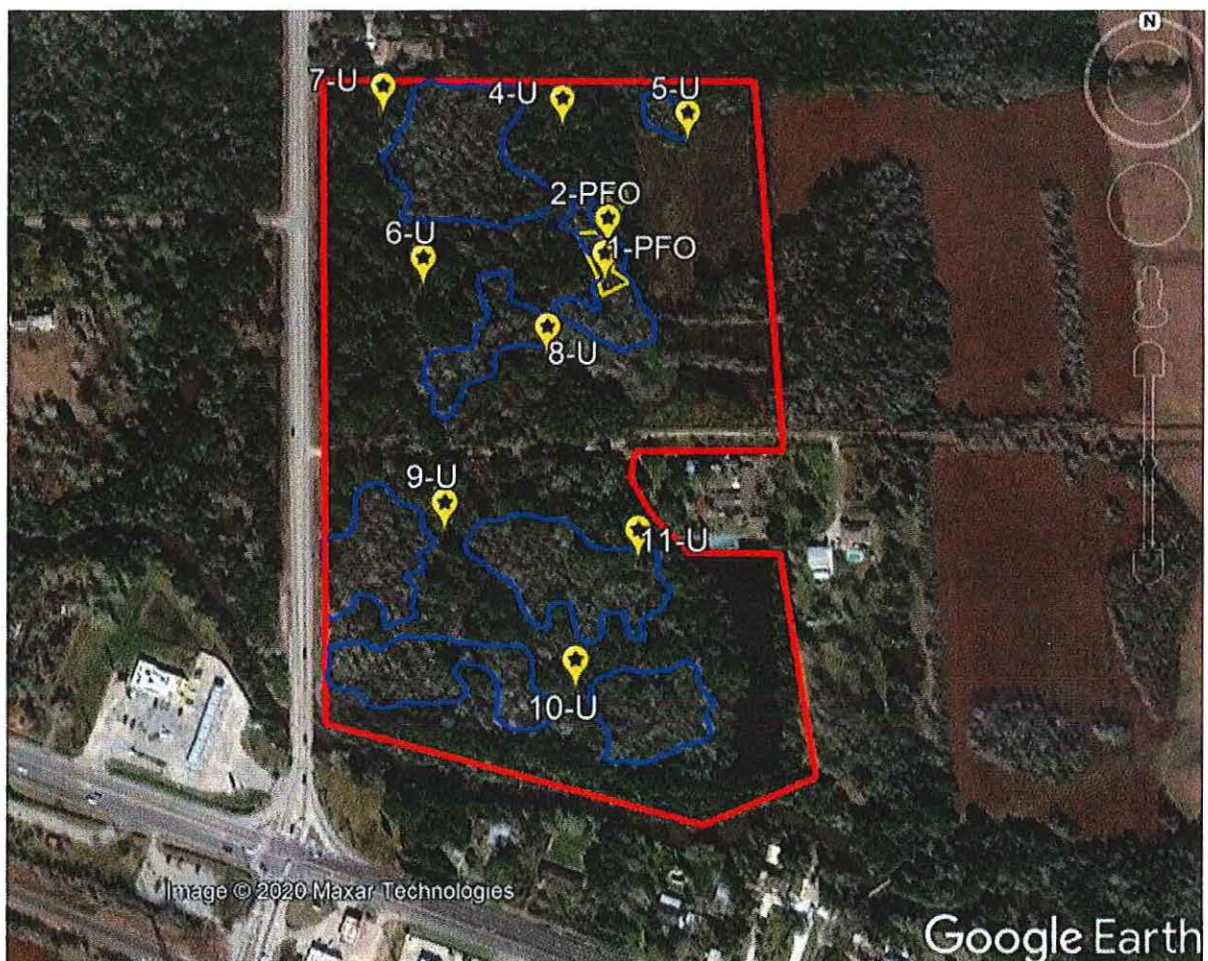
Using this aerial photography, Dr. Jacob drew 8 polygons enclosing areas with tonal patterns strongly suggestive of wetlands. These areas appear to be stands of deciduous trees, consistent with commonly occurring wetland trees, such as Chinese tallow (*Triadica sebifera*), Hackberry (*Celtis laevigata*), elms (*Ulmus*), and others. These wetland polygons sum to 8.4 acres and warrant greater scrutiny of the Oaks at Hitchcock development.

Figure 1. The Oaks at Hitchcock project at FM2004 and Tx Hwy 6.

In Figure 1 above, the red line is the site's boundary. The blue lines are areas that are likely wetland areas, interpreted by recent aerial photography by this investigator, totalling ~8.4 acres—in contrast to the 0.05 acres of wetlands identified in the SWCA Report (the yellow line).

By not mapping the areas outlined in blue, the SWCA Report suggests that these areas are in fact *not* wetlands. But this falls short. It is very much incumbent on the delineators who did the field work to provide solid documentation of why these very obvious areas should not be considered wetlands. It almost seems as if they studiously avoided these areas that stand out so obviously on the aerial photography. At best, they placed a few observations on the very edges of these areas, where one would expect less salient wetland features on the ground.

Given the primacy of aerial photography for delineating wetlands, it is completely inexcusable for neither the SWCA nor the Corps to provide documentation for observations that are not consistent with available, very strong evidence, such as multiple aerial photographs. A desktop delineation is of course only a prelude to observations on the ground, what is commonly called *ground-truthing*, or verifying on-the-ground patterns observed on aerial photography. But the areas sketched out in the office tell us where we should look. What is most distressing about the SWCA Report is that they did not examine, or at least did not provide any documentation that they examined, very distinctive and persistent aerial photographic signatures, which strongly suggest wetland vegetation and hydrology.

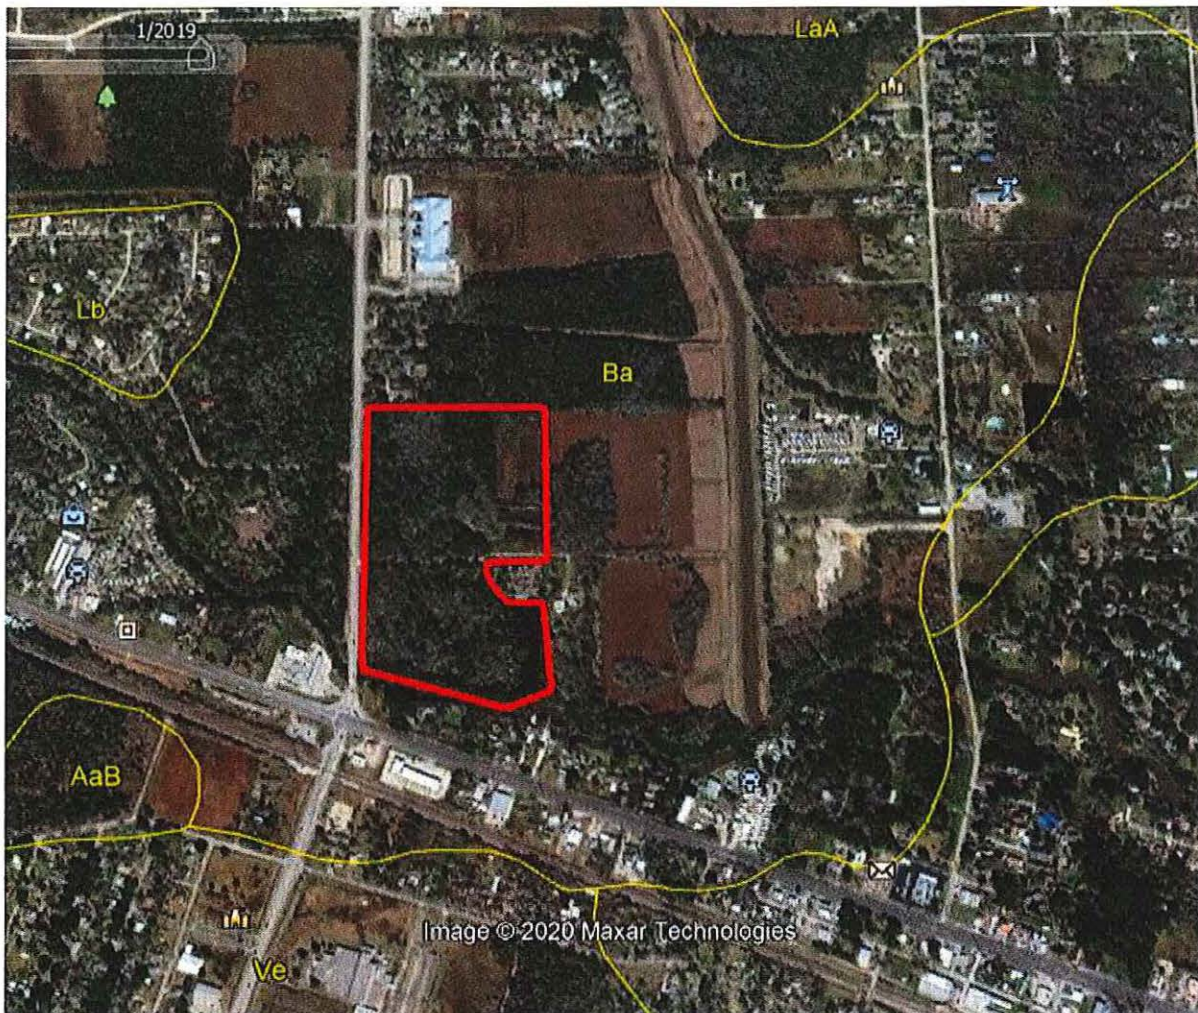
The entire subject property is mapped by the NRCS as *Bacliff clay, 0 to 1 percent slopes, rarely flooded*.<sup>3</sup> The NRCS rates soil mapping units by the strength of the dominance hydric soils in each mapping unit. The Bacliff clay mapping unit is rated as 90, with 100 being the maximum. It is thus very likely that the Bacliff clay mapping unit will be dominated by hydric soils.

Figure 2. Soil map (Soil Web). Ba is the symbol for Bacliff clay, 0 to 1%, rarely flooded mapping unit. Note how well the different tonal patterns stand out on the subject property at this scale.

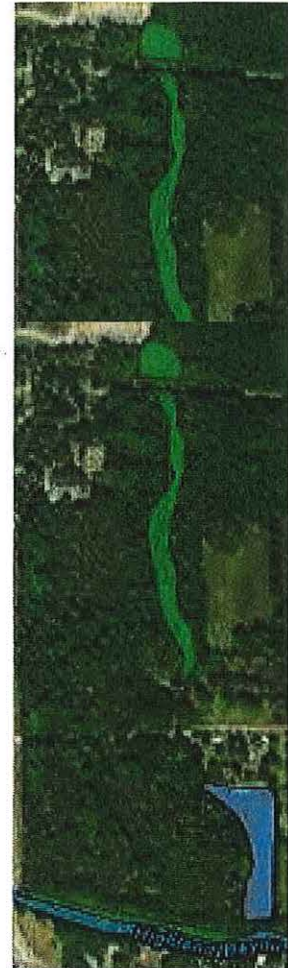
In 2006, the U.S. Fish and Wildlife Service documented a 1.76-acre freshwater forested/shrub wetland habitat classified as a PFO1A and included it in the National Wetland inventory. This wetland is depicted on the NWI map to the right in green; it is the long curving line that bisects the top half of the property:<sup>7</sup>

<sup>7</sup> Another wetland is depicted in green at the top of the picture. Based on the Galveston County Appraisal District maps, this appears to be outside of the properties owned by Oaks Texas City LLC.

This pond is visible in the picture above in blue and is also visible on historical aerial maps as far back as 1969 (the earliest map available on Google Earth Pro). The pond was added to the National Wetland Inventory in 2006 and classified as "PUBx," indicating it is a permanently flooded wetland that potentially was excavated by humans. According to the resident living next door to the property, the pond is "quite large and never goes dry"; it also has a cement lip on one side but is left natural on the other side. Record at 3. The pond is home to wildlife, including "otters, turtles, migrating birds each fall/spring and the occasional alligator." Record at 3.

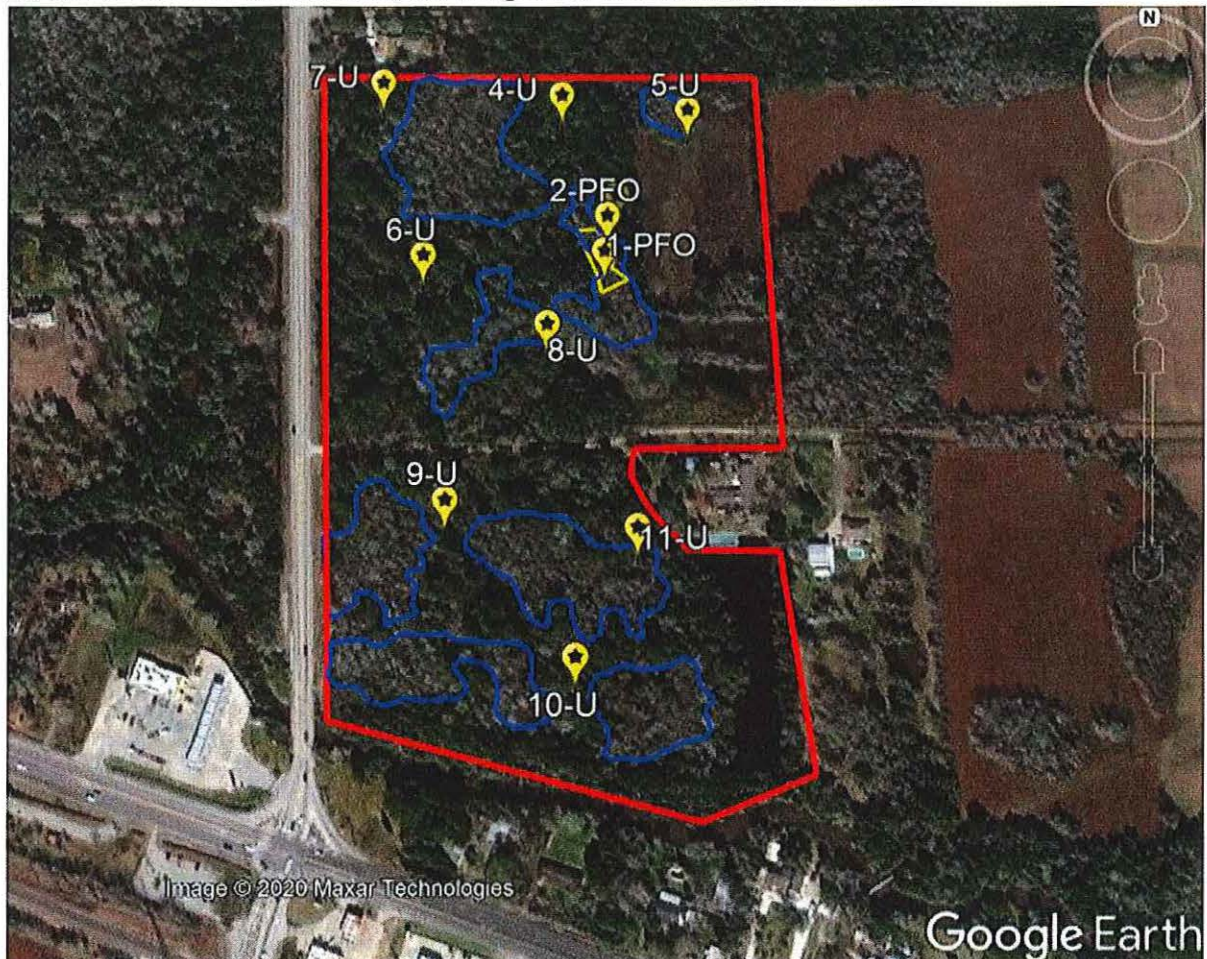
The Corps should investigate the site further to document jurisdictional wetlands in areas where aerial photography and other sources strongly suggest the presence of wetlands, and yet no field observations were recorded, including the areas outlined in blue below:

### **1. Complete further inspection and revise the jurisdictional determination to include other extensive jurisdictional wetlands on the site.**
