Evaluation of the Sunnyside Cogeneration Associates Draft Groundwater Discharge Permit

Stephen T. Nelson

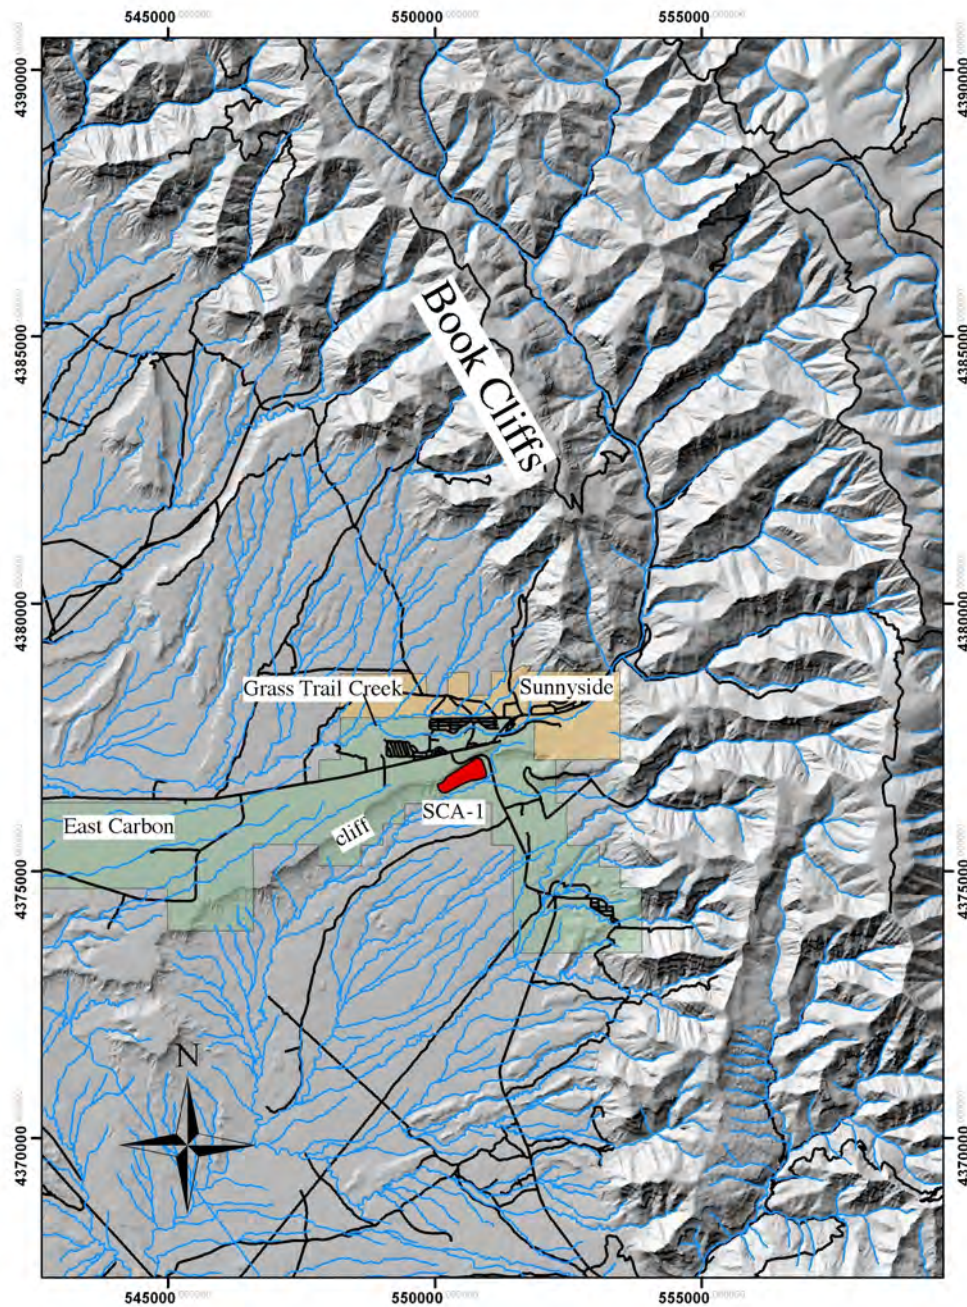
Figure 1 shows the location of coal ash disposal area SCA-1. SCA-2 is not shown because it has not been constructed and its location under the township and range system is too imprecise to evaluate (see below), although it apparently is intended to lie 2 to 3 km east of SCA-1.

As mentioned above, SCA-1 is largely built into a south-facing cliff, which is in places quite steep (e.g., Fig. 1). Figure 5 indicates that the slopes of the cliff in the vicinity of SCA-1 commonly exceed 20 to 25°. When coupled with surface and groundwater flow discussed above, the wisdom of building this facility into the cliff face comes into question. Loading of groundwater into the east end of SCA-1, erosion of the pile by stream piracy, or undercutting of the pile by present or diverted stream flows to the south of the pile may make this facility vulnerable to slope failure.

Figure 1. Index map of the Sunnyside Cogeneration geographic setting. Disposal area SCA-1 is shown in red. Black lines show roads and blue lines drainages (data from Utah Automated Geographic Reference Center, <http://gis.utah.gov/data/>) superimposed upon a hillshade generated from topographic data obtained from the US Geological Survey (<http://viewer.nationalmap.gov/viewer/>). Perimeter ticks represent positions and distances in meters (UTM projection NAD83, Zone 12S).

- SCA-1 should not, in my opinion, have been constructed in its current location. There are plenty of flat, pediment surfaces away from active drainage systems that could have accommodated this coal ash. It should never have been constructed into the cliff of an active drainage system. As it is, SCA-1 is vulnerable to flooding and permanent reorganization of the drainage network by stream capture. This could result in direct dispersal of coal ash during surface water flows similar to a 100-year event, as well as undercutting down-slope areas of the landfill before, during or after diversion. There is also likely to be increased seepage from diverted underflow from Grass Trail Creek flowing beneath the east end of the pile. These processes may combine to undermine the slope stability of the landfill. Even if none of this were to occur, because SCA-1 is perched on a cliff it will eventually be eroded and transported into the Green River—Colorado River system. Although no landfill can be considered a “permanent” feature, the permit should be disqualified on geologic considerations.

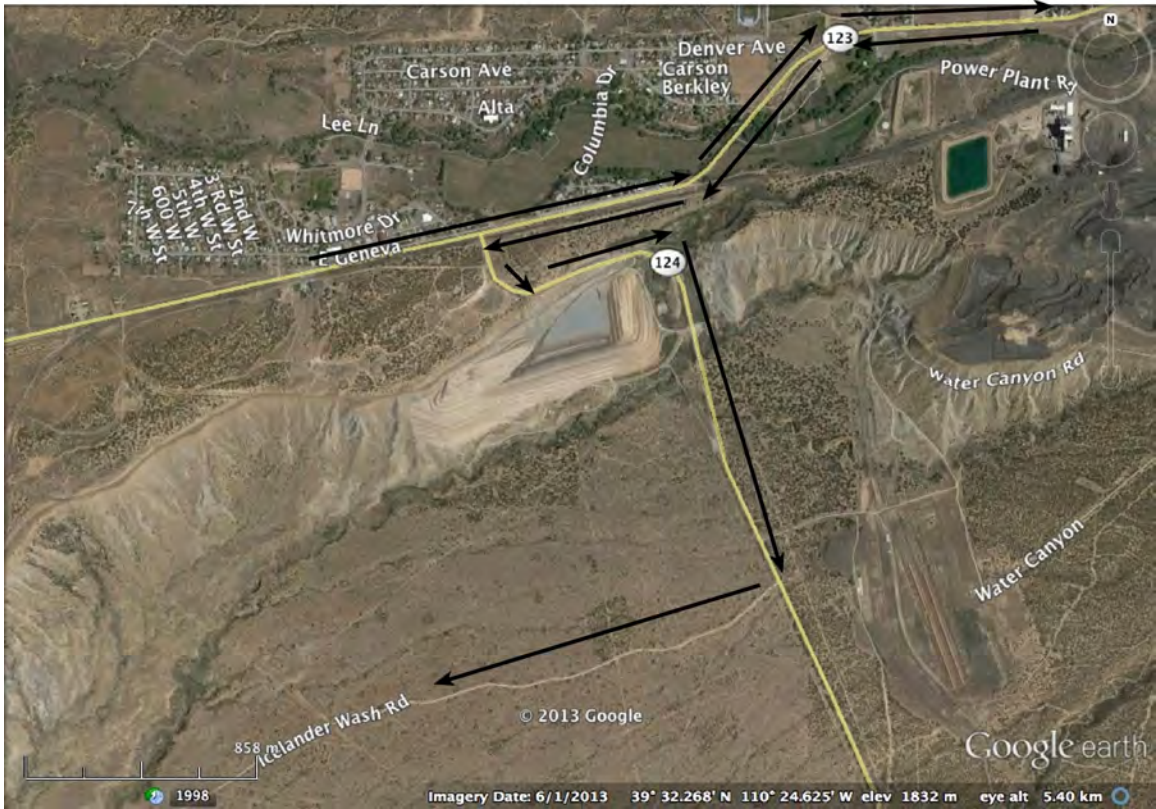
Fig. A1. Black arrows show the path of my inspection of SCA landfill and power plant area. The image was obtained from Google earth.
